INKOMATI-USUTHU
CATCHMENT MANAGEMENT AGENCY

ANNUAL WATER QUALITY STATUS REPORT FOR THE INKOMATI WATER MANAGEMENT AREA

2013 / 14 Financial Year

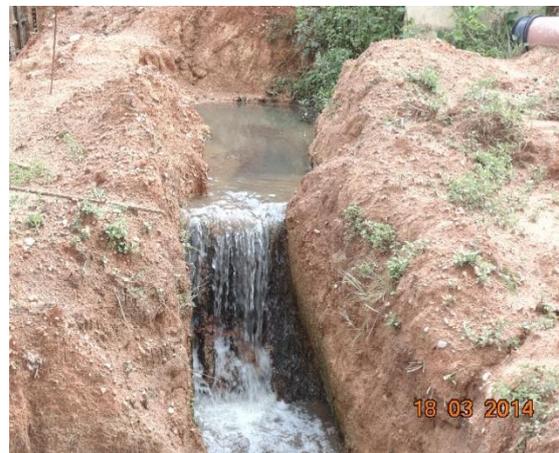
- Owing to the hole in pond 4, partially treated sewage seeps into the Inyaka Dam. See attached Figure 30 (a).
- The sewer manhole pipe has been broken since January 2014 and to date nothing has been done to fix it. See attached Figure 30.

b. Broken manhole inflow into the inlet

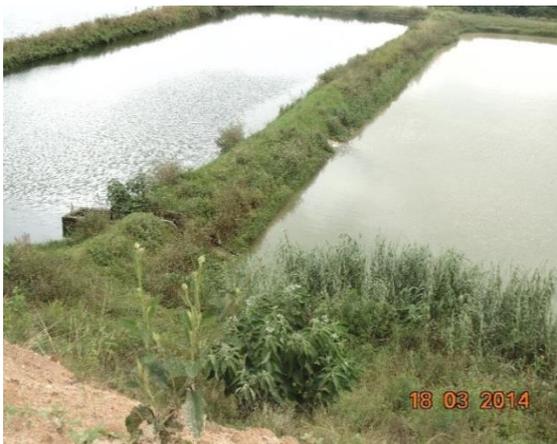
c. Oxidation ponds

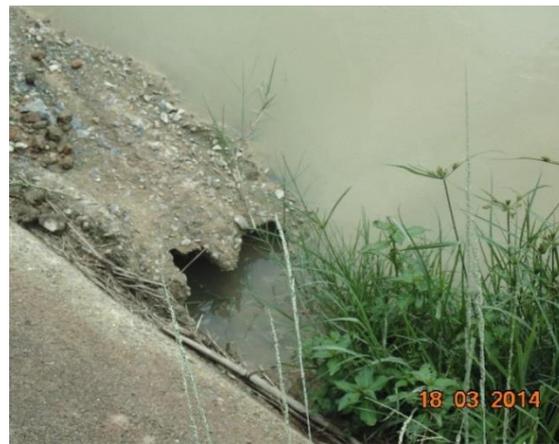
d. Outflow into the Injaka Dam

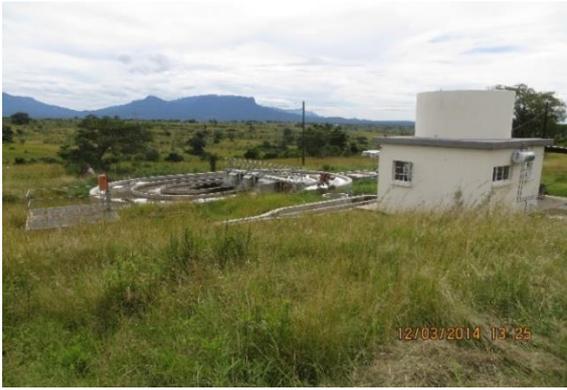
- The WWTW has been refurbished and functioned well for a few months but currently the plant is not in a good state of repair.
- The humus tanks are not functional due to the failure of the recycling pumps. See Figure 42.

a. Full view of the plant overgrown with grass

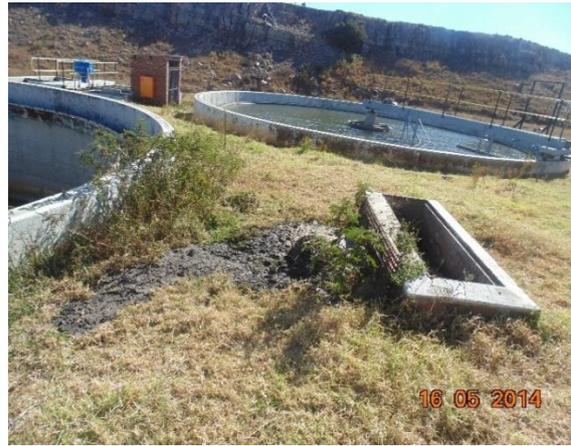
- Only two mixers were in use.
- The de-sludging pump was not working.
- One of the two clarifiers was broken.
- Recently there was no electricity at the plant. The plant was not working.

c. One clarifier in use with sludge being disposed of next to the broken clarifier

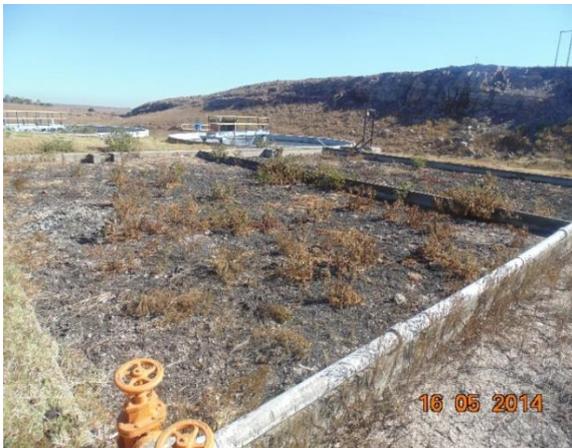
d. Drying beds no longer in use

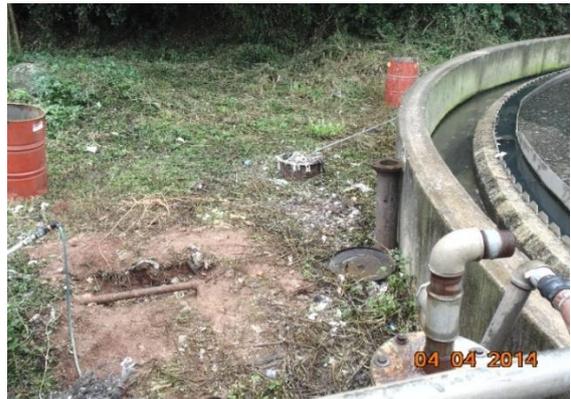
d. Improperly disposed of screenings next to the clarifier

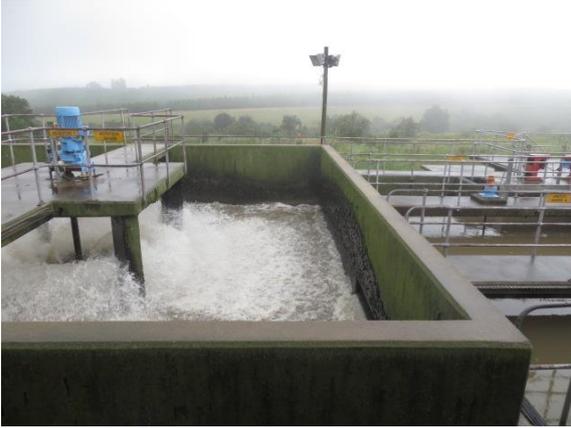
a. Cracked aeration tank

Figure 84: Pictures showing cracked aeration tank with overflow to the emergency pond at Graskop WWTW

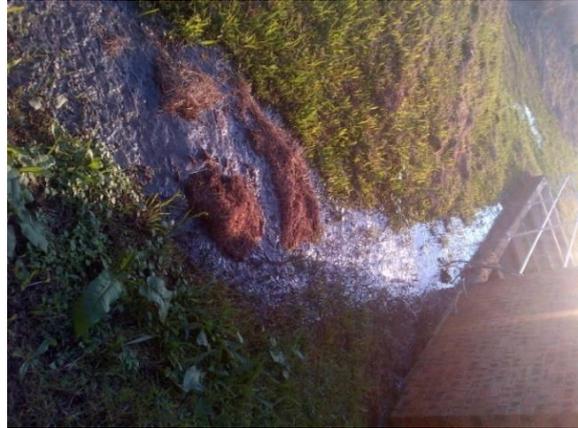
b. Overflow of raw sewage from the cracked aeration tank

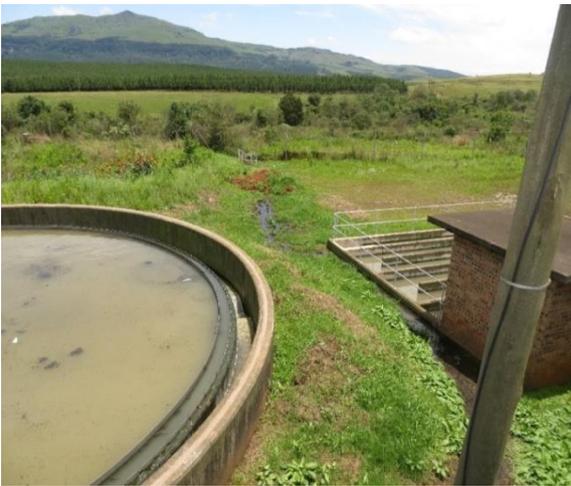
c. Overflow to the emergency pond

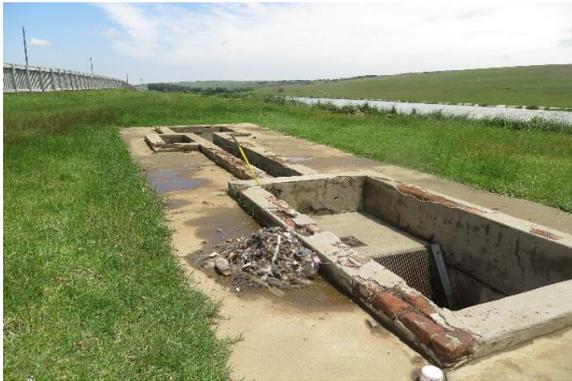
a. Screenings disposed of next to the inlet

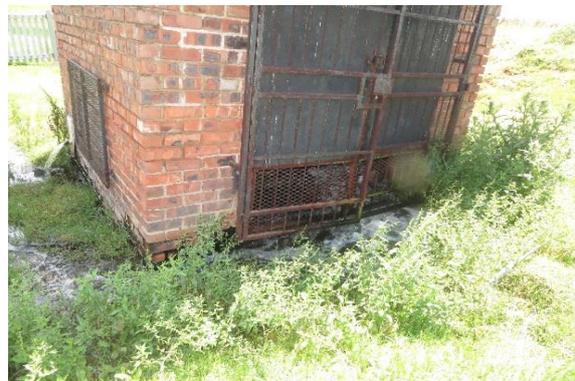
- The pump at the final pond is broken and the final effluent is discharged into the neighbouring farm's dam downstream of the WWTW.
- The plant discharges partially treated sewage into the neighbouring farm's dam downstream of the WWTW (see Figure 86 (d)).

d. Broken pump station

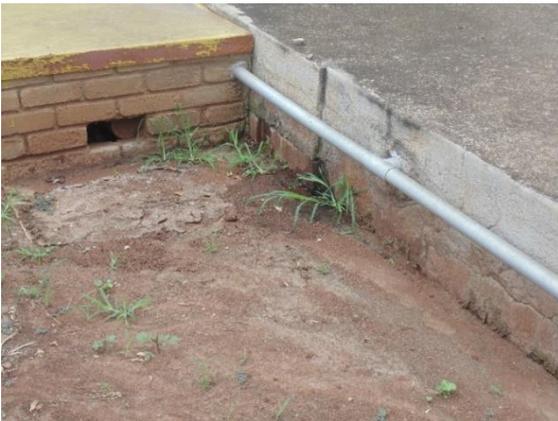
a. Traces of sewage from the bio-filters

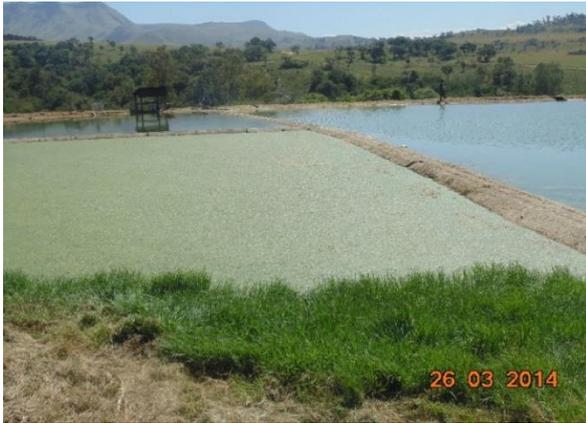
a. Ponds full of algae
