ECOSTATUS OF THE CROCODILE RIVER CATCHMENT

INKOMATI RIVER SYSTEM PHASE II (2017)

Date: January 2018

Mpumalanga Tourism and Parks Agency
Scientific Services: Aquatic & Herpetology

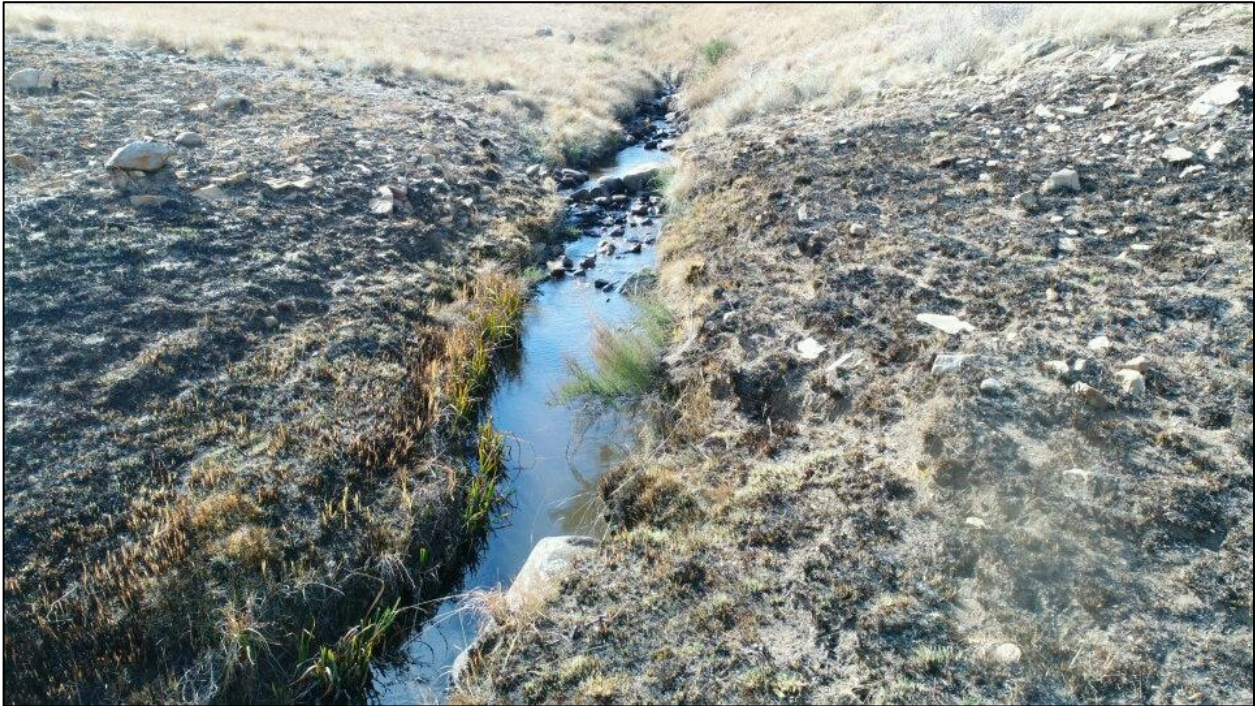
Figure 12: Headwaters of the Crocodile River.

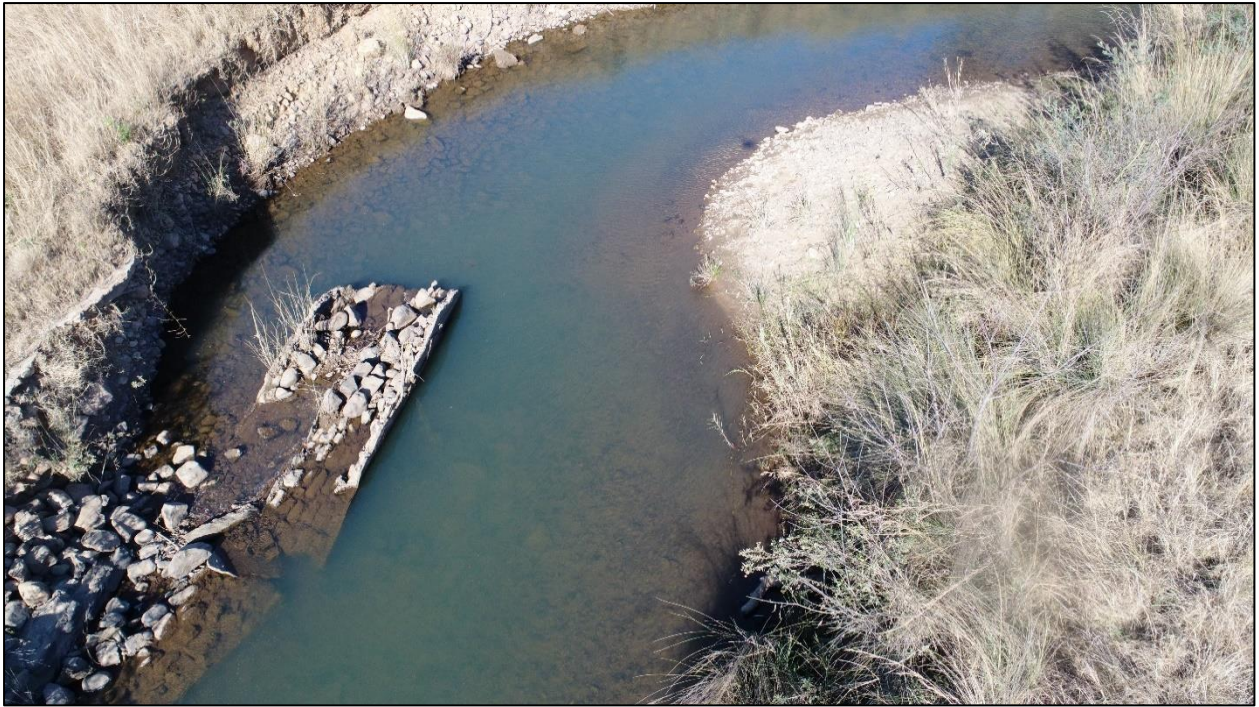
Figure13: Bank instability in the Crocodile River at EWR 2: X2CROC-GOEDE.

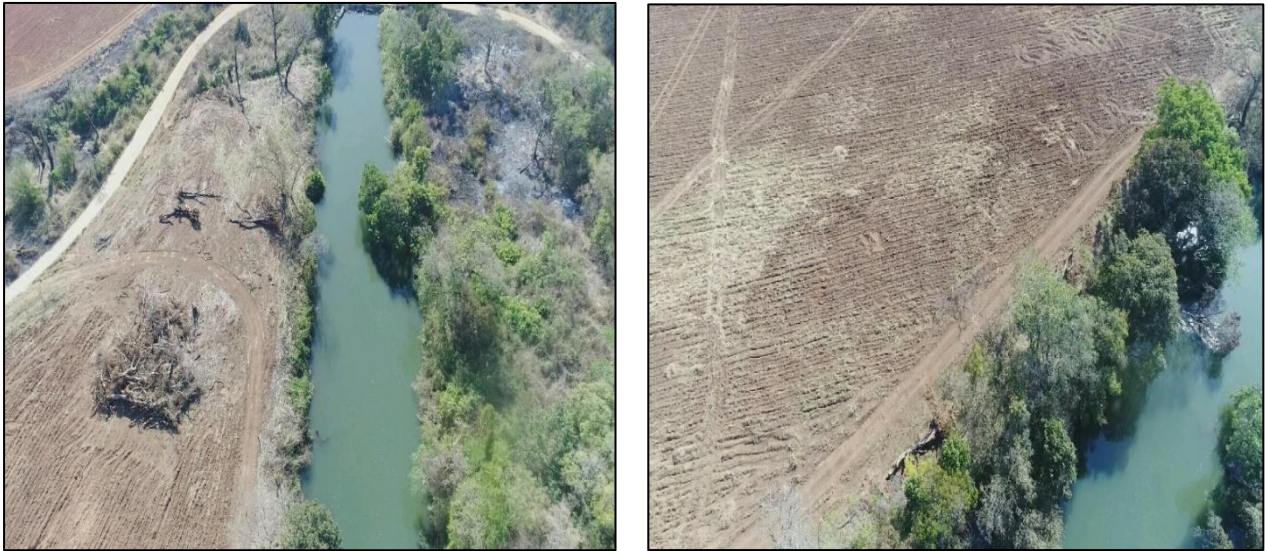
Figure 14: Cultivation in riparian zone and removal of riparian vegetation

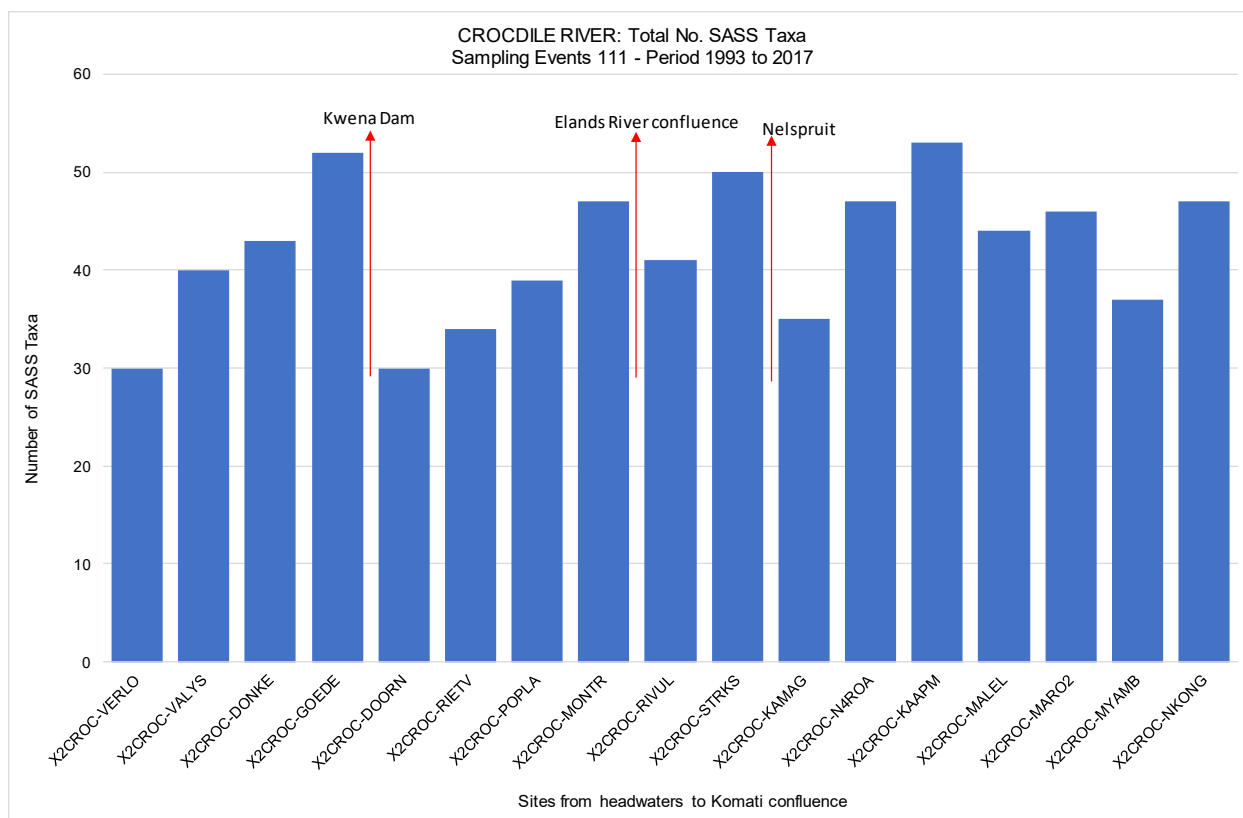
Figure 16: SASS taxa diversity recorded at each site during different surveys ranging from 1993 to 2017. Sites are listed from headwaters (left) towards the Komati confluence (right). The number of sampling events per site and seasonal distribution are listed in Table 37 above. The location of Kwena Dam, the Elands River confluence, and Nelspruit-Kanyamazane town between sampling locations are indicated as red arrows.

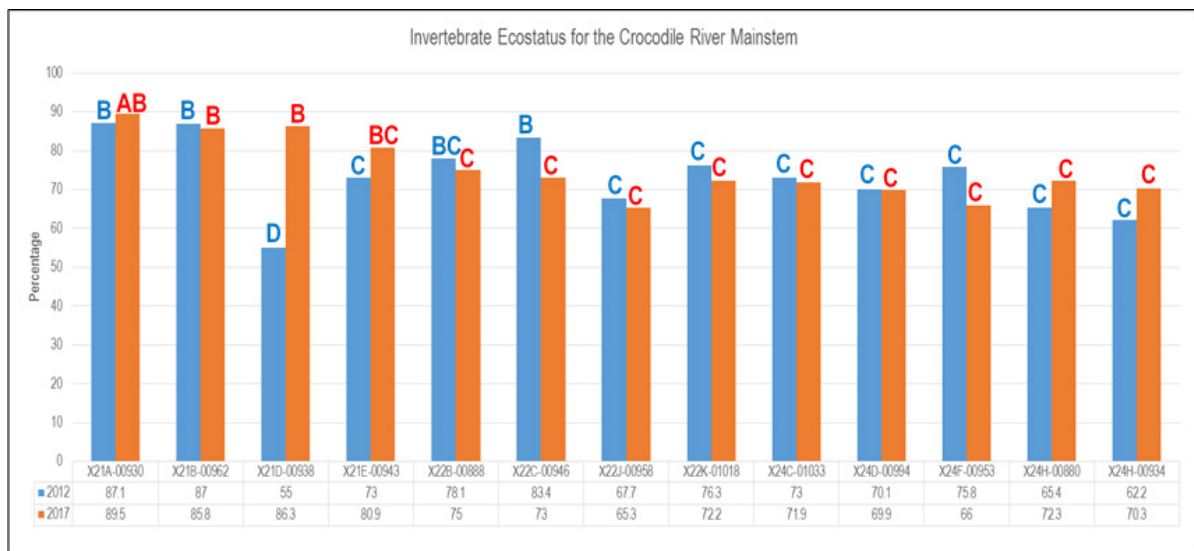
Filamentous algal growth increased considerably from the Kamagugu site (X2CROC-KAMAG) in a downstream direction, with high sand deposition from Mbyamiti (X2CROC-MBYAM) towards Nkongoma (X2CROC-NKONG).

Figure 17: Graphical comparison of the Invertebrate Ecstatus of the main Crocodile River in 2012 and 2017.

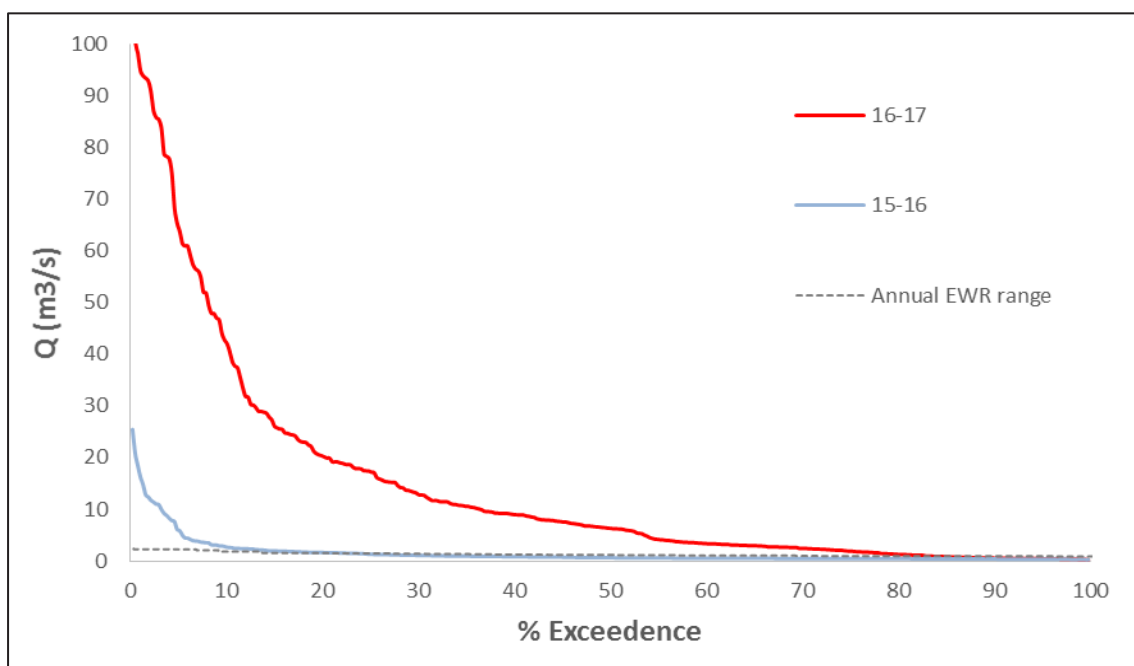
The present Ecstatus study was conducted during the 2016-17 hydrological year (October-September). Whilst that year had average hydrological conditions it followed the severe El Nino induced drought of 2014-16 and it is therefore likely that traces of this drought would still be felt in both the biotic response and abiotic parameters. It's important to note therefore that an interim drought arrangement was agreed by the CROCOC for August to November 2016 for minimum flows at Tenbosch set as $0.6 \text{ m}^3 \cdot \text{s}^{-1}$. This was largely achieved although there were instances where the flows dropped considerably below this for several hours or more. The following charts depict the hydrological status of the Crocodile River during the reporting period, and commences with the most downstream gauge. It is quite clear from Figure 8 that flows were markedly different at the lowest end of the catchment comparing the study period with the previous hydrological year. Here represented as annualised flow duration curves demonstrate that during 2016-17 flows were 90% compliant with the ecological reserve, although during 2015-16 at the height of the drought there was 70% non-compliance with the ecological reserve. One must be cognisant of the fact that flows are typically compliant with EWR requirements even during dry times up to the Riverside Weir (X2H036 – the next weir upstream from Tenbosch) in order to meet the large irrigation requirements between the two weirs. Furthermore, whilst there was high non-compliance with the ecological reserve during the drought, in fact the river performed significantly better than during previous major droughts.

Figure 18: Flow duration curve for Compliance with the ecological reserve at EWR 6 (Tenbosch, X2H016) during the reporting and previous hydrological years

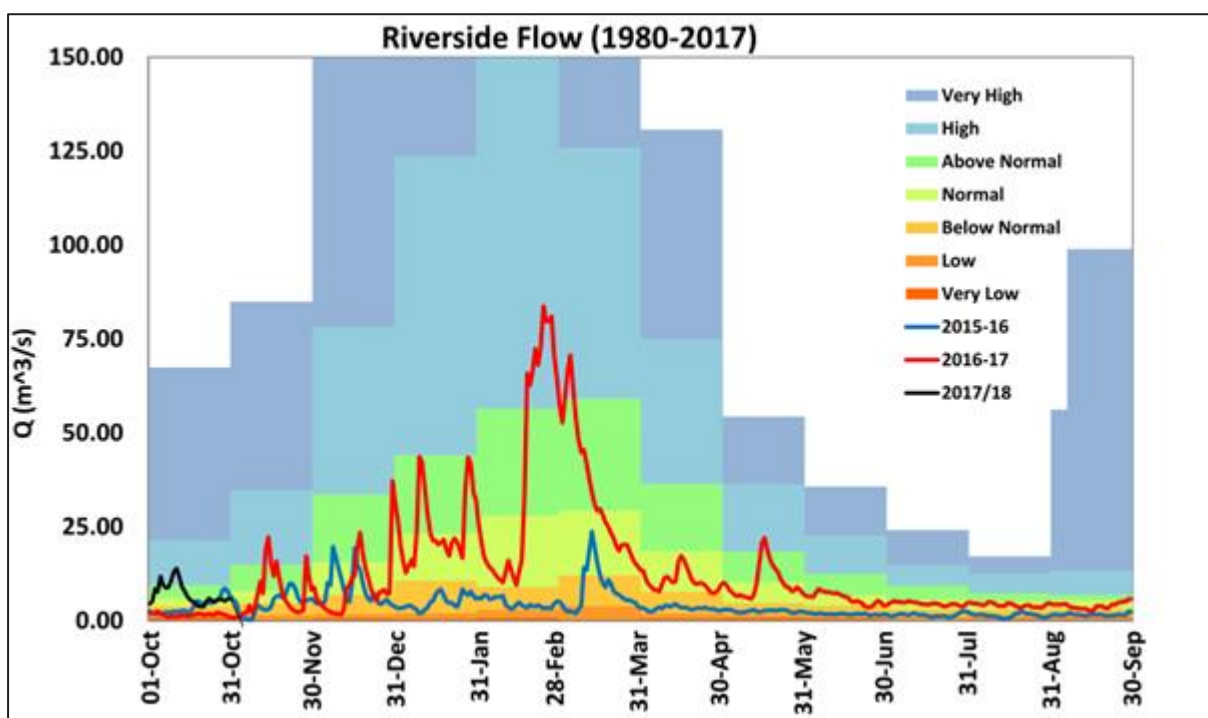
Figure 19: Observed flows at Riverside (X2H046) during the reporting period against the previous hydrological year and historical range of flows (Courtesy: Siphon Magagula, IUCMA)

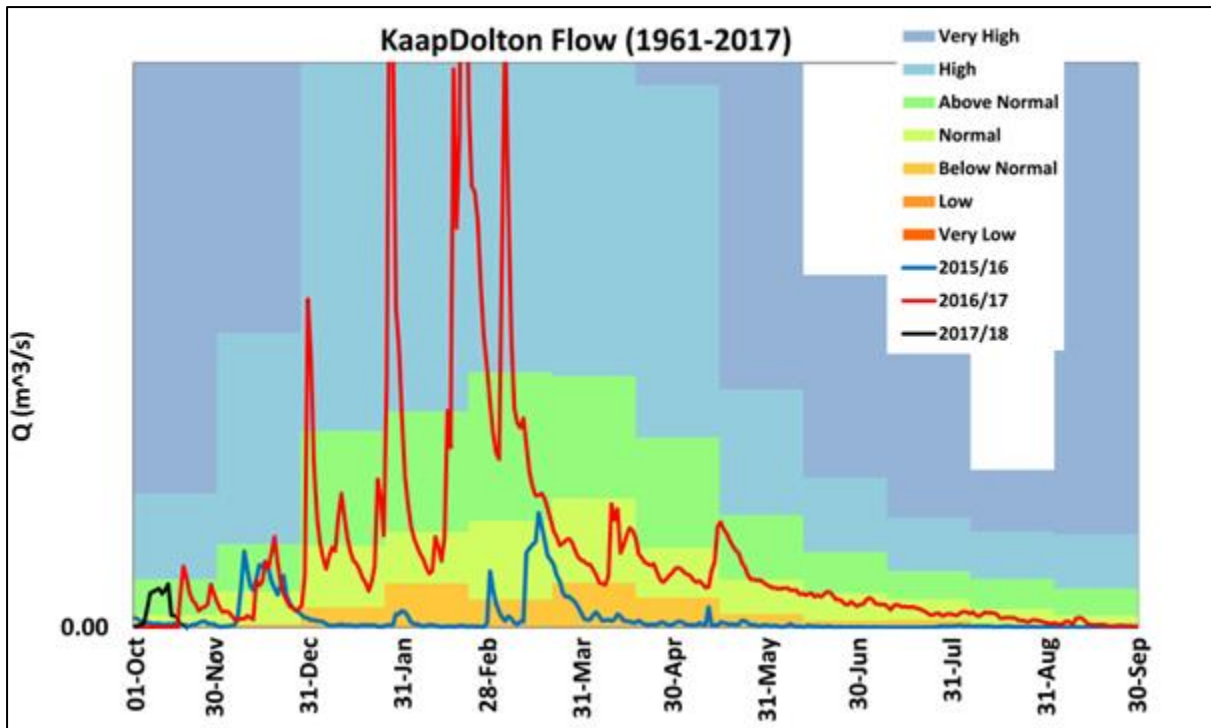
Figure 20: Observed flows at Dalton (X2H022) during the reporting period against the previous hydrological year and historical range of flows (Courtesy: Siphon Magagula, IUCMA)

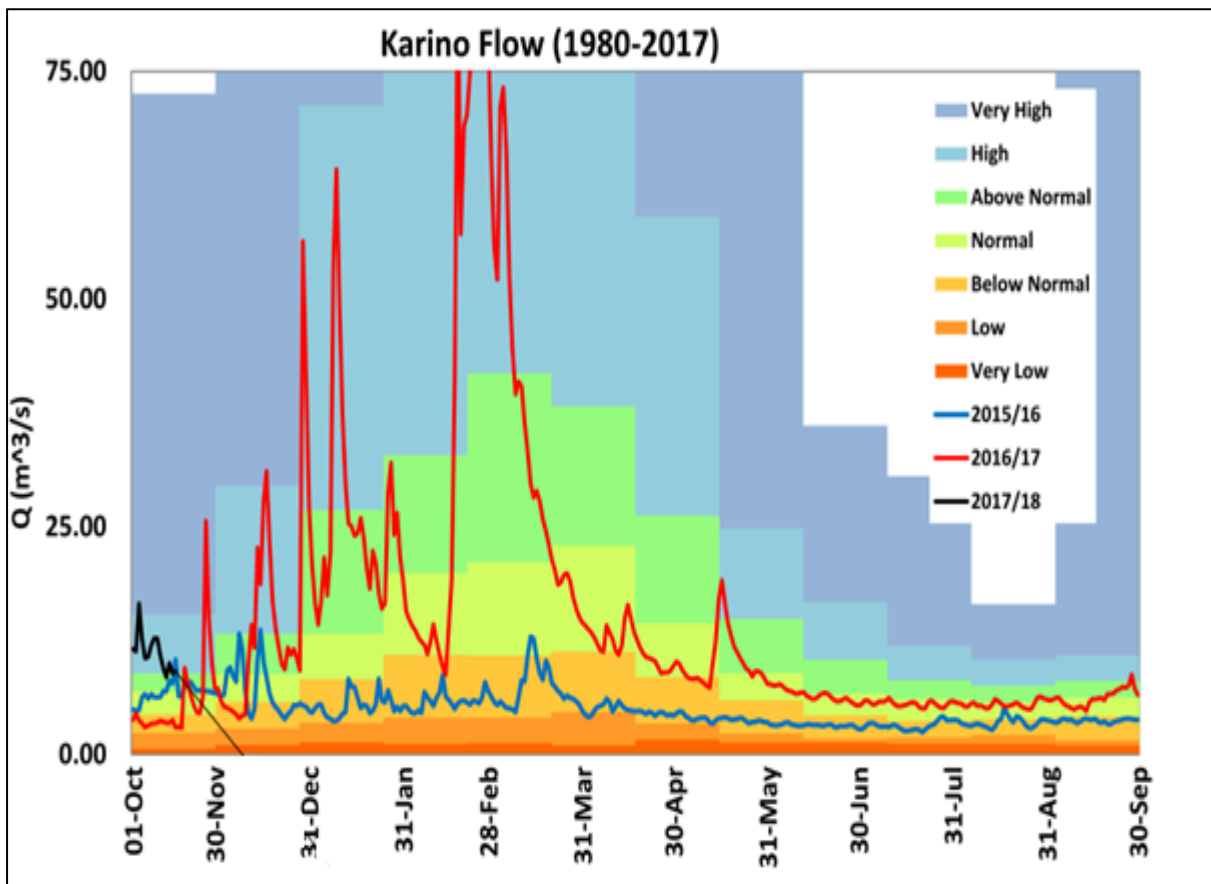
Figure 21: Observed flows at Karino (X2H006) during the reporting period against the previous hydrological year and historical range of flows (Courtesy: Siphon Magagula, IUCMA)

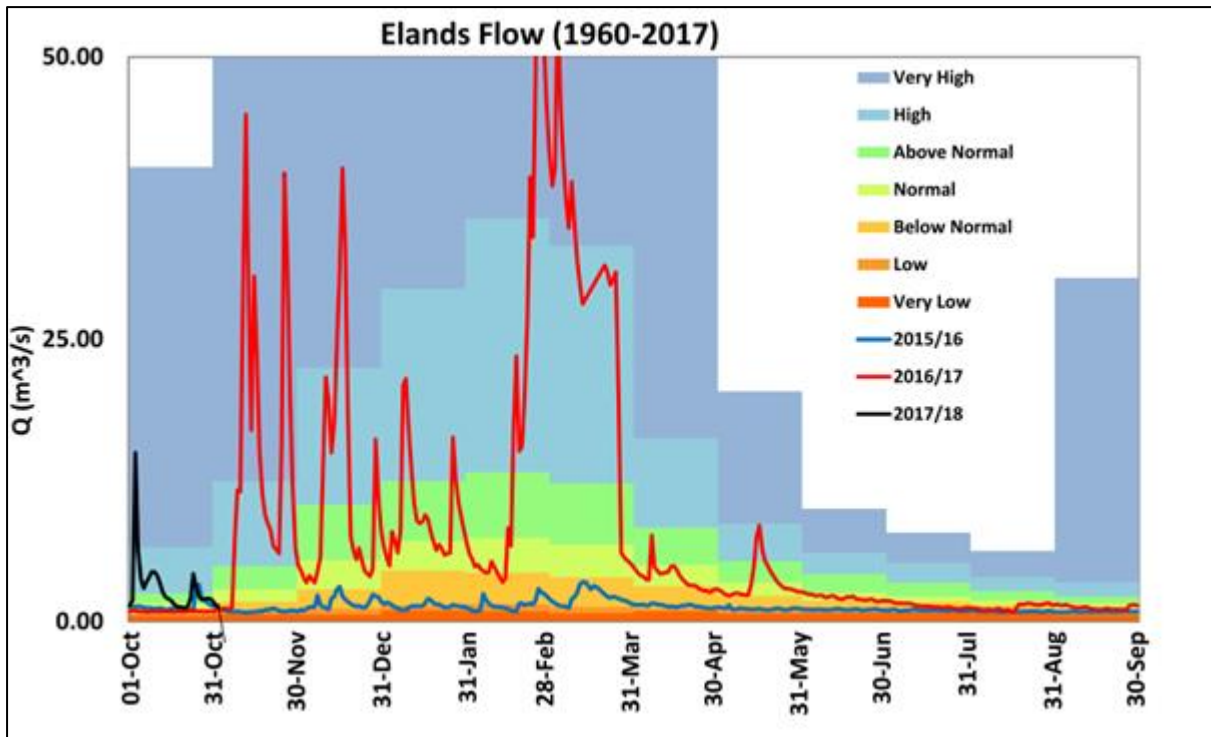
Figure 22: Observed flows at Elands Lindenau (X2H015) during the reporting period against the previous hydrological year and historical range of flows (Courtesy: Siphon Magagula, IUCMA)

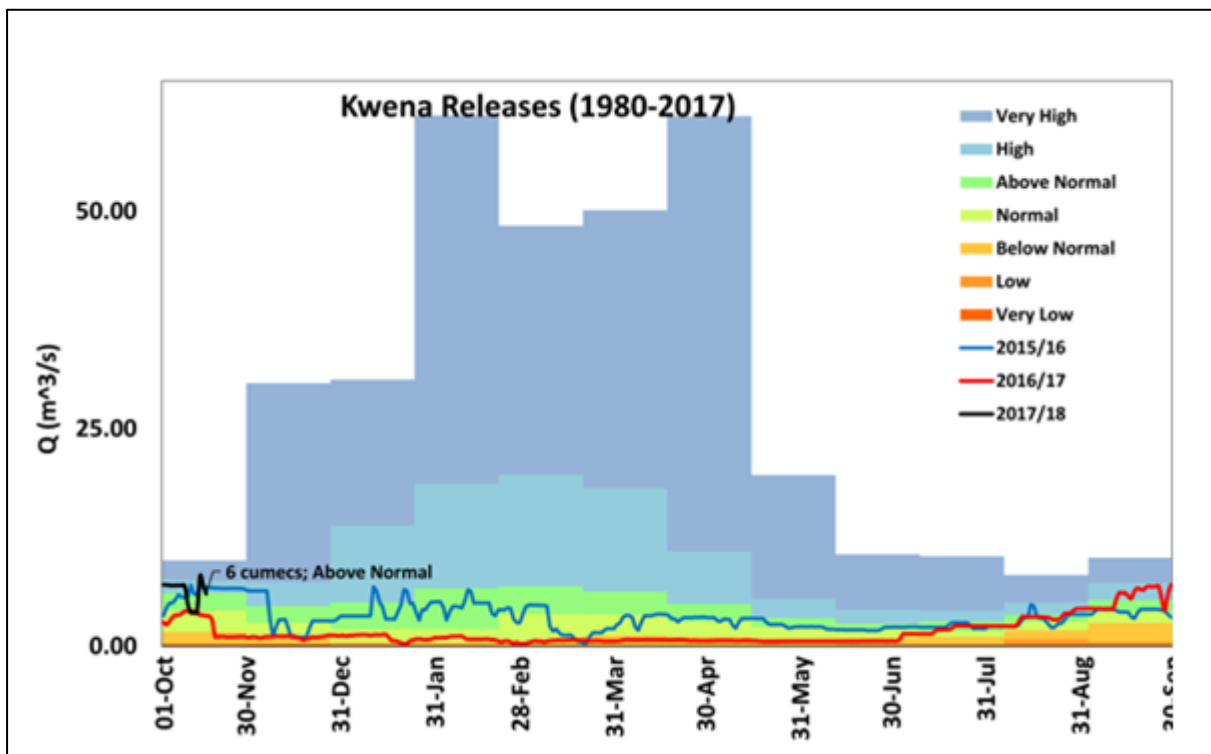
Meanwhile, outflows from the Kwena Dam (Figure23) were in the above normal to very high range during the drought of 2015-16, as discussed this was to supply the needs of bulk users, EWR and International flows targets downstream. Releases during 2016-17 were however below normal in order to recover storage following the drought. However outflows did begin to increase once again from June 2017 onwards, coinciding with warm late winter and early spring conditions. These outflows are therefore represent reversed seasonality in the upper reaches of the river and must be considered when interpreting the river ecostatus data for upstream sites between Kwena and Montrose.

Figure 23: Releases from the Kwena Dam (X2H070) during the reporting period against the previous hydrological year and historical range of outflows (Courtesy: Siphon Magagula, IUCMA)

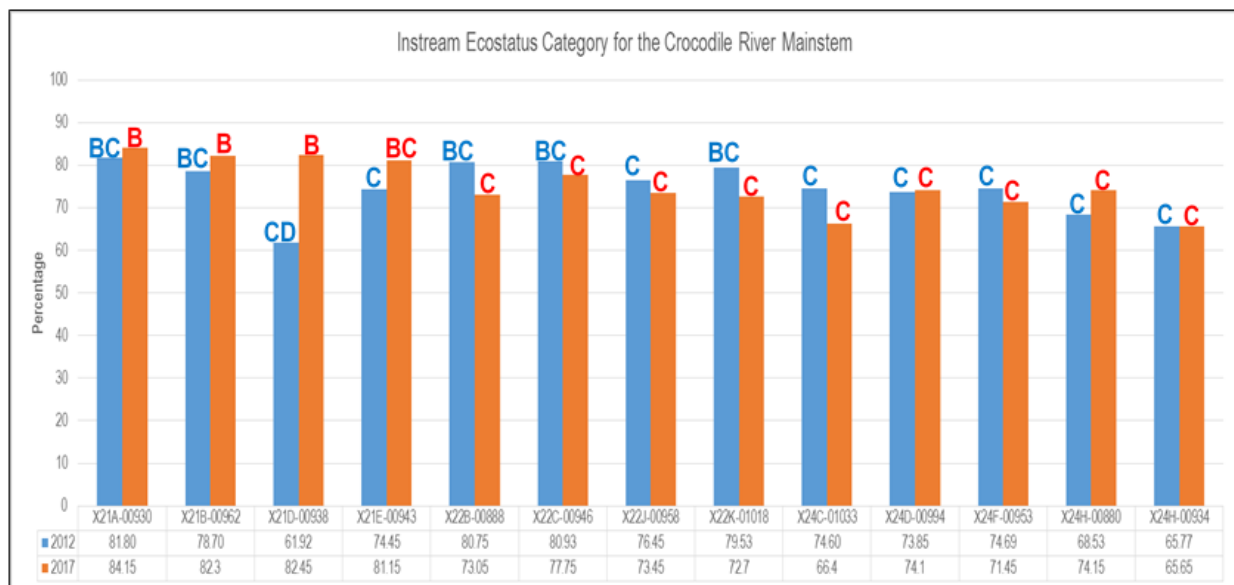
Figure 24: Comparison of the Instream Ecstatus of the main Crocodile River in 2012 and 2017.

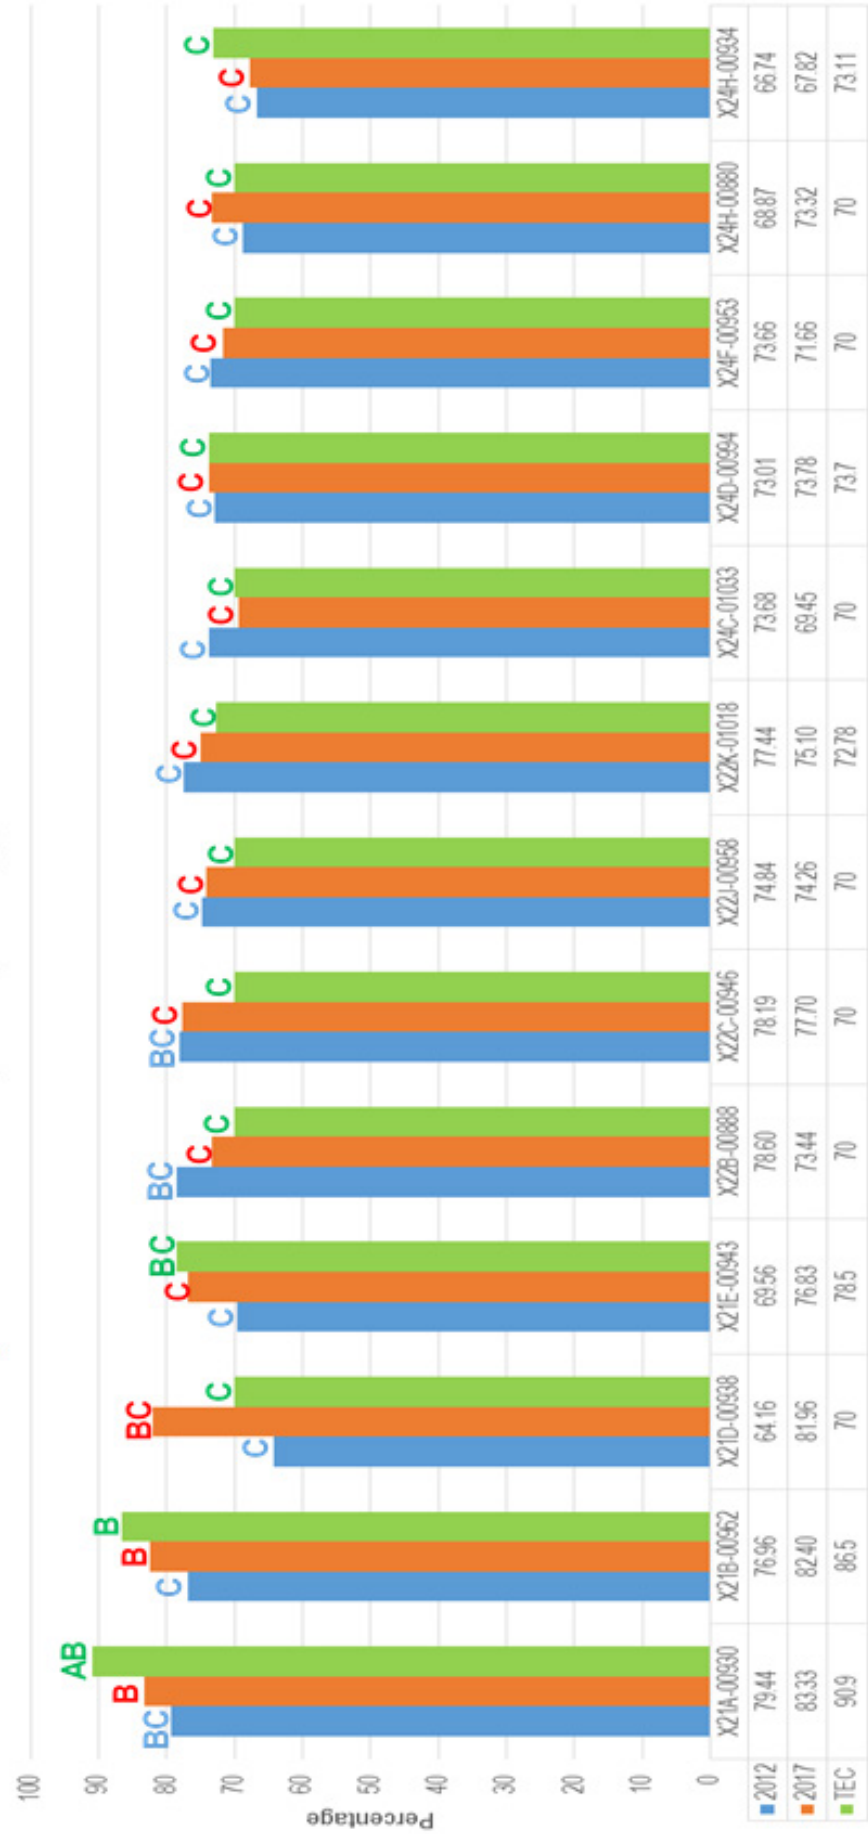
Figure 25: Comparison of the Integrated Ecosystem and Target Ecological Category for the main Crocodile River in 2012 and 2017.

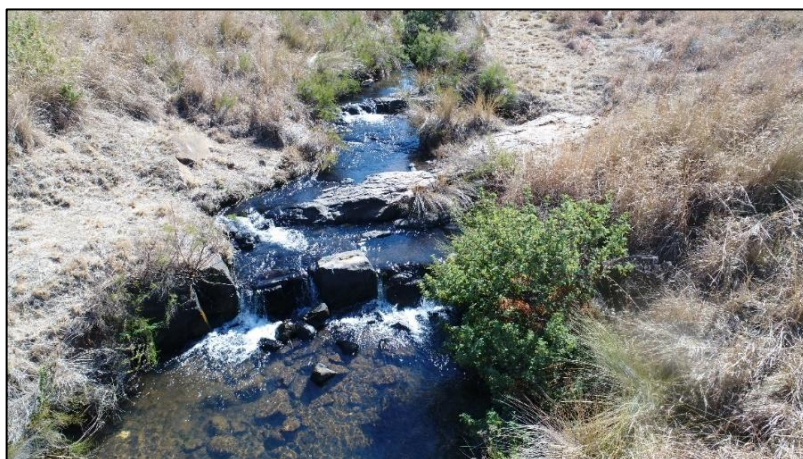
Figure 26: Kareekraalspruit from DJI drone indicating hydraulic biotopes.

The Kareekraalspruit at the sampling site is 1 to 2 m wide, dominated by cobble, gravel, boulders, and mud-silt (Figure 20). Hydraulic biotopes include cascades, riffles, runs, pools, and glides.

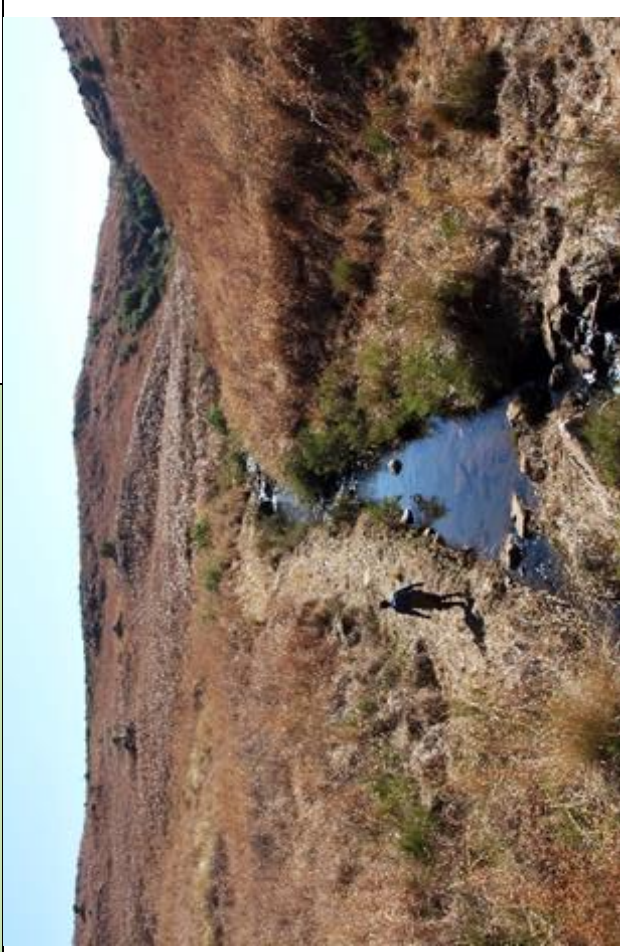
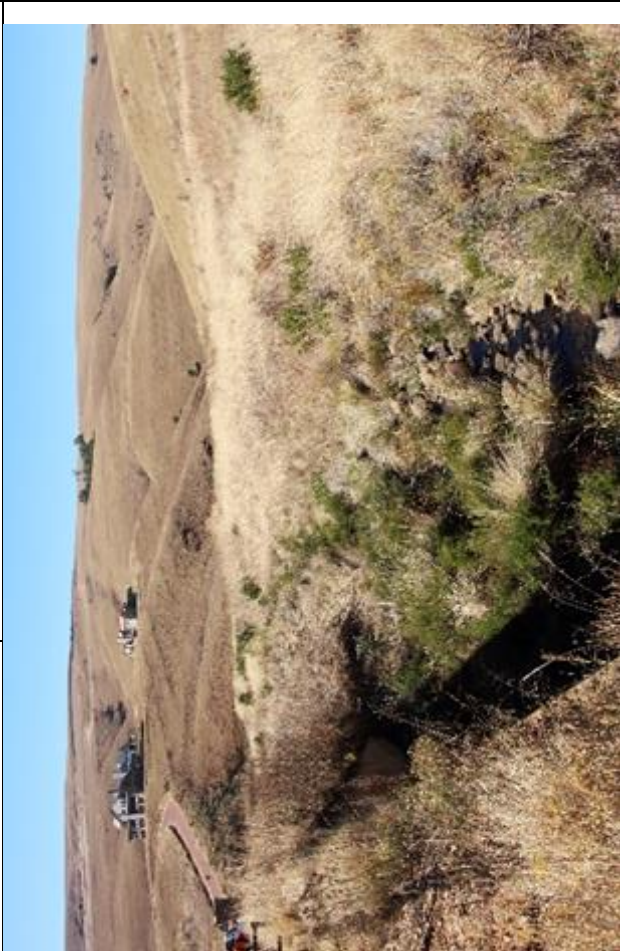
The Integrated Ecostatus Category for this reach was consistent with a Category C (77.2%) suggesting a moderately modified habitat. The loss and change of natural habitat and biota has occurred in terms of frequencies of occurrence and abundance. Basic ecosystem functions are still predominantly unchanged. There is no TEC available for this SQ Reach as it is not on an allocated reach, however it is recommended that the TEC for this reach is set at a Category B (85%).

<p>Figure A-35. Upstream view of the Kareekraalspruit on the Highlands Golf Estate (July 2017, G Diedericks).</p>		<p>Figure A-36. Downstream view of the Kareekraalspruit on the Highlands Golf Estate (July 2017, G Diedericks).</p>

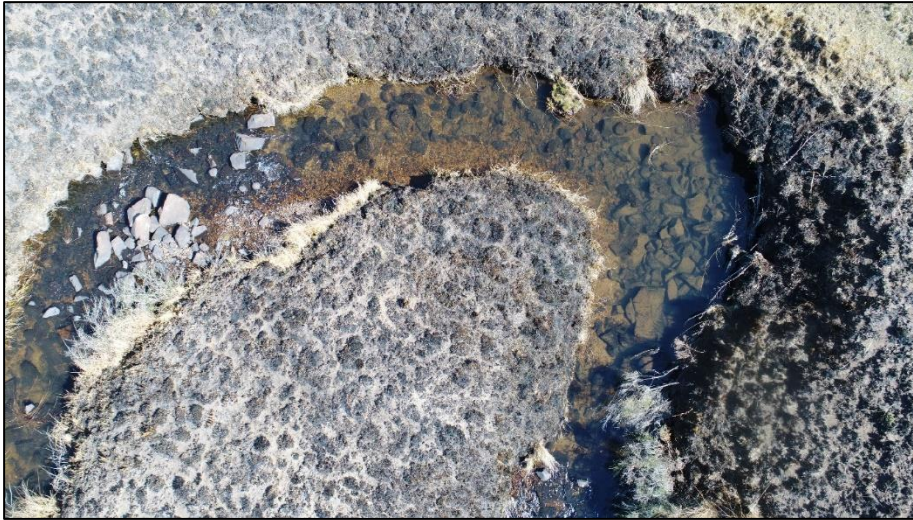
Figure 27: Drone photograph of the biotopes indicating instream fish habitat in the X21B-00898 SQ reach.

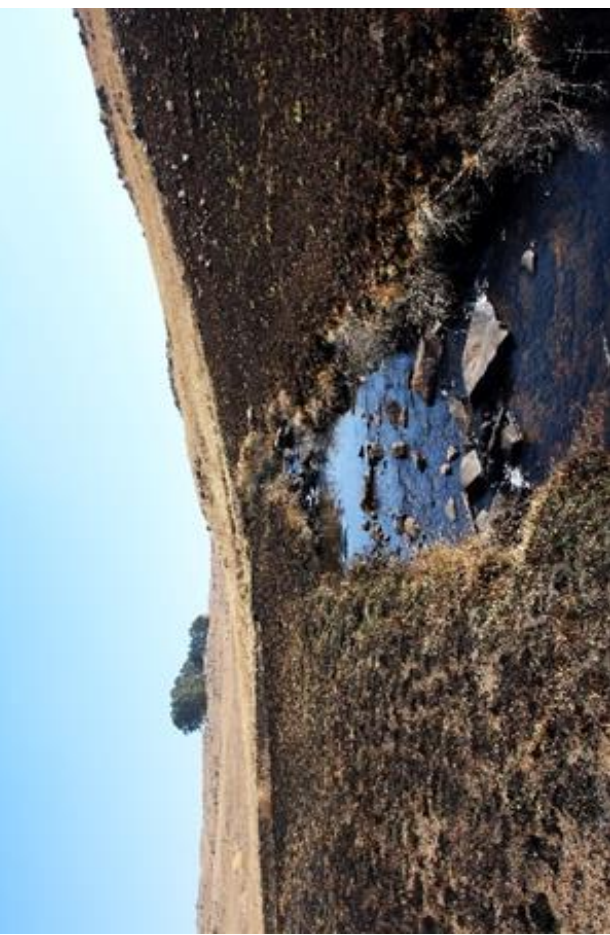
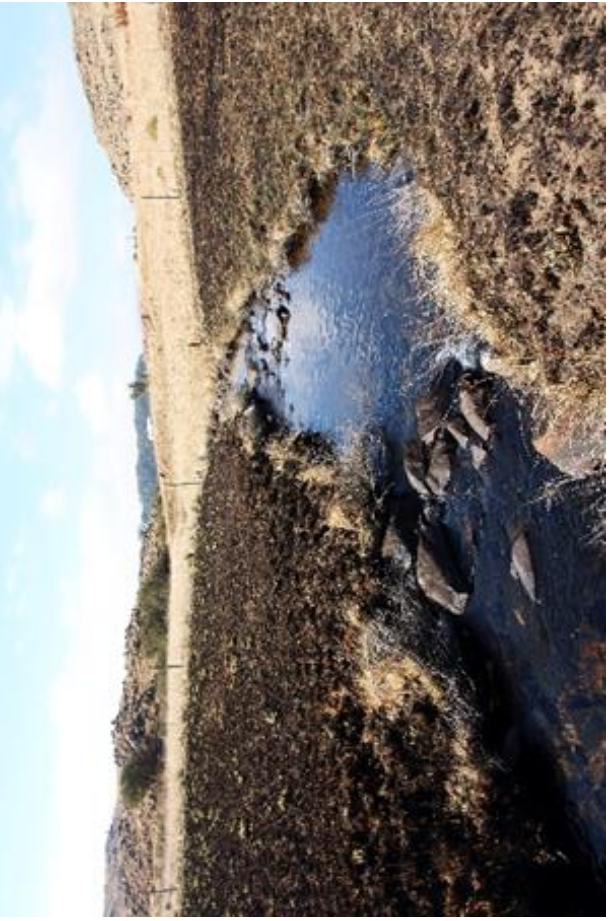
The main impact on this reach is the alien and invasive Trout Industry, creating numerous dams and weirs impacting on the natural flow regime and reduced water quality. This NEMBA species also impacts on the indigenous fish species. For more impact see National Trout Risk Assessment by the Environmental Programs: Directorate of the Department of Environmental Affairs, South Africa (May, 2014).

<p>Figure A-37. Upstream view of the Verloren Valei site on the Lunsklip, X2LUNS-VERLO (July 2017, G Diedericks).</p>		<p>Figure A-38. Downstream view of the Verloren Valei site on the Lunsklip, X2LUNS-VERLO (July 2017, G Diedericks).</p>

It is recommended that the TEC for this reach be adapted to reflect a Category B.

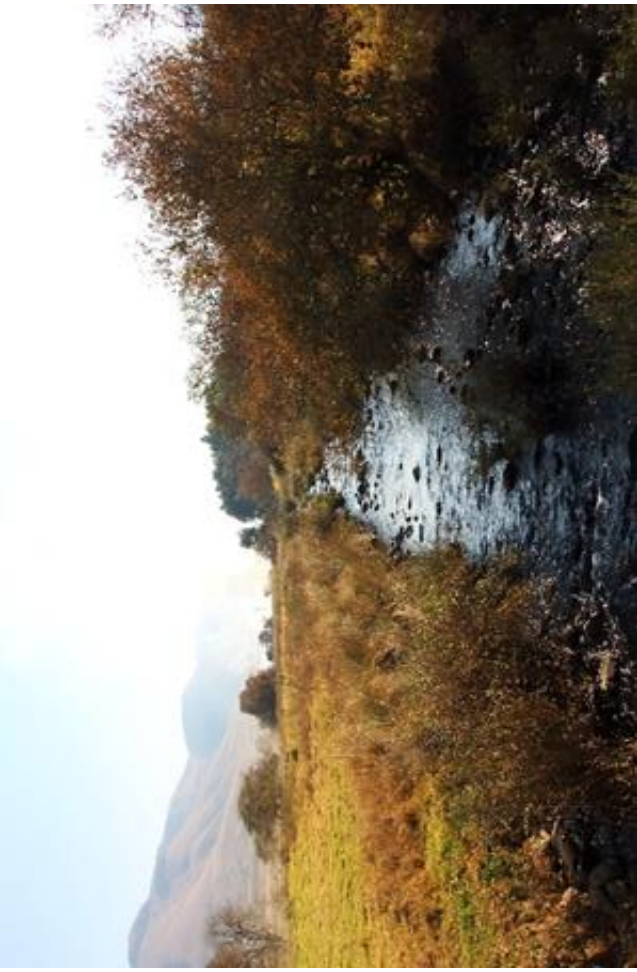
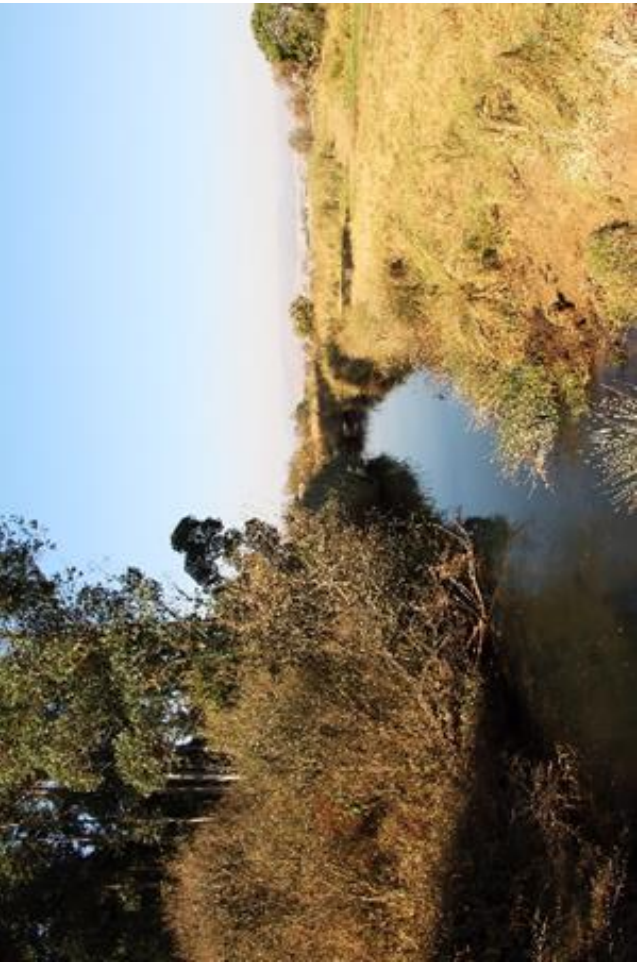
The main impact on this reach is the alien and invasive Aquaculture Facility, impacting on the natural flow regime and reduced water quality of this reach. This NEMBA species also impacts on the indigenous fish species. For more impact see National Trout Risk Assessment by the Environmental Programs: Directorate of the Department of Environmental Affairs, South Africa = (May, 2014).

Figure A-39. Upstream view of the Uitwaak site, X2LUNS-UITWA, on the Lunsklip River (July 2017, G Diedericks).	Figure A-40. Downstream view of the Uitwaak site, X2LUNS-UITWA, on the Lunsklip River (July 2017, G Diedericks).

It is recommended that the TEC for this reach be adapted to reflect a Category B.

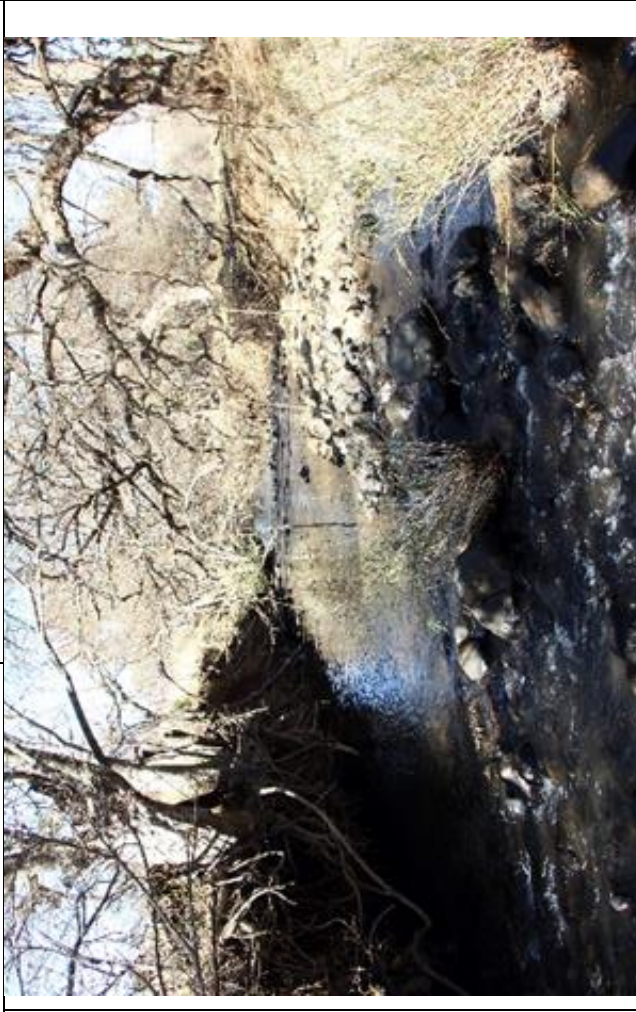
- Stream bank trampling
- Siltation in pools
- Invasive plant species
- Alien and invasive fish species
- Bank scouring
- Stream crossing creates upstream impoundment
- Stream crossing physical barrier during low flow conditions
- Poor road drainage

Figure A-42. Downstream view of the Rietfontein site, X2ALEX-RIETF, on Alex-se-Loop (July 2017, G Diedericks).

It is recommended that the TEC for this reach be adapted to reflect a Category B due to the presence of *Kneria sp. nov.* 'South Africa'.

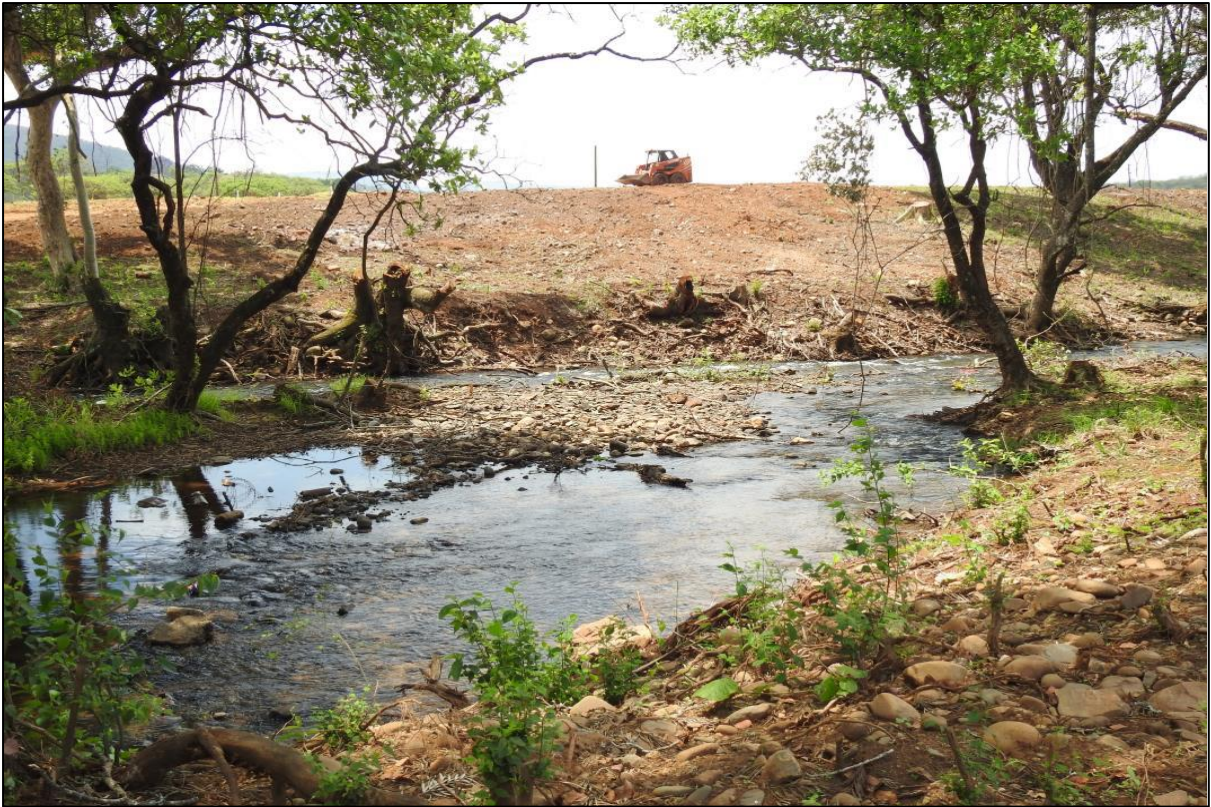
Figure 28: Removal of riparian vegetation in the Houtbosloop River riparian zone near the confluence with the Crocodile River.

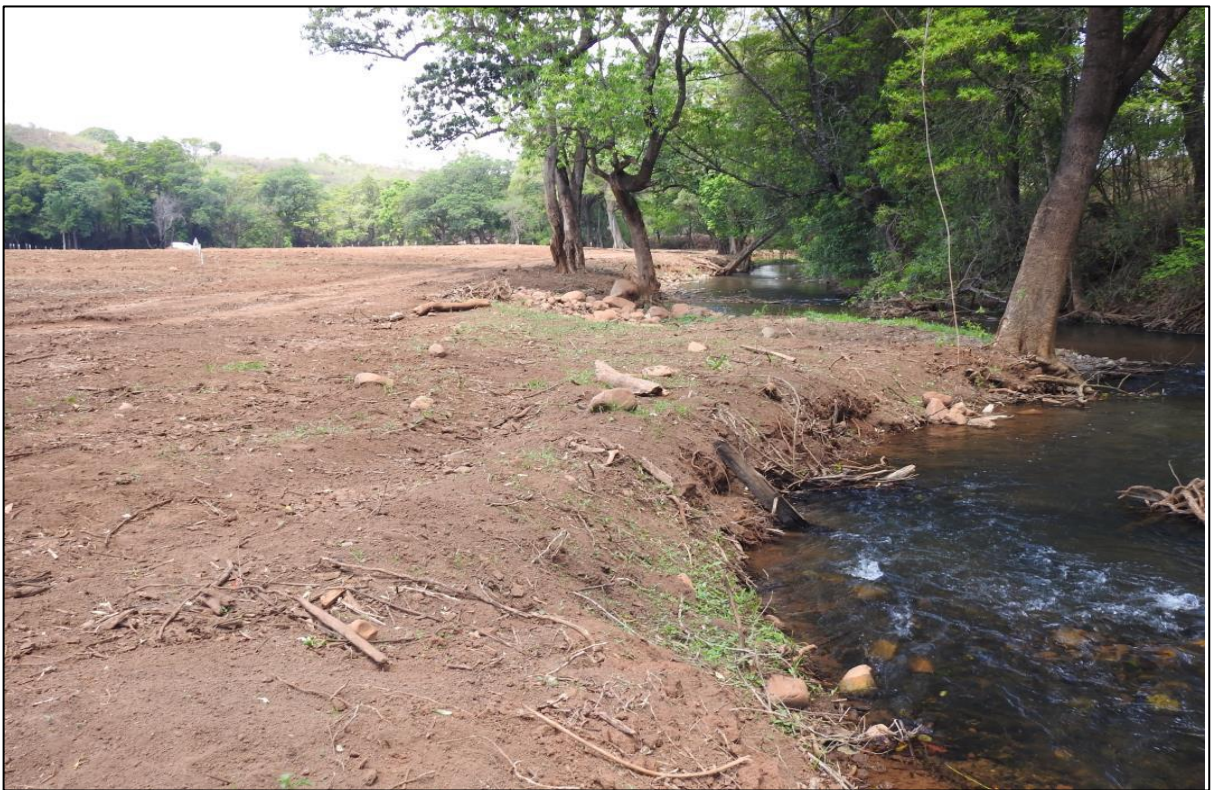
Figure 29: Houtbosloop River riparian zone with cultivation in the riparian zone.

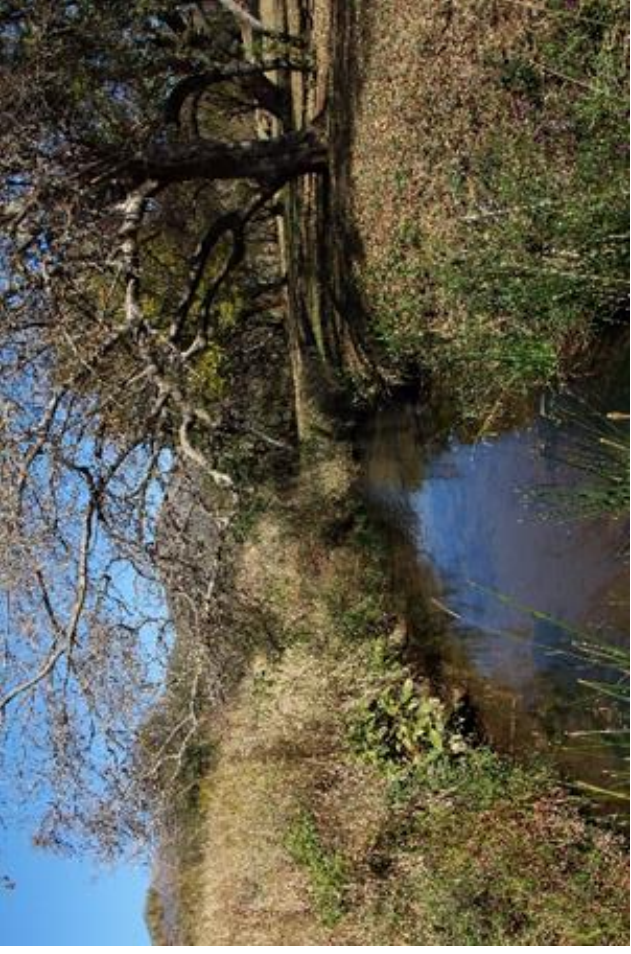
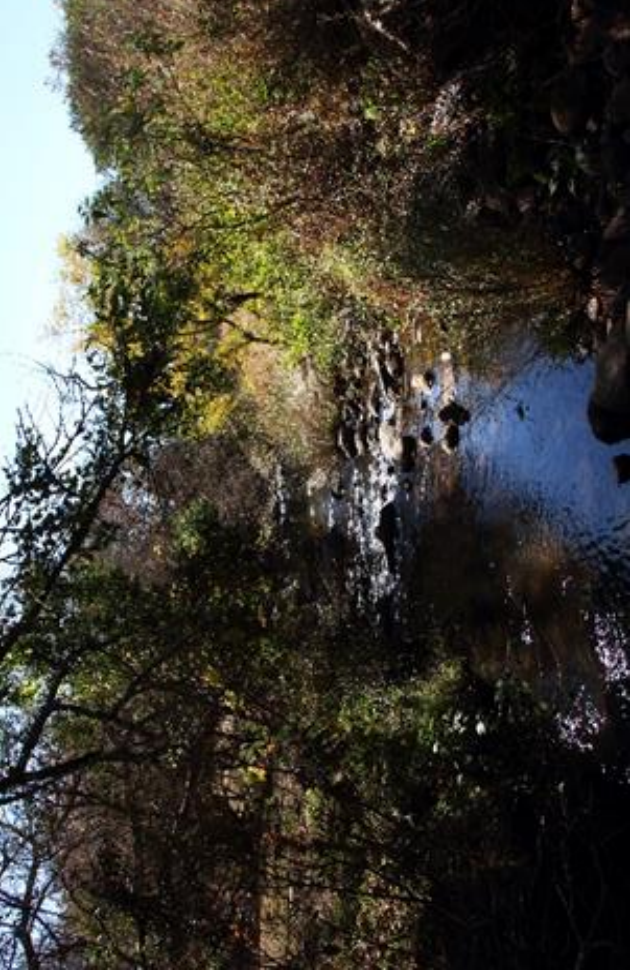
<p>Figure A-43. Upstream view of the Buffelskloofspruit site, X2BUFF-SOMER (July 2017, G Diedericks).</p>		<p>Figure A-44. Downstream view of the Buffelskloofspruit site, X2BUFF-SOMER (July 2017, G Diedericks).</p>

Although target is met, but due to the presence of *Kneria* sp. nov. 'South Africa' the Target Ecological Category should be managed at a Category B
