ECOSTATUS OF THE CROCODILE RIVER CATCHMENT

INKOMATI RIVER SYSTEM PHASE II (2017)

Date: January 2018

Mpumalanga Tourism and Parks Agency
Scientific Services: Aquatic & Herpetology

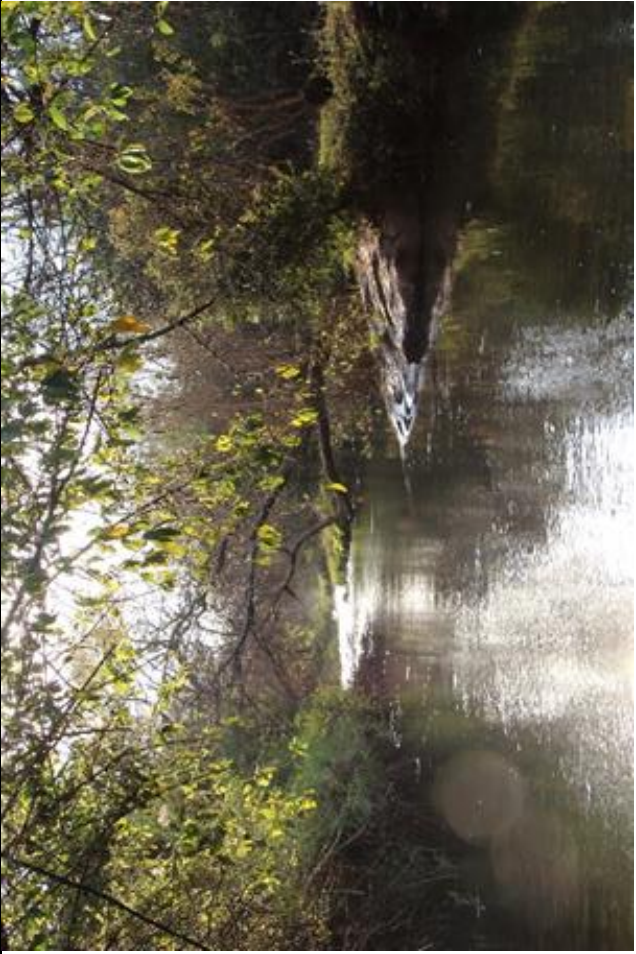
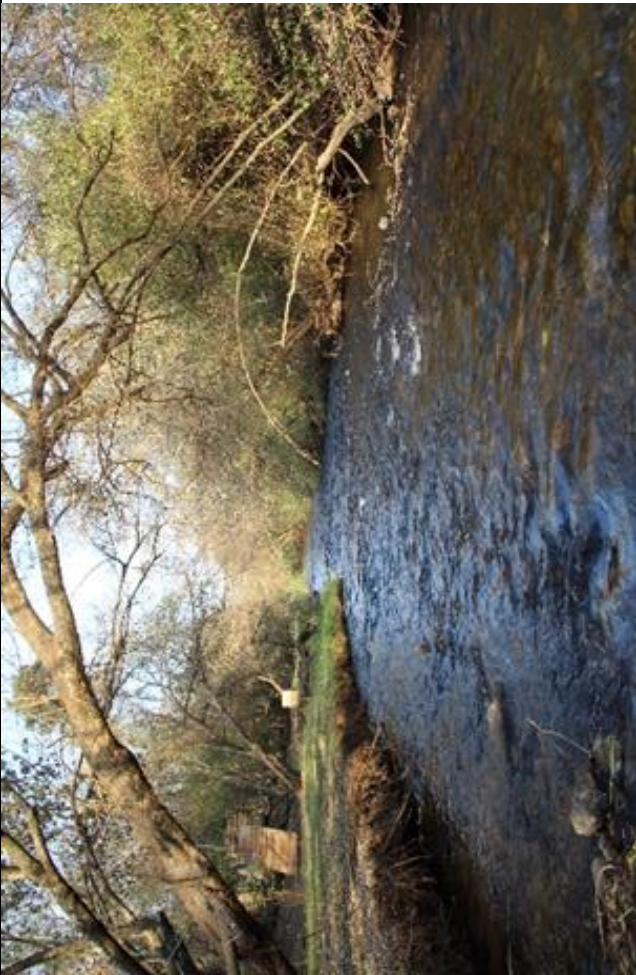
- Forestry related activities cause high sedimentation loads, resulting in loss of available instream habitat to fish and macroinvertebrates.

<p>Figure A-45. Upstream view of the Houtbosloop site, X2HOUT-SUDWA at Marekele (July 2017, G Diedericks).</p>		<p>Figure A-46. Downstream view of the Houtbosloop site, X2HOUT-SUDWA at Marekele (July 2017, G Diedericks).</p>

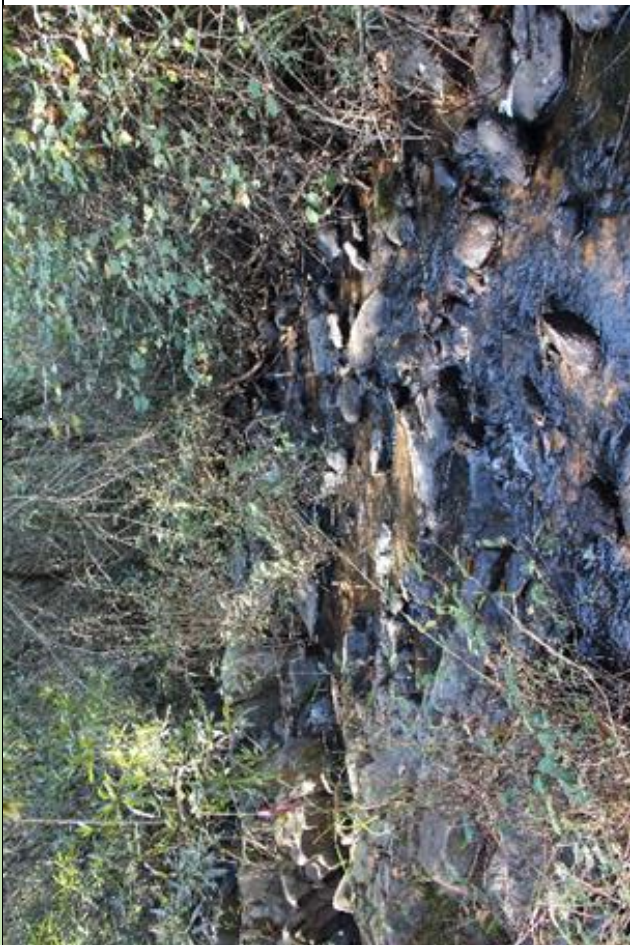
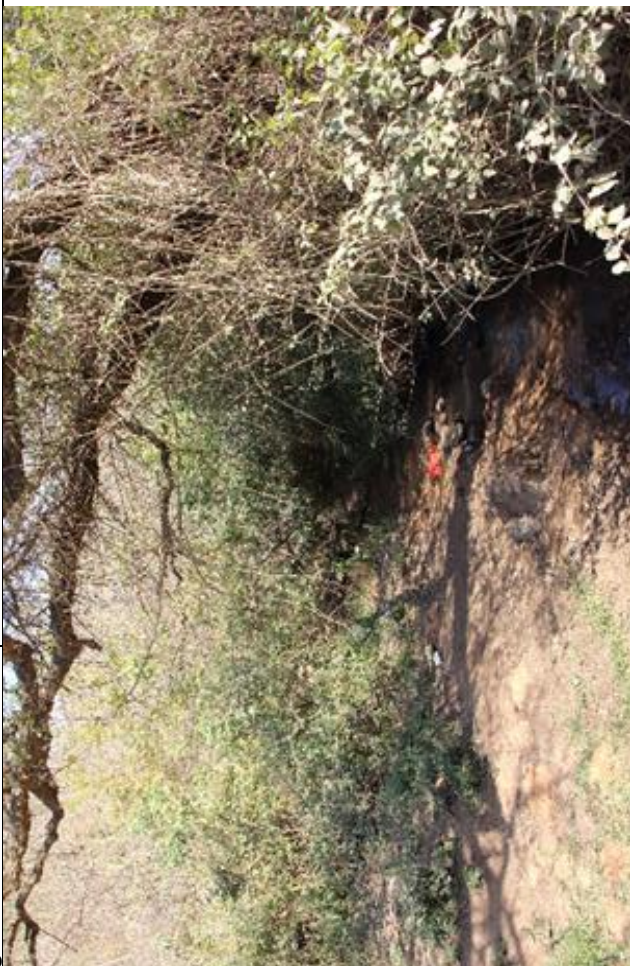
INTEGRATED ECOSTATUS	TARGET ECOSTATUS
Category BC (80.1%)	Category BC
Close to largely natural most of the time. Conditions may rarely and temporarily decrease below the upper boundary of a C Category	Close to largely natural most of the time with few modifications.

<p>Figure A-47. Upstream view of the Visspuit site, X2VISS-ALKMA (July 2017, G Diedericks).</p>		<p>Figure A-48. Downstream view of the Visspuit site, X2VISS-ALKMA (July 2017, G Diedericks).</p>

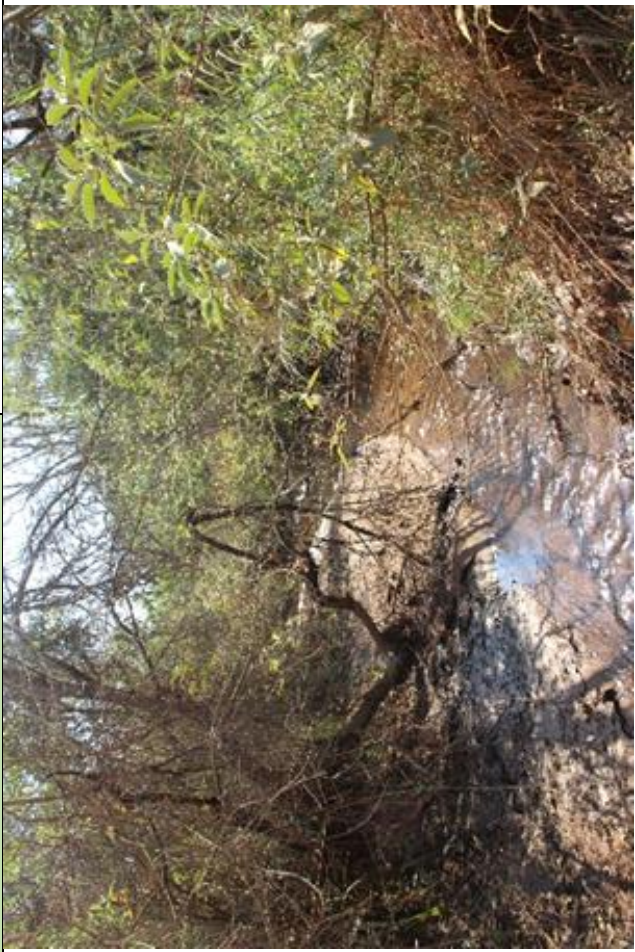
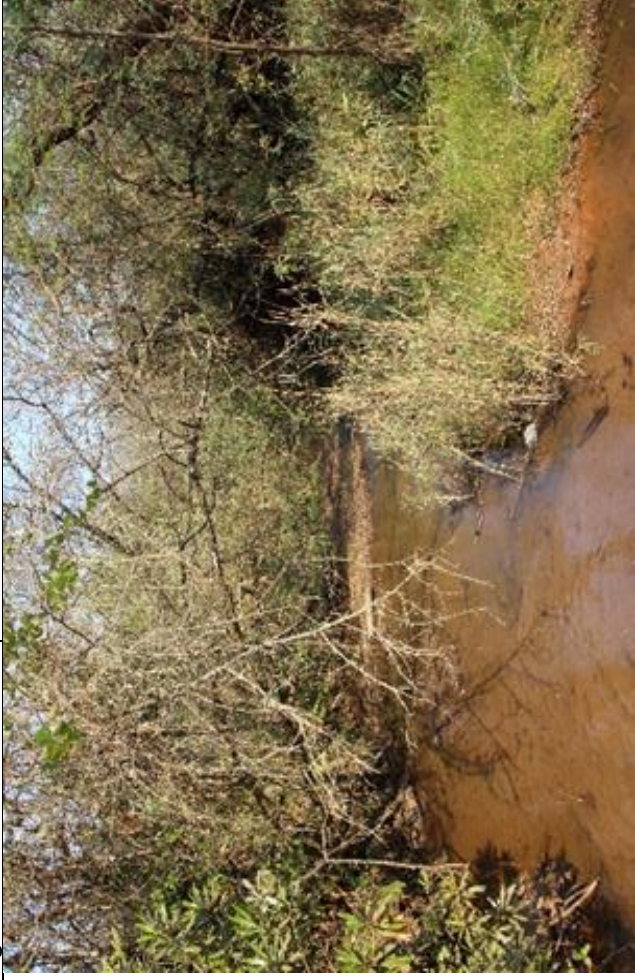
Poorly managed forestry related activities results in siltation and sedimentation drastically reducing instream available habitat.

<p>Figure A-49. Upstream view of the Gladdespruit site, X2GLAD-HERMA (July 2017, G Diedericks).</p>		<p>Figure A-50. Downstream view of the Gladdespruit site, X2GLAD-HERMA (July 2017, G Diedericks).</p>

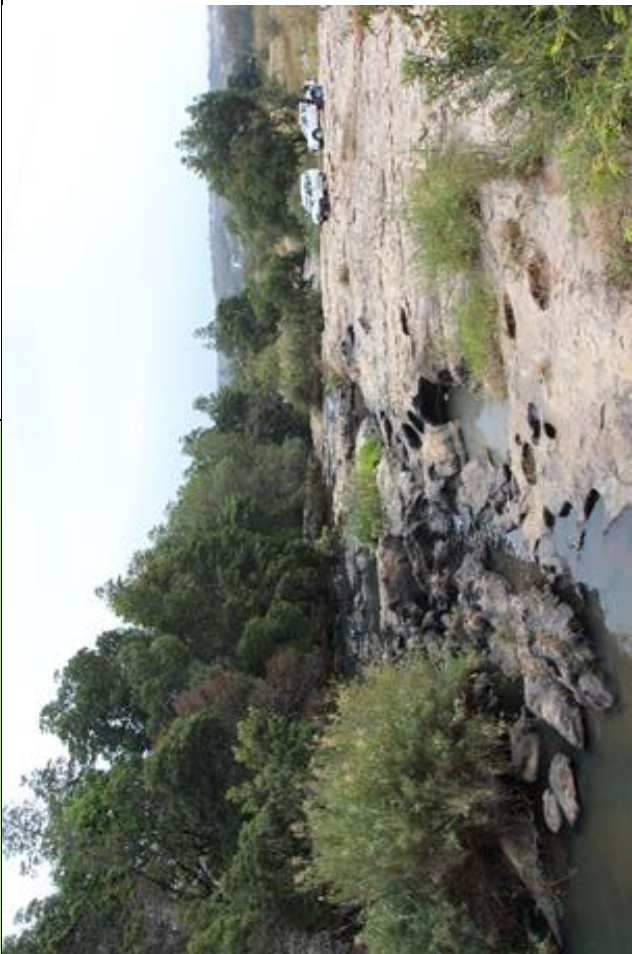
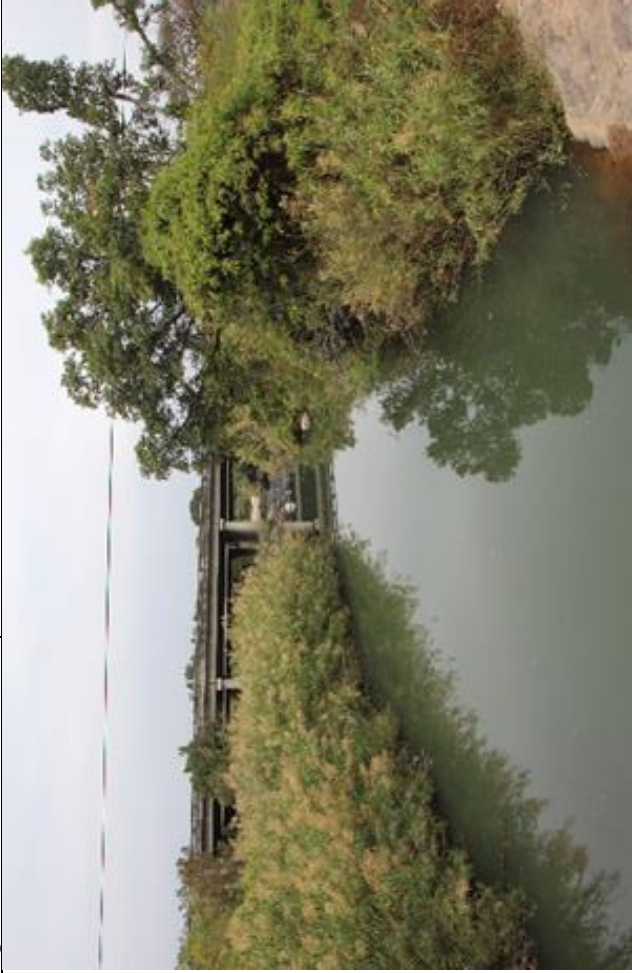
<p>Figure A-51. Upstream view of the Nelsriver site, X2NELS-R40BR (July 2017, G Diedericks).</p>		<p>Figure A-52. Downstream view of the Nelsriver site, X2NELS-R40BR (July 2017, G Diedericks).</p>

It is recommended that the TEC for this reach be adapted to reflect a Category BC through integrated catchment management.

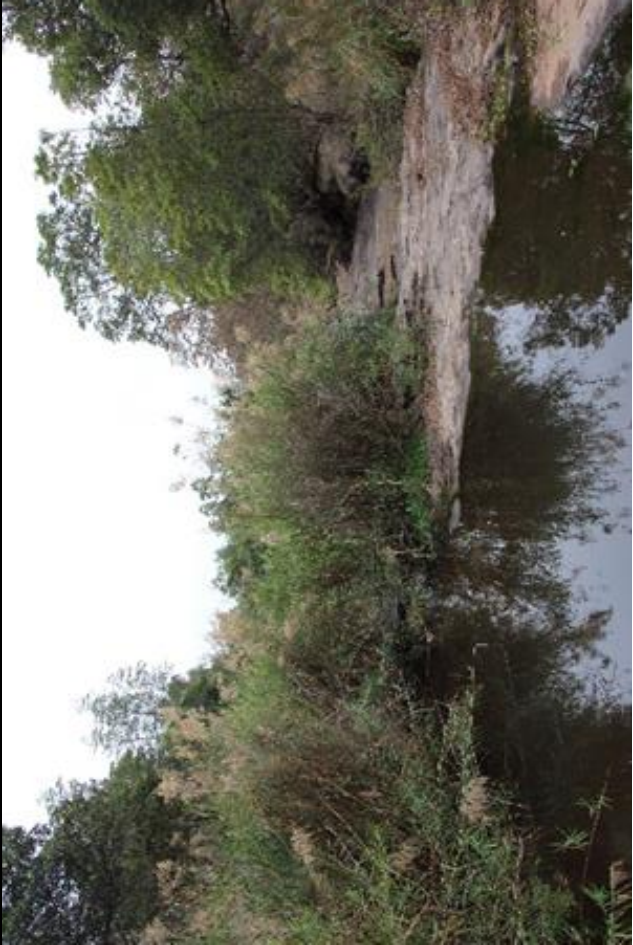
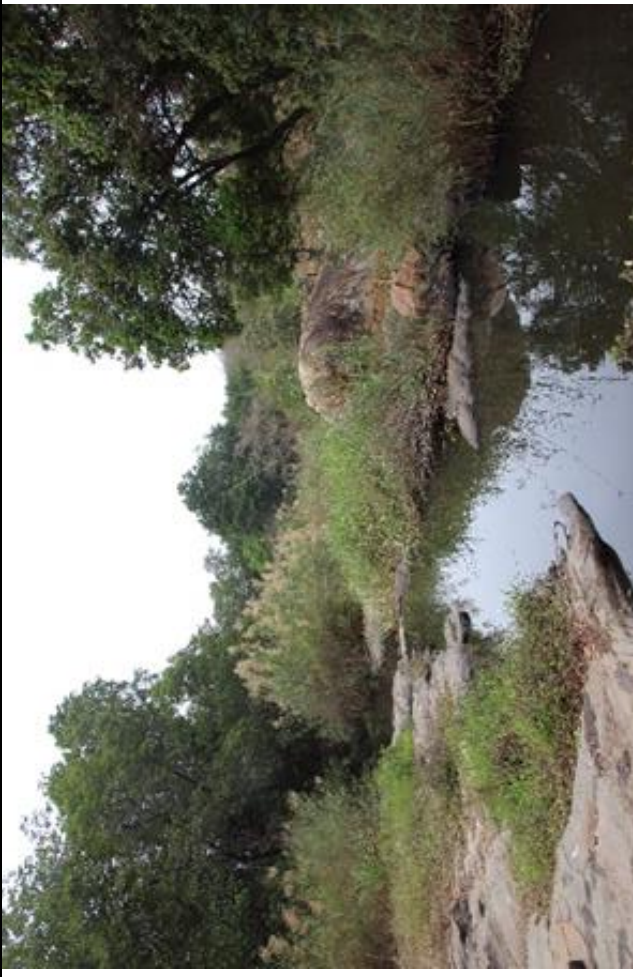
This SQ reach is not a EWR site and the TEC for this site is derived from the PES-EIS desktop assessment (DWA, 2014b) indicating the ecological sensitivity and importance. The information for setting targets is thus limited, as this site was not assessed in detail. The integrated Ecostatus of a Category D indicate that a more detailed assessment is required.

<p>Figure A-53. Upstream view of the White River site, X2WITR-VALLE (July 2017, G Diedericks).</p>		<p>Figure A-54. Downstream view of the White River site, X2WITR-VALLE (July 2017, G Diedericks).</p>

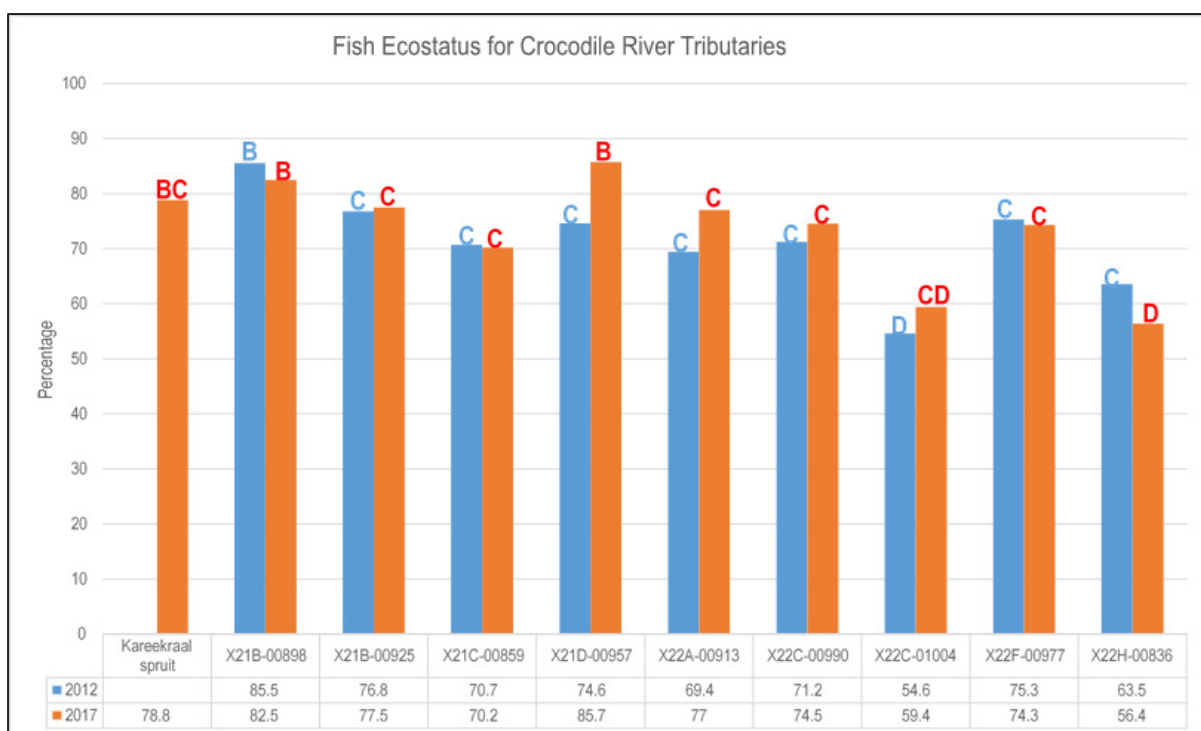
Figure 30: Comparison of the Fish Ecstatus of the Crocodile River tributaries in 2012 and 2017.

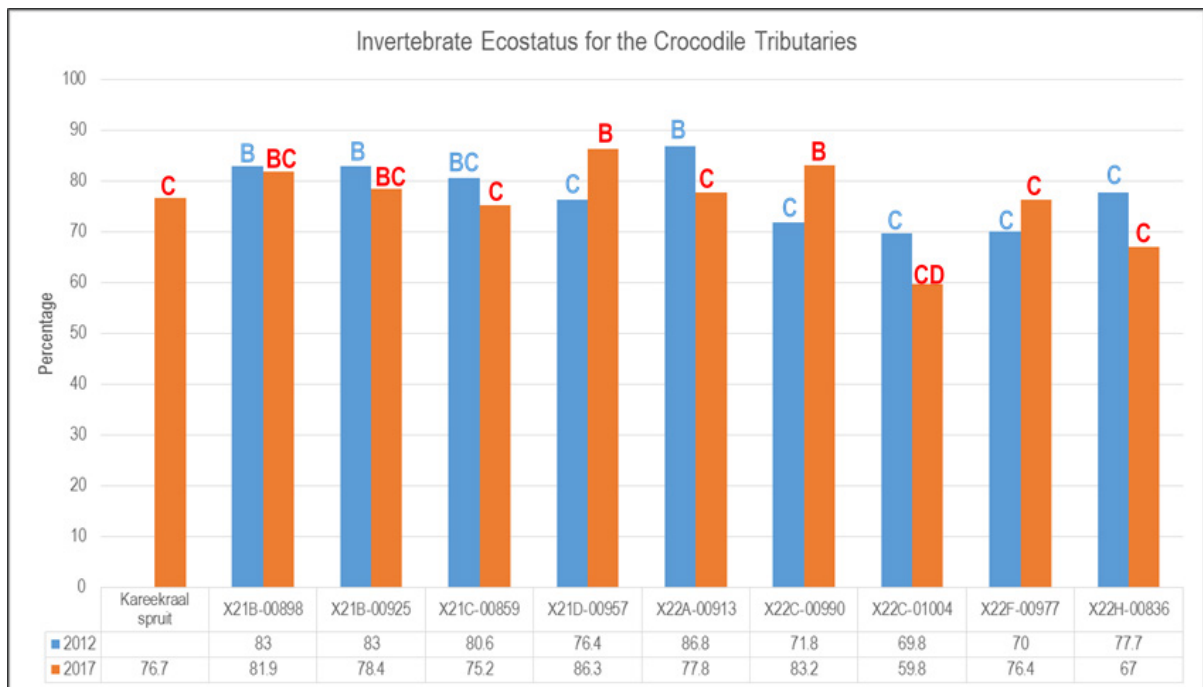
Figure 31: PESEIS Reach Invertebrate categories derived from the RIVDINT model summarised for the Crocodile River tributaries, comparing 2012 to 2017.

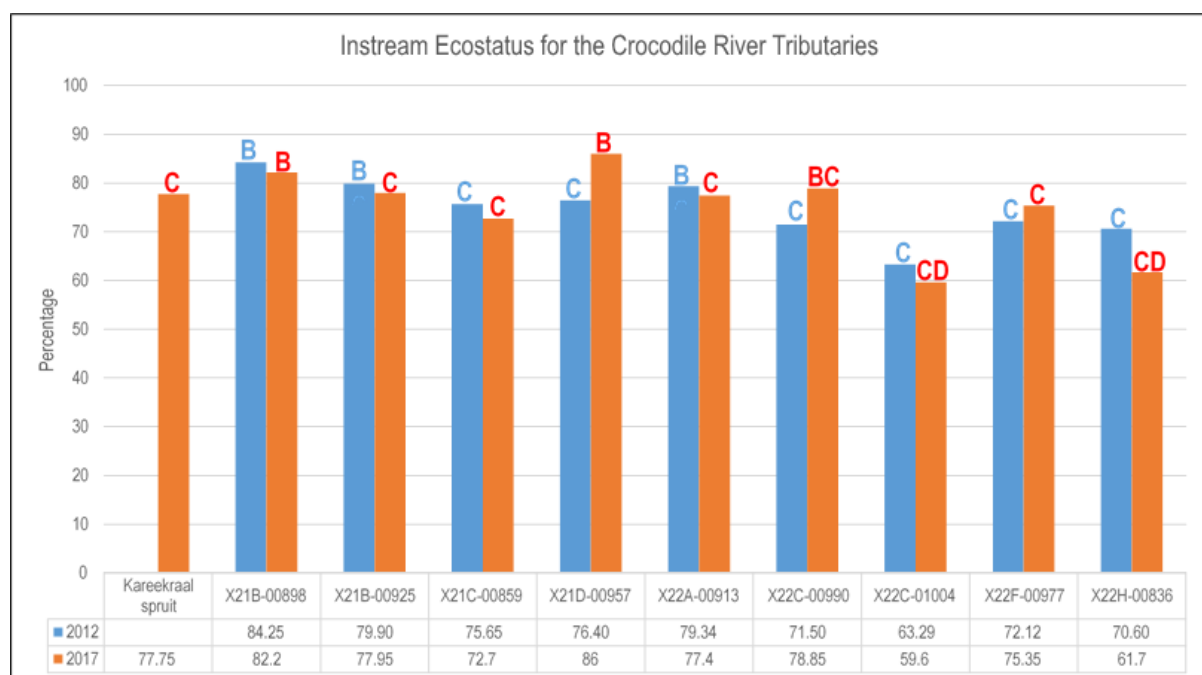
Figure 32: Instream Ecostatus derived from the RIVDINT model for the tributaries of the Crocodile River, comparing 2012 to 2017.

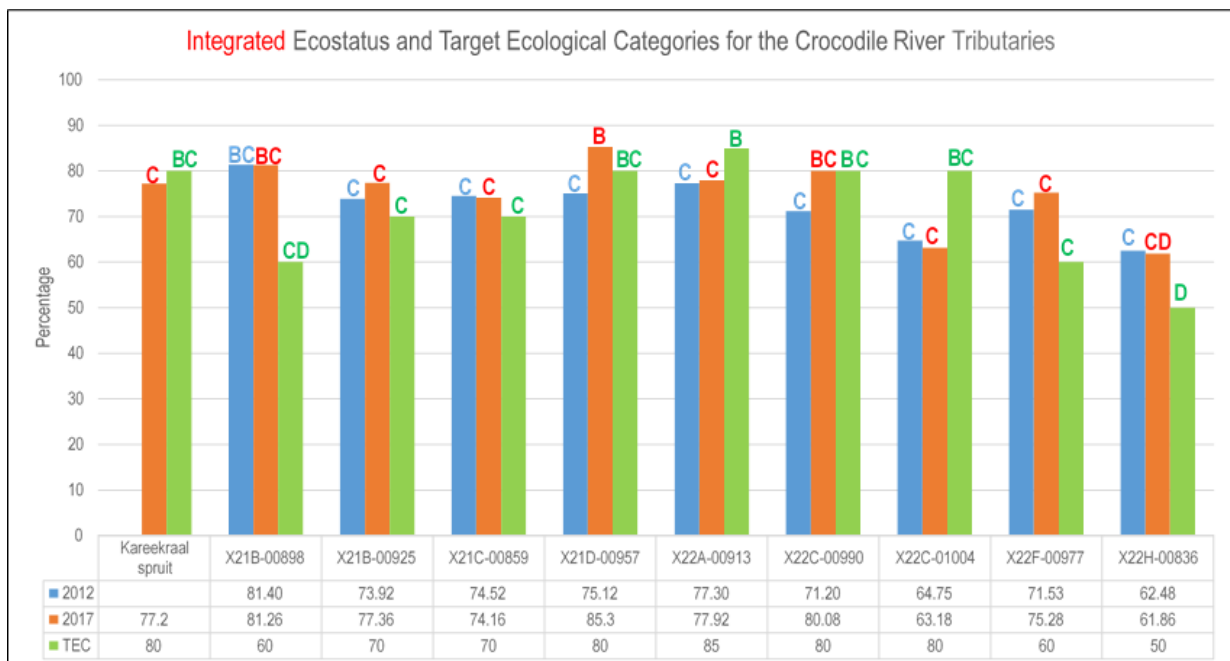
Figure 33: Integrated Ecostatus for the tributaries of the Crocodile River, comparing 2012 to 2017.

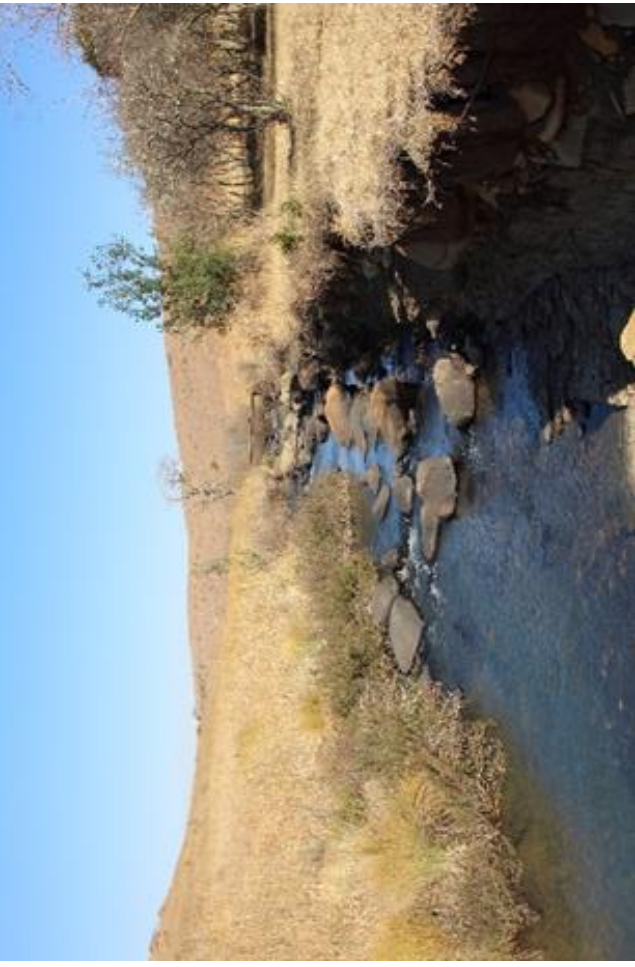
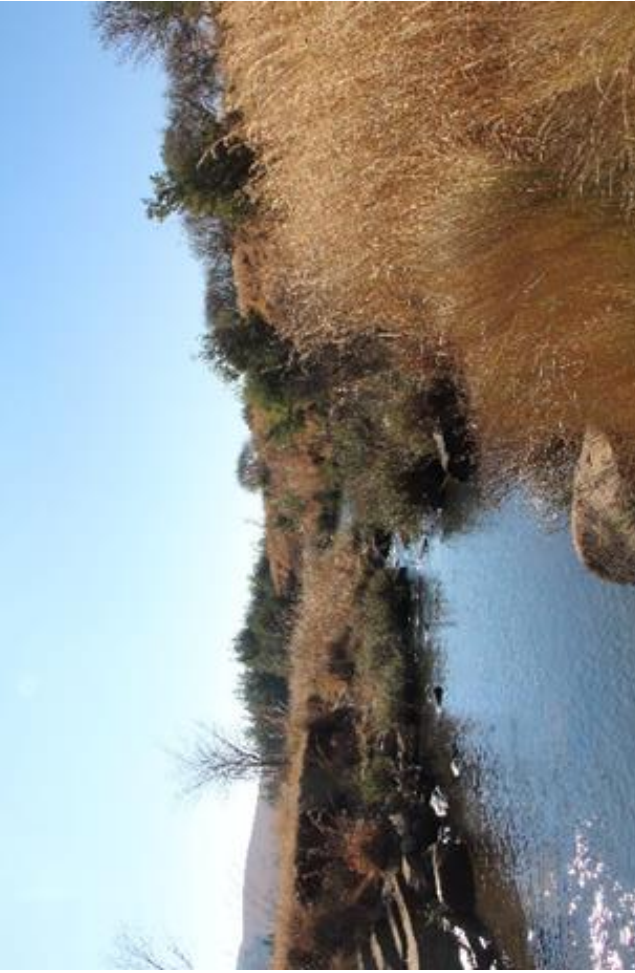
Figure A-55. Upstream view of the De Goede site, X2ELAN-DEGOE, on the Elands River (July 2017, G Diedericks).

Figure A-56. Downstream view of the De Goede site, X2ELAN-DEGOE, on the Elands River (July 2017, G Diedericks).

It is recommended that the TEC for this reach be adapted to reflect a Category BC through integrated catchment management.

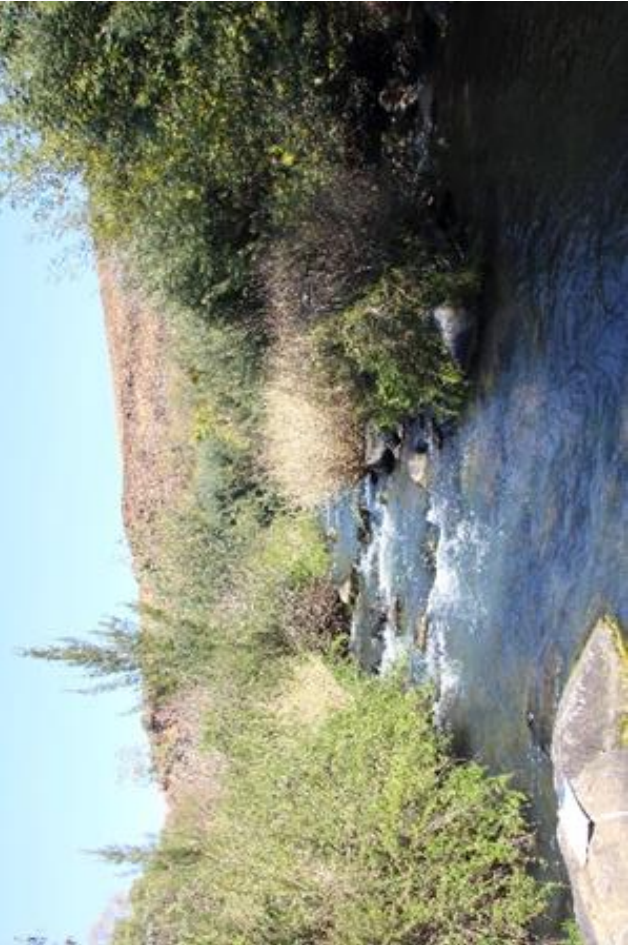
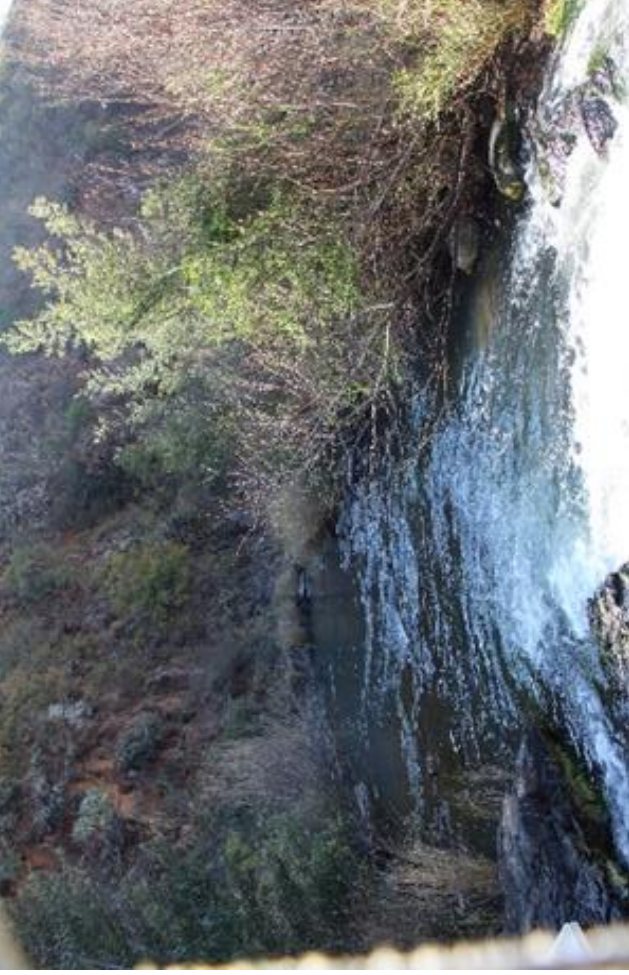
<p>Figure A-57 Upstream view of the Waterval Boven site, X2ELAN-WATER, on the Crocodile River (July 2017, G Diedericks).</p>		<p>Figure A-58. Downstream view of the Waterval Boven site, X2ELAN-WATER, on the Crocodile River (July 2017, G Diedericks).</p>

This SQ Reach should be managed at a TEC of 85% Category B as set in RQO's.

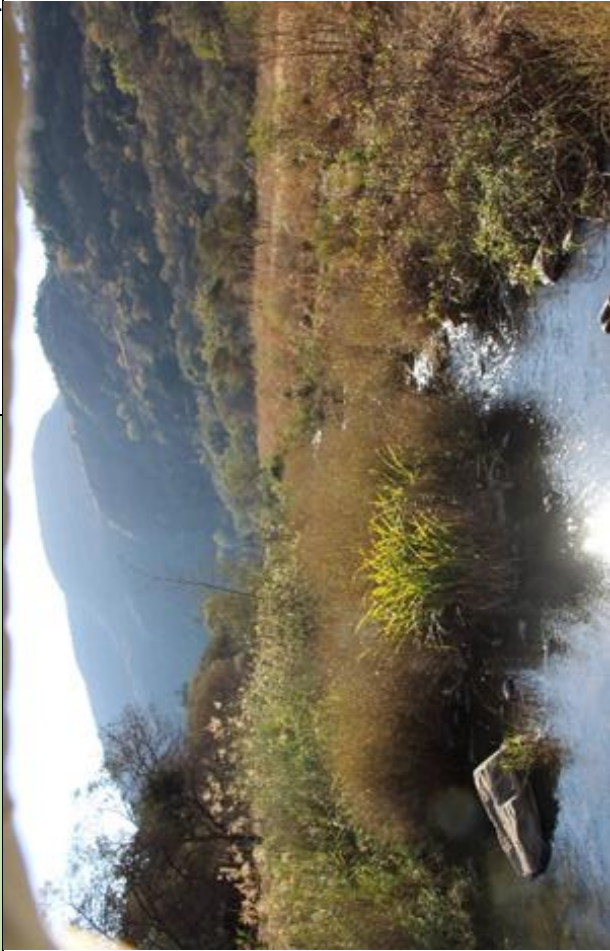
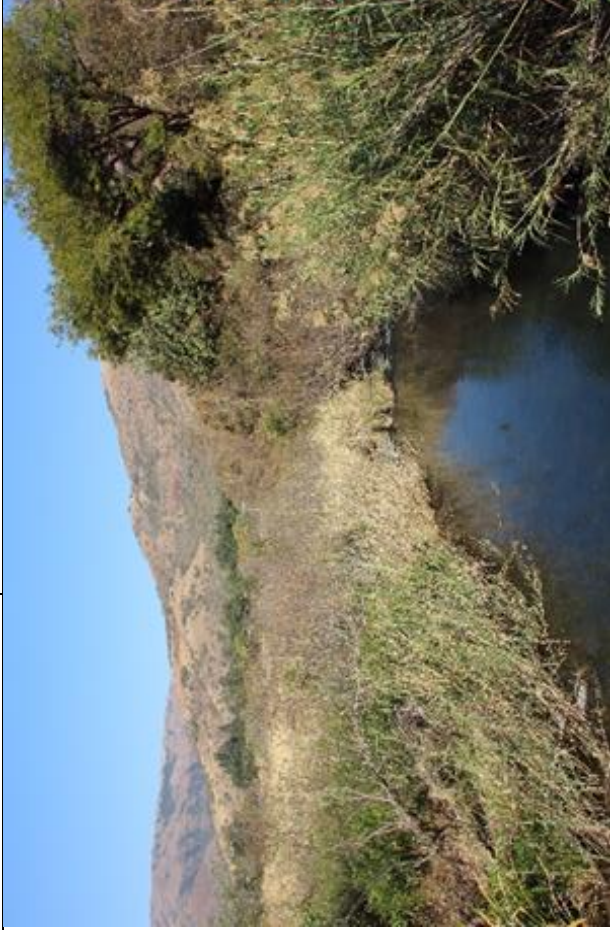
<p>Figure A-59. Upstream view of the Doornhoek site, X2ELAN-DOORN, on the Elands River (July 2017, G Diedericks).</p>		<p>Figure A-60. Downstream view of the Doornhoek site, X2ELAN-DOORN, on the Elands River (July 2017, G Diedericks).</p>

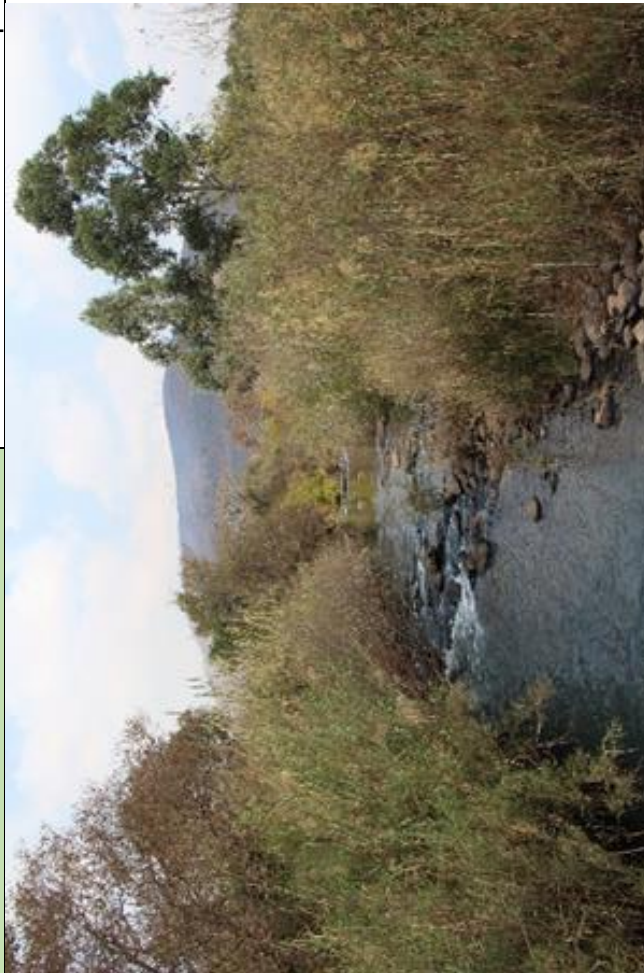
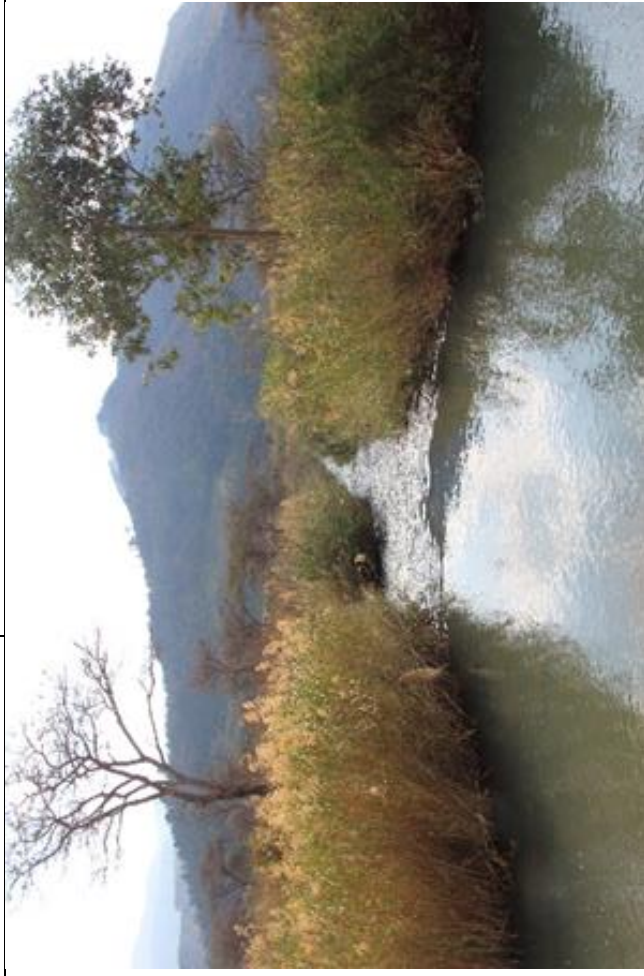
- Combined effect of reduced water quality from upstream urban run off
- Non-functional WWTW at Emgwenya impacting water quality
- Over-abstraction of water from the Elands River for irrigational purposes
- Sedimentation and siltation from forestry related activities

Figure A-61. Upstream view of the Hemlock site, X2ELAN-HEMLO, on the Elands River (July 2017, G Diedericks).

Figure A-62. Downstream view of the Hemlock site, X2ELAN-HEMLO, on the Elands River (July 2017, G Diedericks).

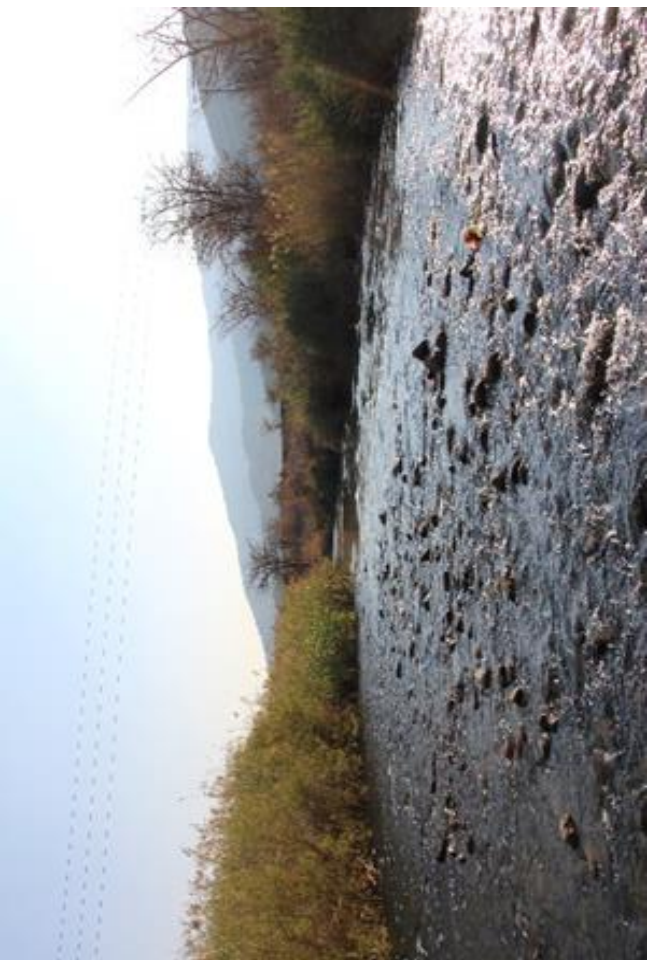
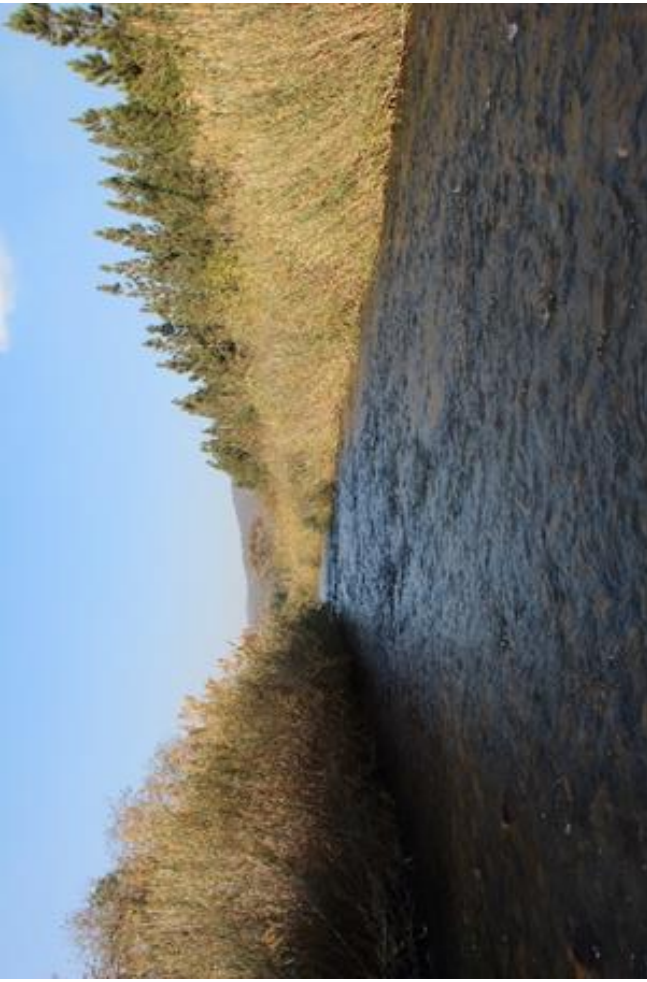
<p>Figure A-63. Upstream view of the Roodewal site, X2ELAN-ROODE, on the Elands River (July 2017, G Diedericks).</p>		<p>Figure A-64. Downstream view of the Roodewal site, X2ELAN-ROODE, on the Elands River (July 2017, G Diedericks).</p>

The TEC for this SQ Reach should be managed at a Category B (85%) through integrated water management. The distribution range of *Chiloglanis bifurcus* is entirely within privately owned land without any formal conservation protection and impacted by land use practices in the catchment. The two sub-populations remaining for this species need to be given priority for conservation efforts. Land and water use practices need to be carefully managed.

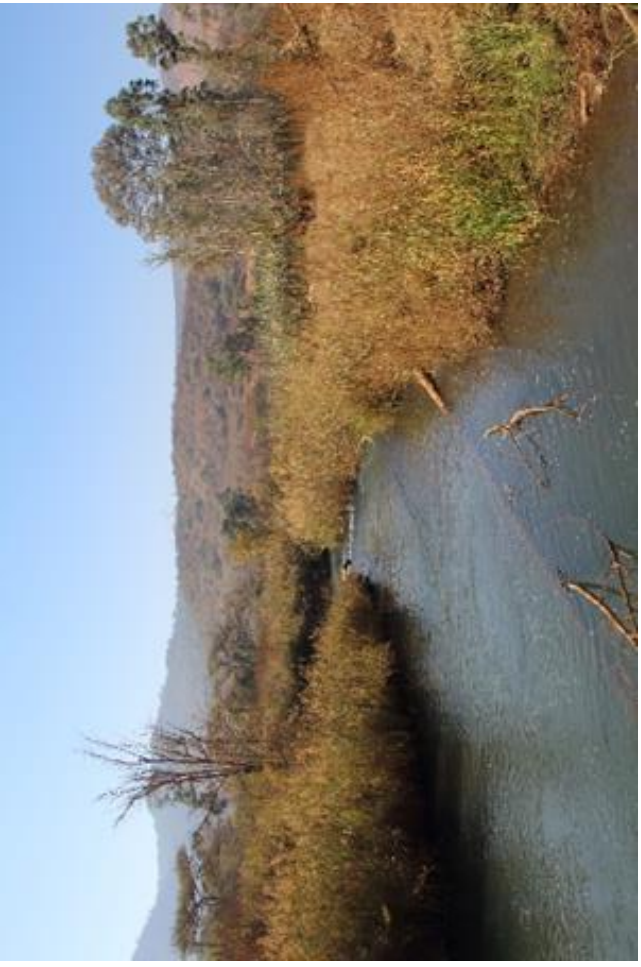
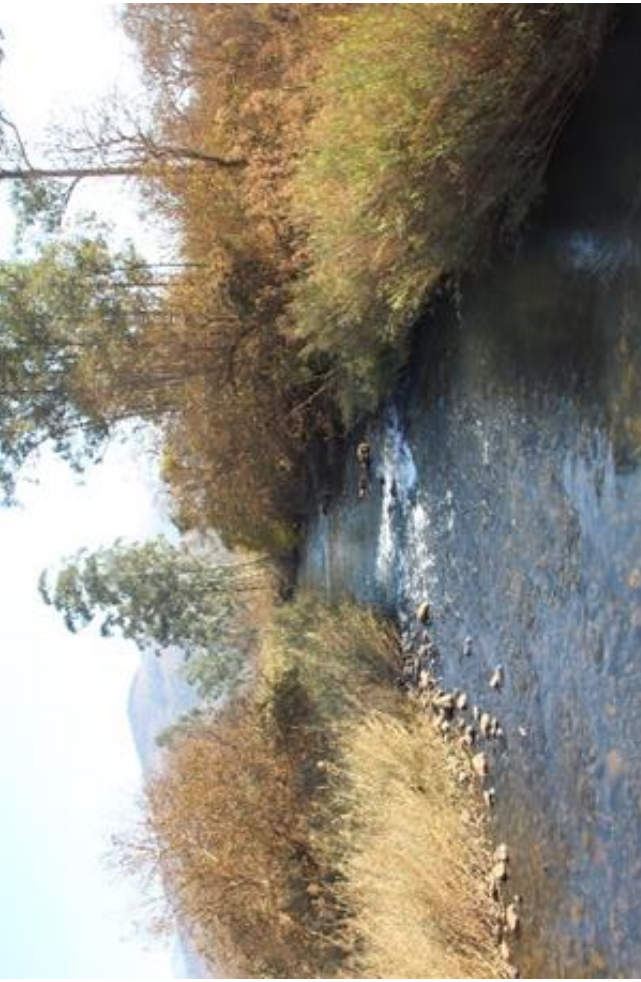
<p>Figure A-65. Upstream view of the Goedegeeluk site, X2ELAN-GOEDG, on the Elands River (July 2017, G Diedericks).</p>		<p>Figure A-66. Downstream view of the Goedegeeluk site, X2ELAN-GOEDG, on the Elands River (July 2017, G Diedericks).</p>

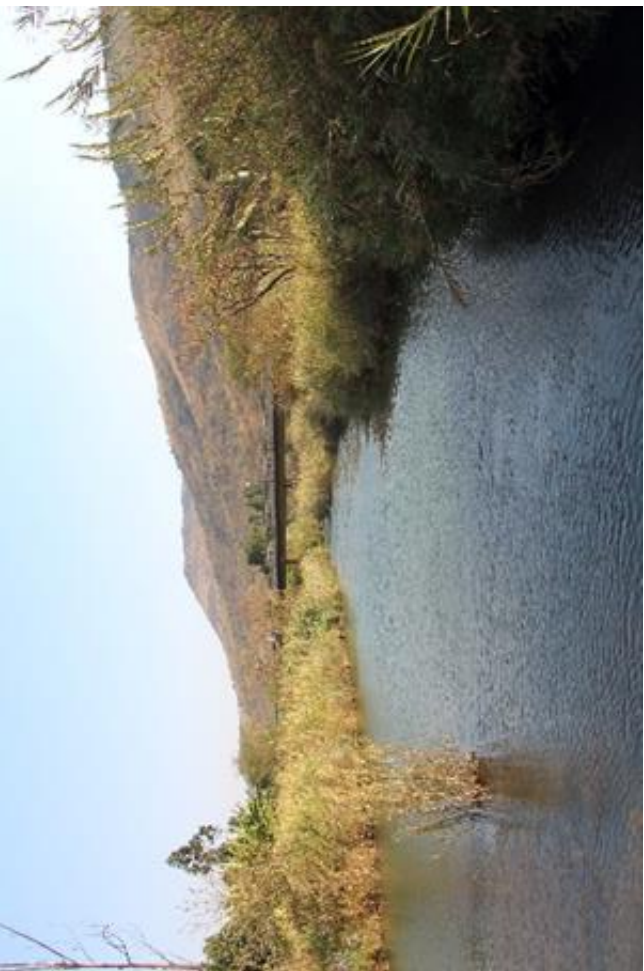
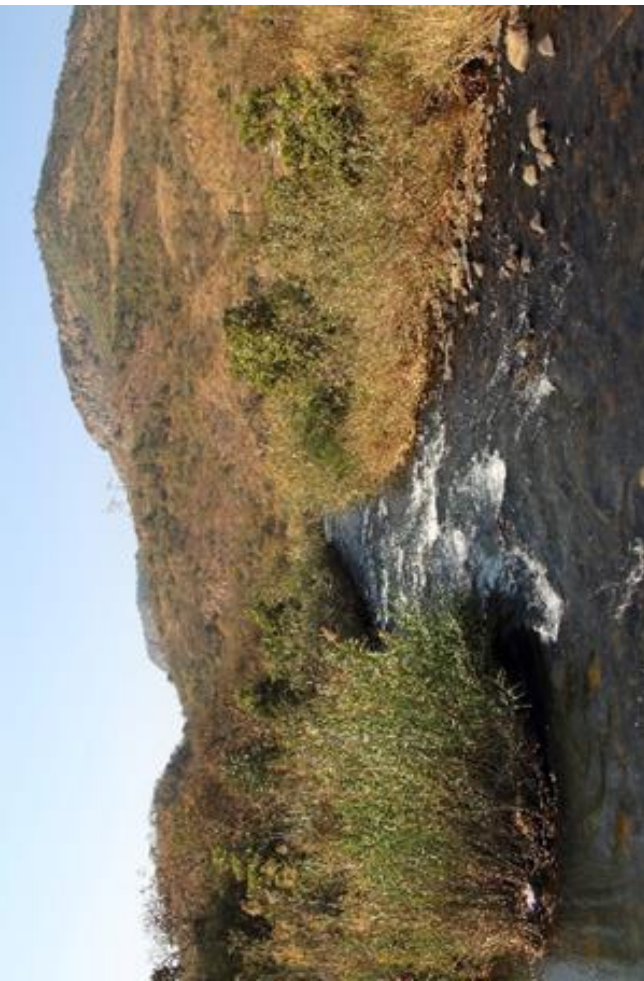
<p>Figure A-67. Upstream view of the Elandshoek site, X2ELAN-EHOEK, on the Elands River (July 2017, G Diedericks).</p>		<p>Figure A-68. Downstream view of the Elandshoek site, X2ELAN-EHOEK, on the Elands River (July 2017, G Diedericks).</p>

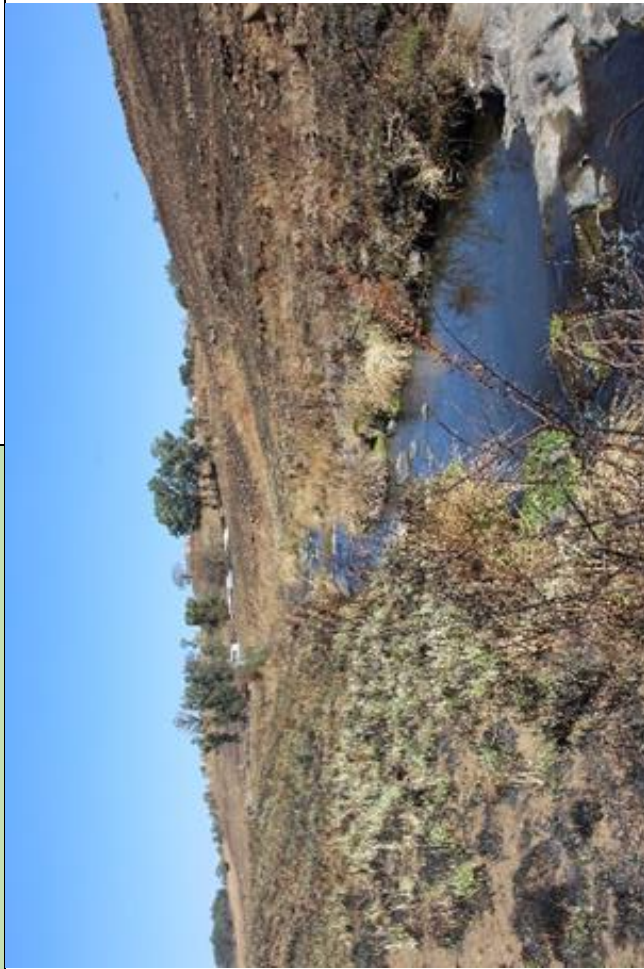
Figure A-69. Upstream view of the Leeuspruit site, X2LEEU-GELUK (July 2017, G Diedericks).

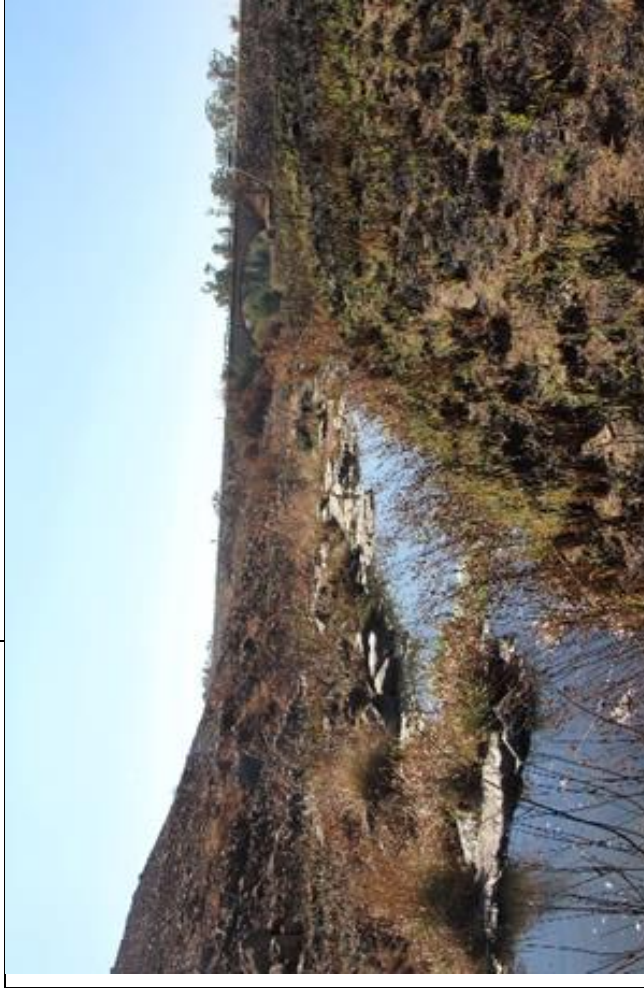
Figure A-70. Downstream view of the Leeuspruit site, X2LEEU-GELUK (July 2017, G Diedericks).

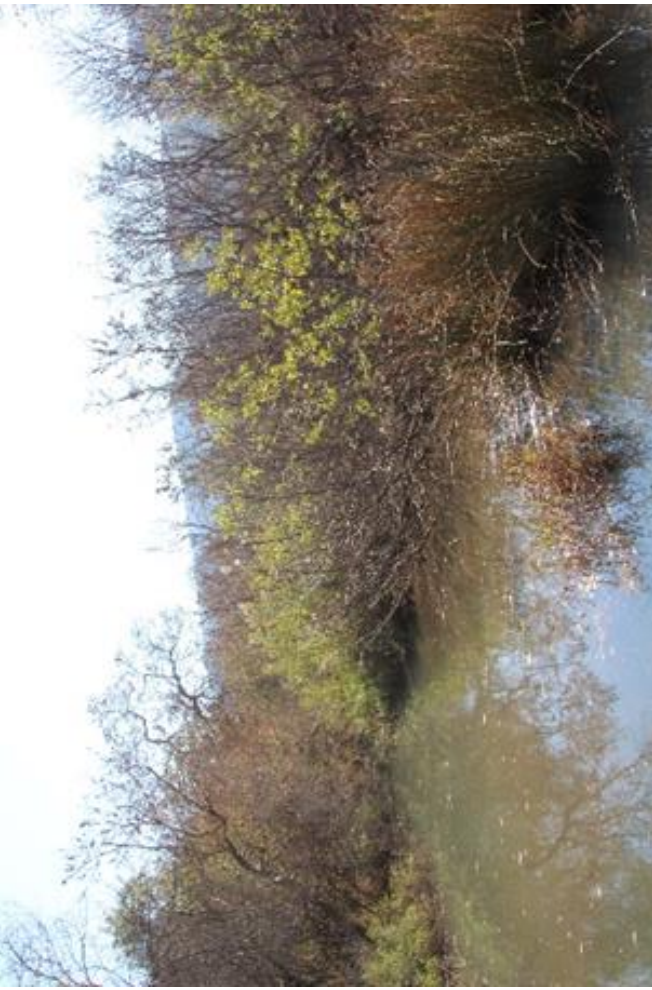
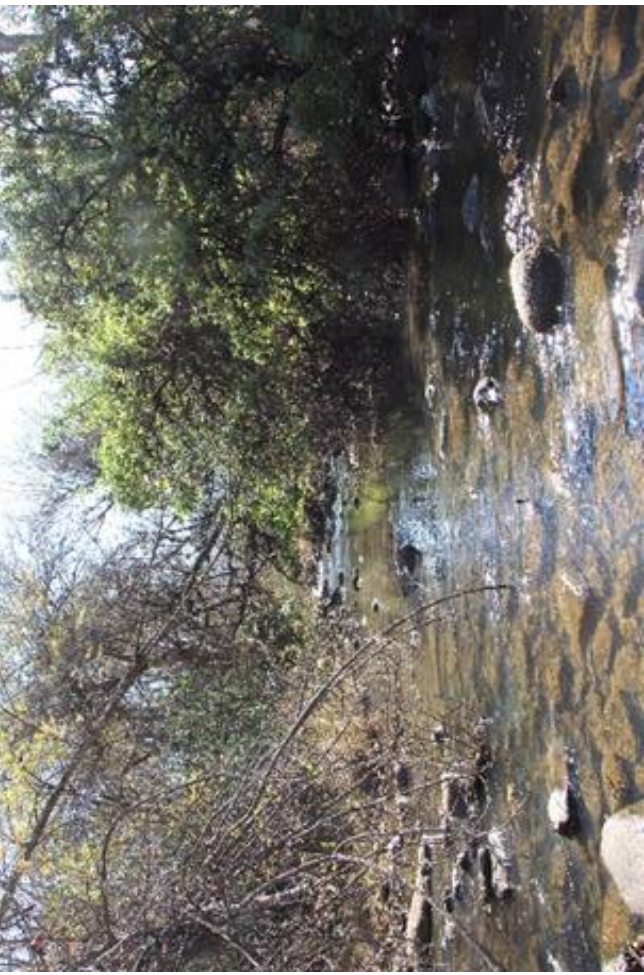
Figure A-71. Upstream view of the Swartkoppiespruit site, X2SWAR-KINDE (July 2017, G Diedericks).

Figure A-72. Downstream view of the Swartkoppiespruit site, X2SWAR-KINDE (July 2017, G Diedericks).
