ECOSTATUS OF THE CROCODILE RIVER CATCHMENT

INKOMATI RIVER SYSTEM PHASE II (2017)

Date: January 2018

Mpumalanga Tourism and Parks Agency
Scientific Services: Aquatic & Herpetology

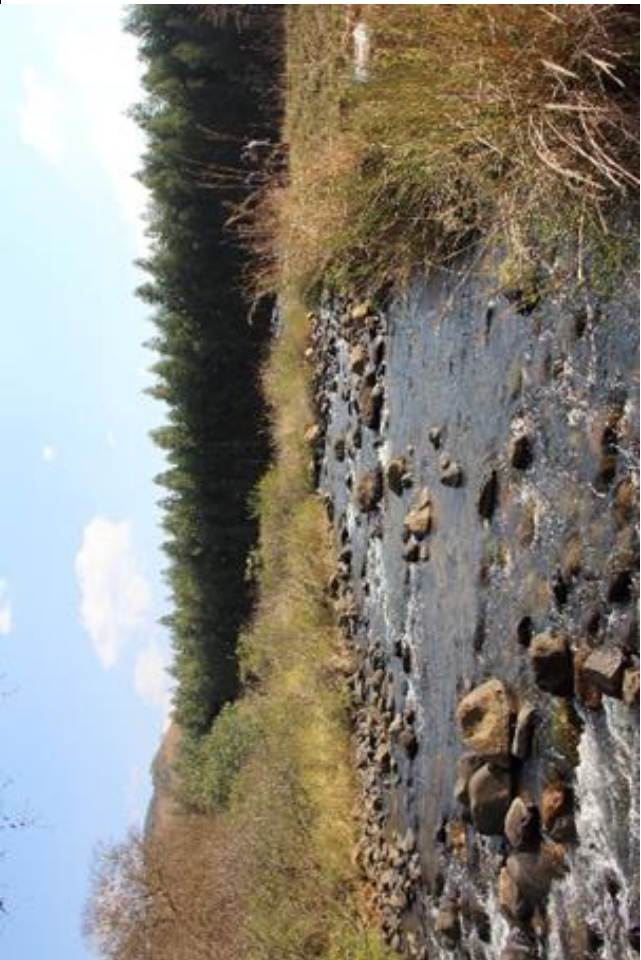
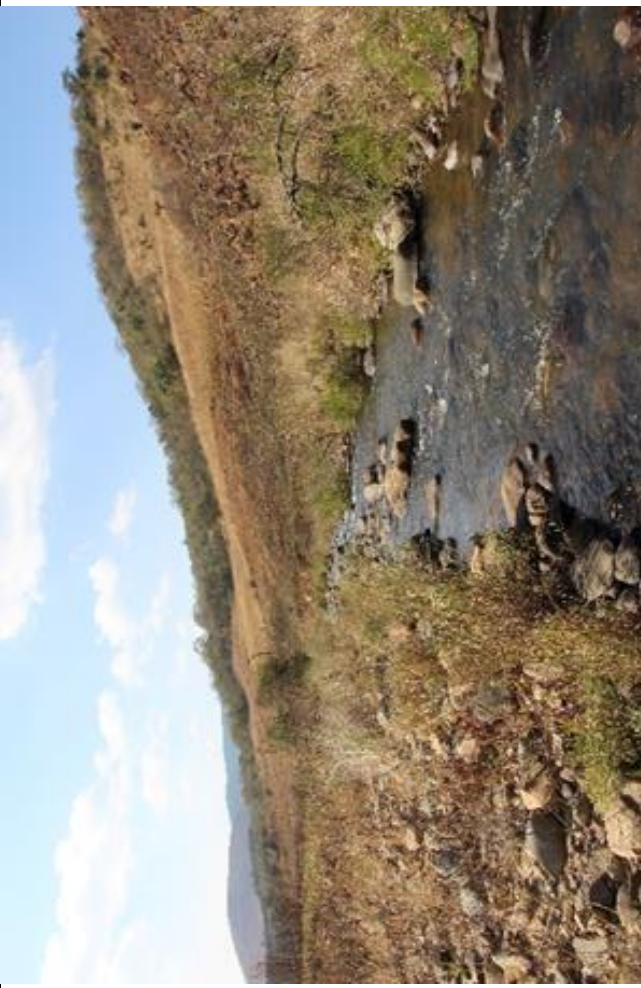
<p>Figure A-73. Upstream view of the Ngodwana River site, X2NGOD-NOOIT (July 2017, G Diedericks).</p>		<p>Figure A-74. Downstream view of the Ngodwana River site, X2NGOD-NOOIT (July 2017, G Diedericks).</p>

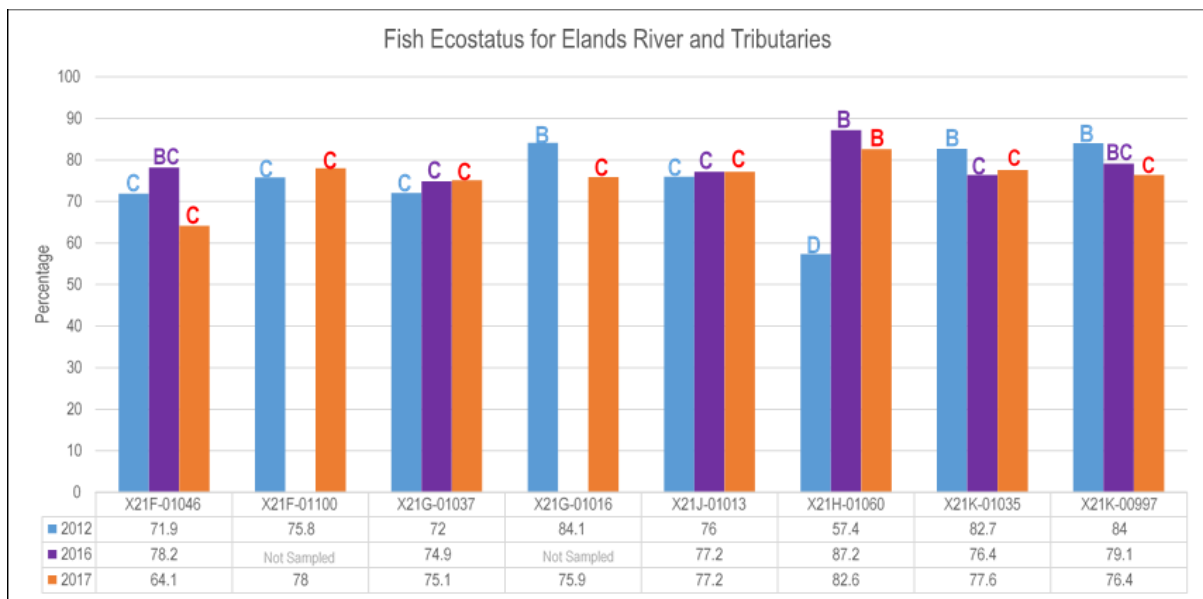
Figure 34: Fish Ecostatus rating derived from the RIVDINT model summarised for the Elands River and Tributaries, comparing 2012, 2016 to 2017.

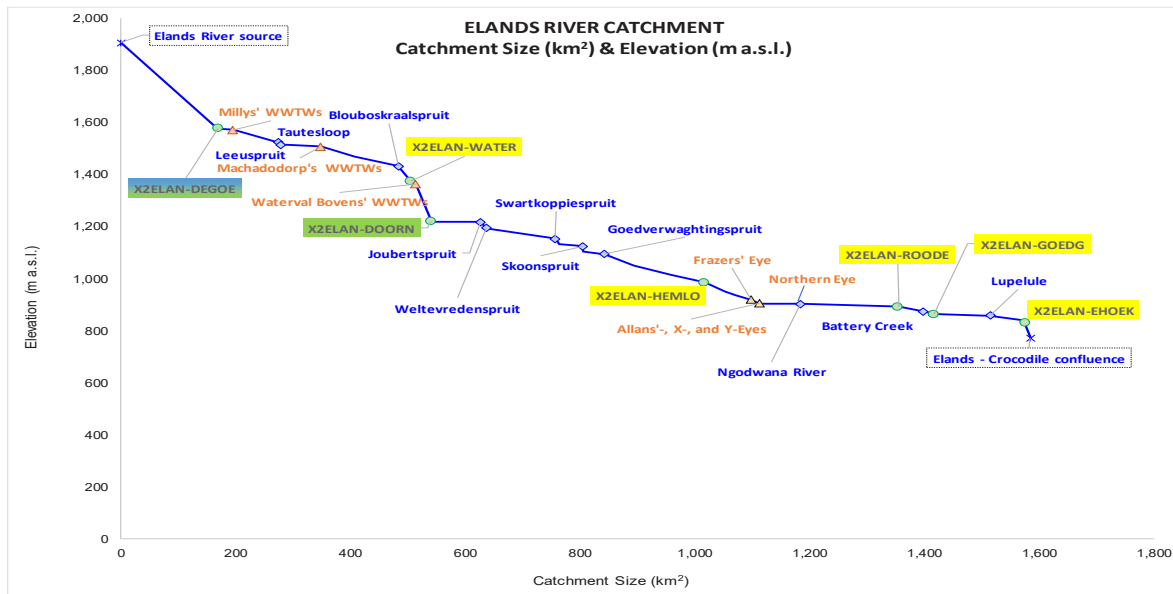
Figure 35: The Elands River is plotted on catchment size against elevation. Sites sampled in 2017 are indicated as green circles, and labeled with the site code. The points where tributaries merge with the Elands are indicated as blue diamonds, and the tributaries are labeled. The location of Waste Water Treatment Works (WWTWs) and known groundwater eyes near Ngodwana Mill are indicated as orange triangles.

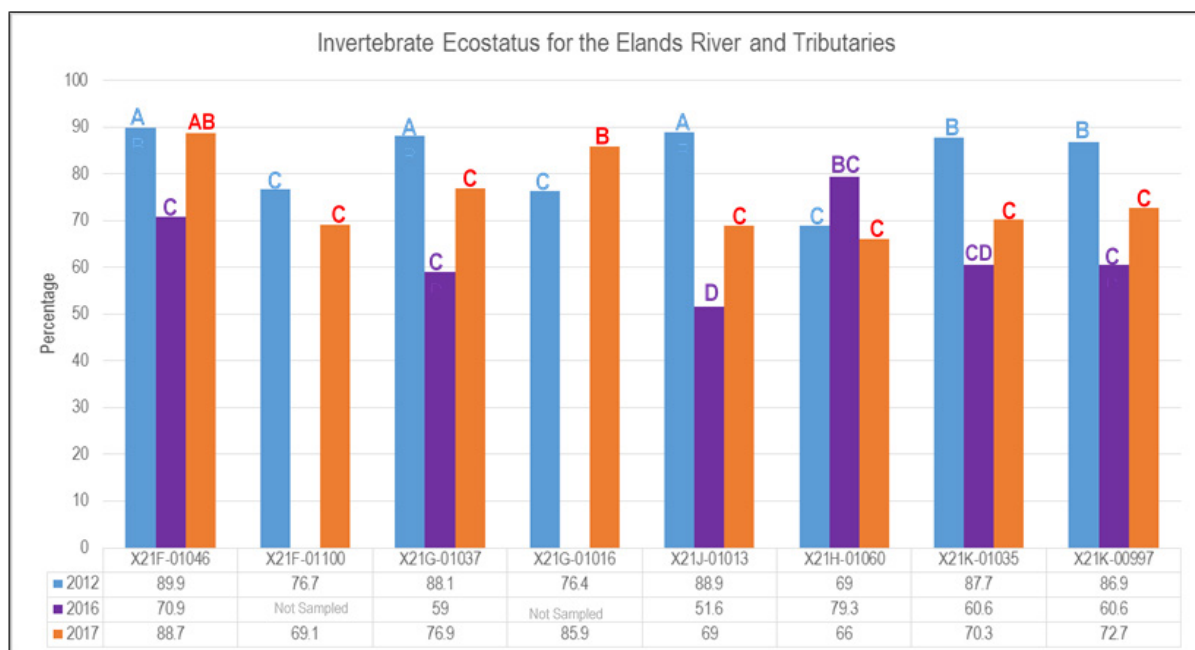
Figure 36: Invertebrate Ecostatus rating derived from the RIVDINT model summarised for the Elands River and Tributaries, comparing 2012, 2016 and 2017.

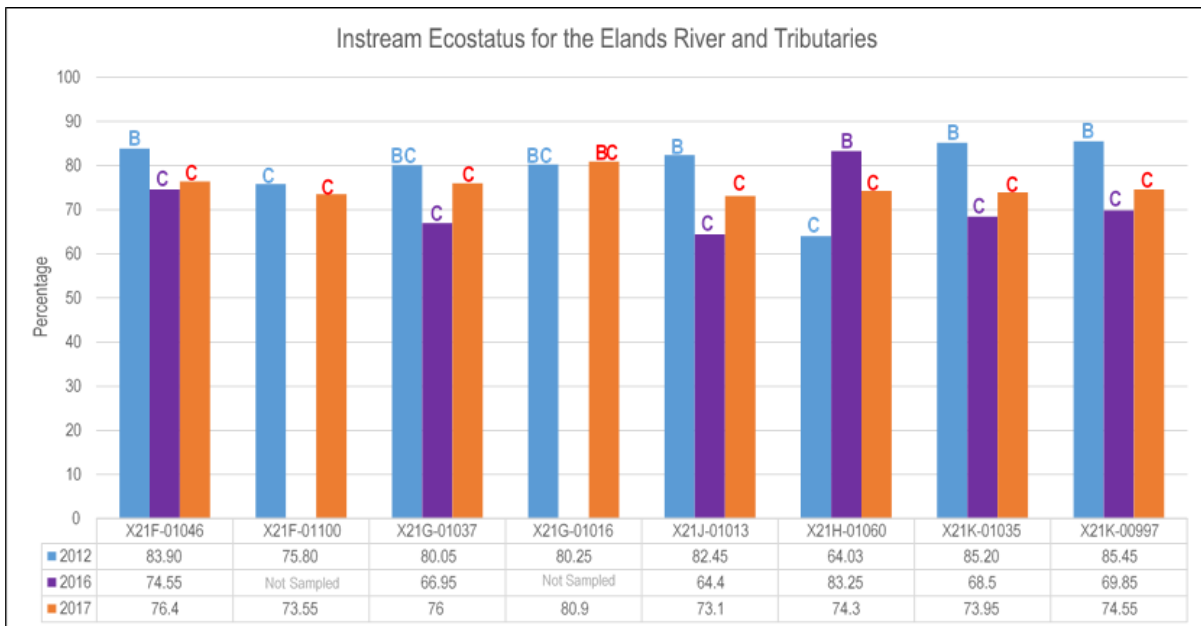
Figure 37: Instream Ecostatus derived from the RIVDINT model summarised for the Elands River and Tributaries, comparing 2011, 2016 and 2017.

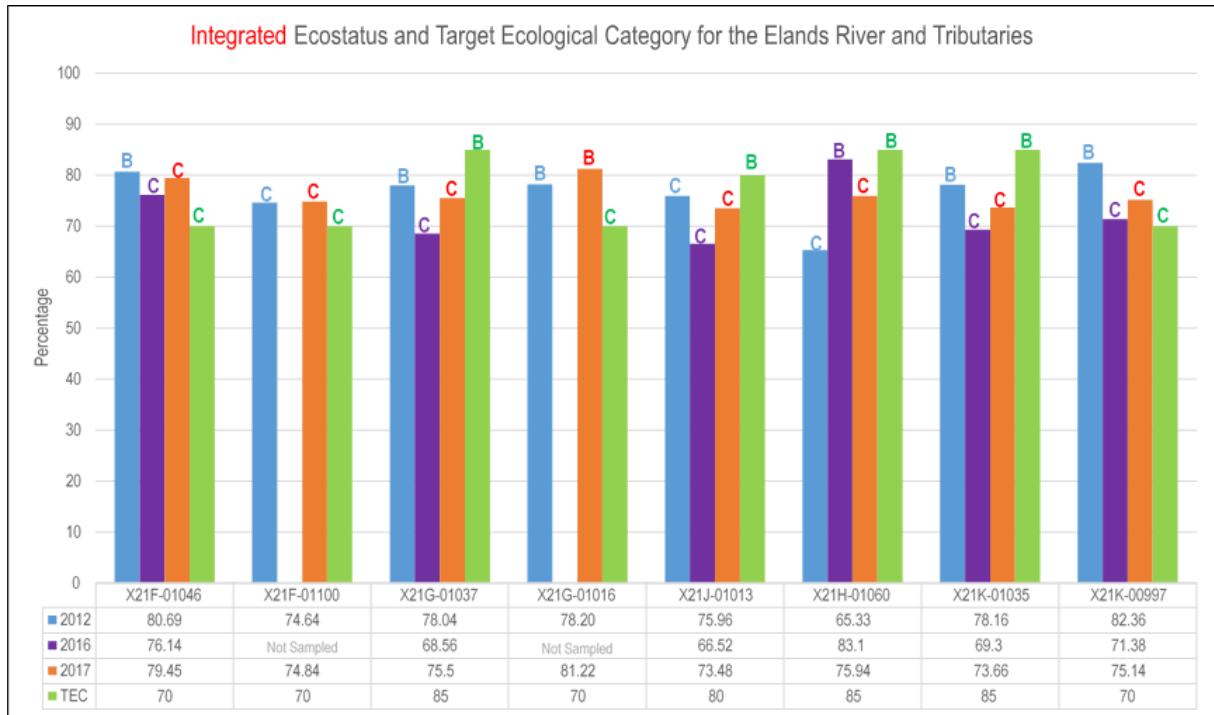
Figure 38: Integrated Ecostatus derived from the RIVDINT model summarised for the Elands River and Tributaries, comparing 2012, 2016 and 2017.

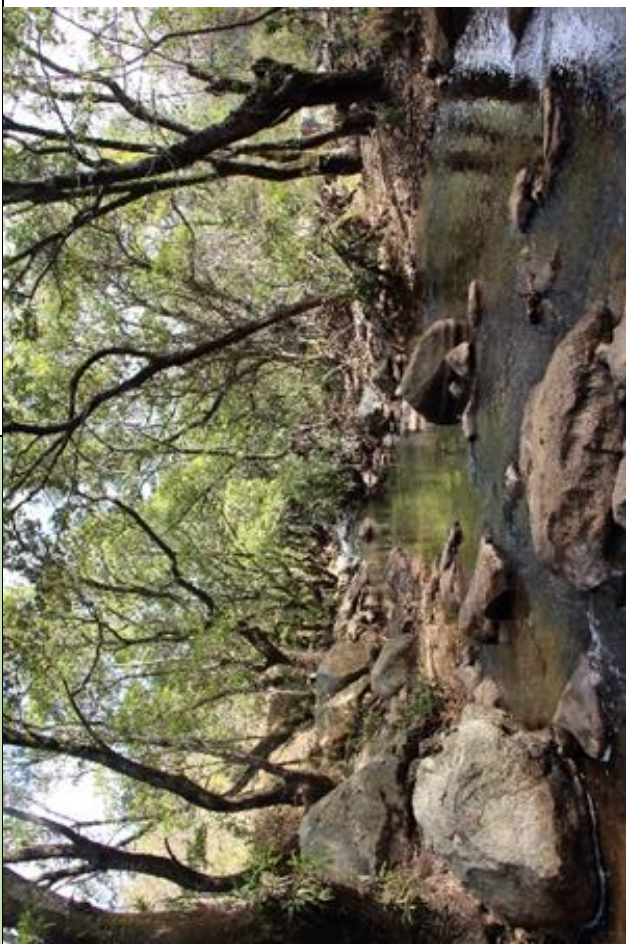
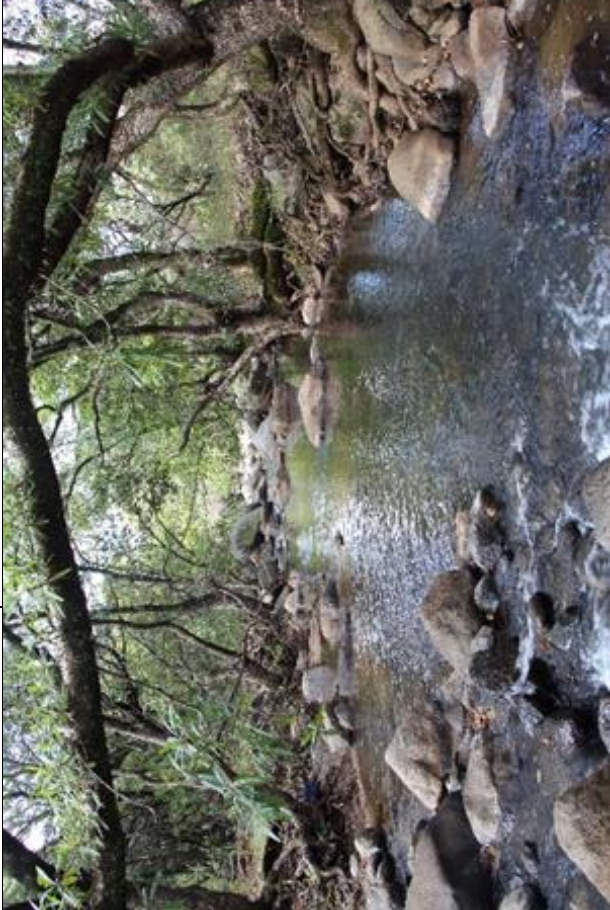
Figure A-75. Upstream view of the Hilversum site on the Queens River, X2QUEE-HILVE (July 2017, G Diedericks).	Figure A-76. Downstream view of the Hilversum site on the Queens River, X2QUEE-HILVE (July 2017, G Diedericks).

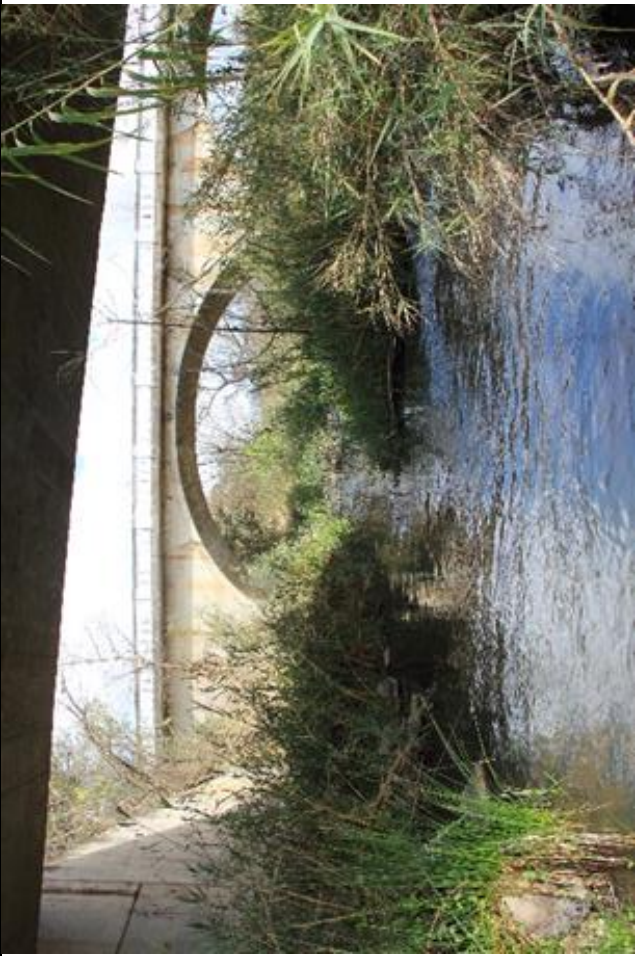
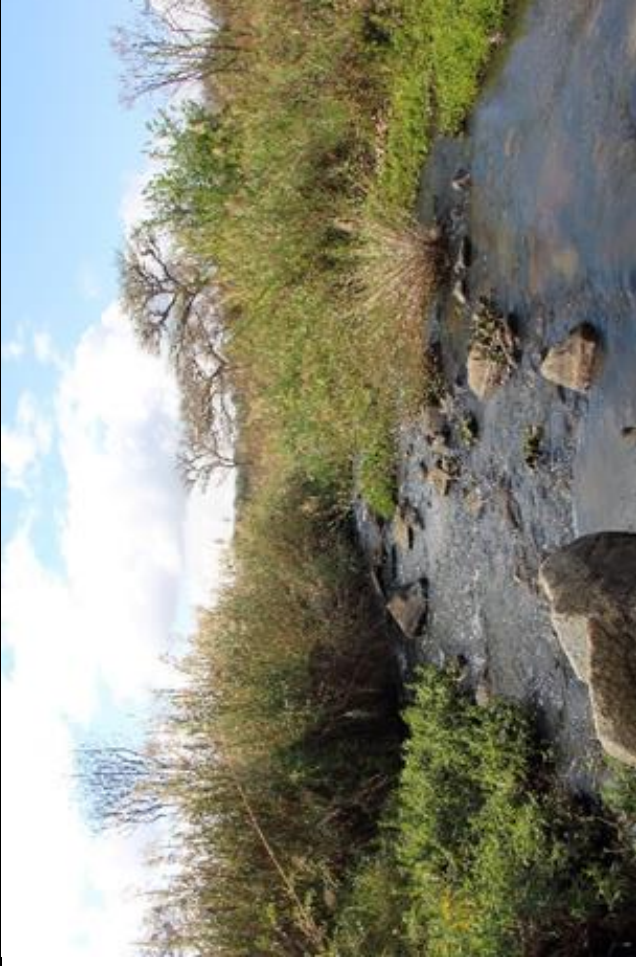
<p>Figure A-77. Upstream view of the Suid-Kaap site, X2SUID-DAISY (July 2017, G Diedericks).</p>		<p>Figure A-78. Downstream view of the Suid-Kaap site, X2SUID-DAISY (July 2017, G Diedericks).</p>

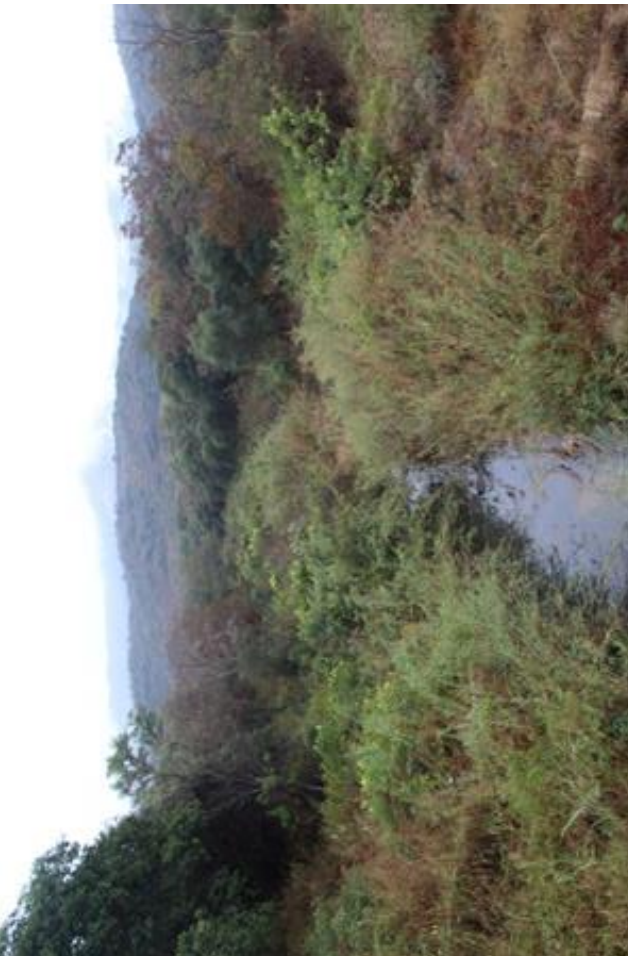
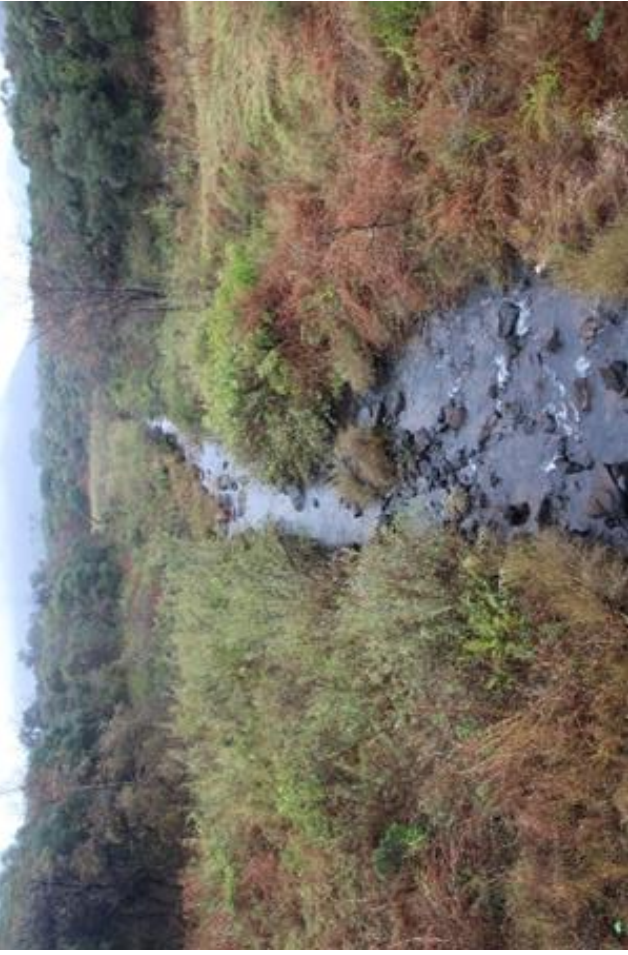
<p>Figure A-79. Upstream view of the Riverside site, X2NOOR-RIVER, on the Noord-Kaap River (July 2017, G Diedericks).</p>		<p>Figure A-80. Downstream view of the Riverside site, X2NOOR-RIVER, on the Noord-Kaap River (July 2017, G Diedericks).</p>

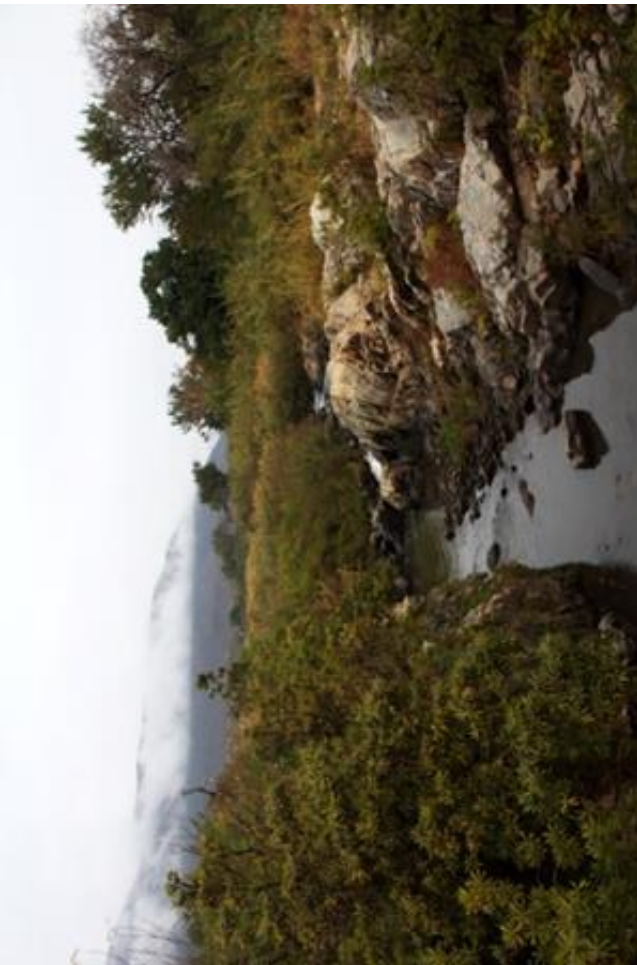
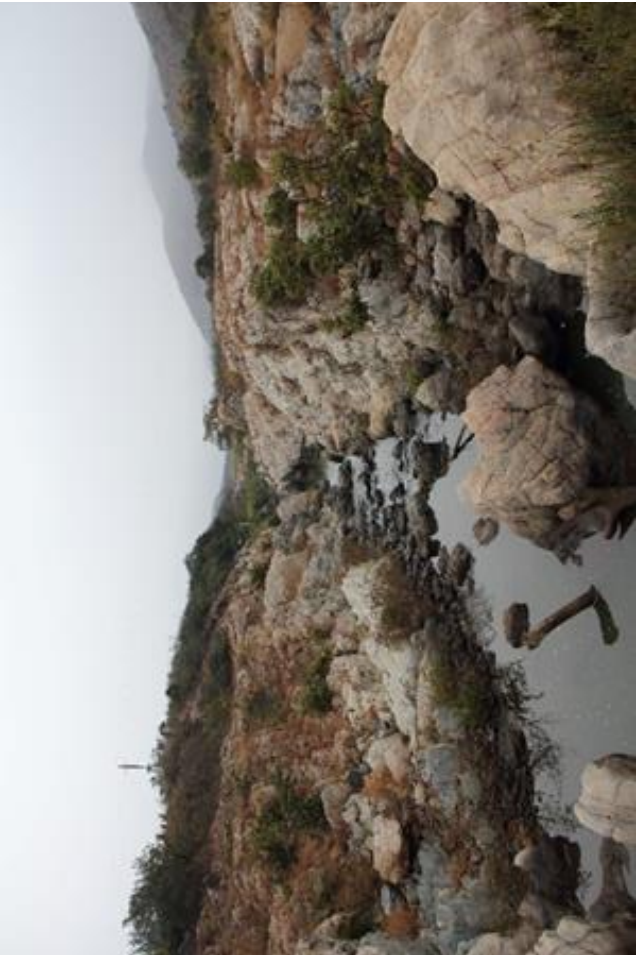
<p>Figure A-81. Upstream view of the Honeybird site, X2KAAP-HONEY, on the Kaap River (July 2017, G Diedericks).</p>		<p>Figure A-82. Downstream view of the Honeybird site, X2KAAP-HONEY, on the Kaap River (July 2017, G Diedericks).</p>

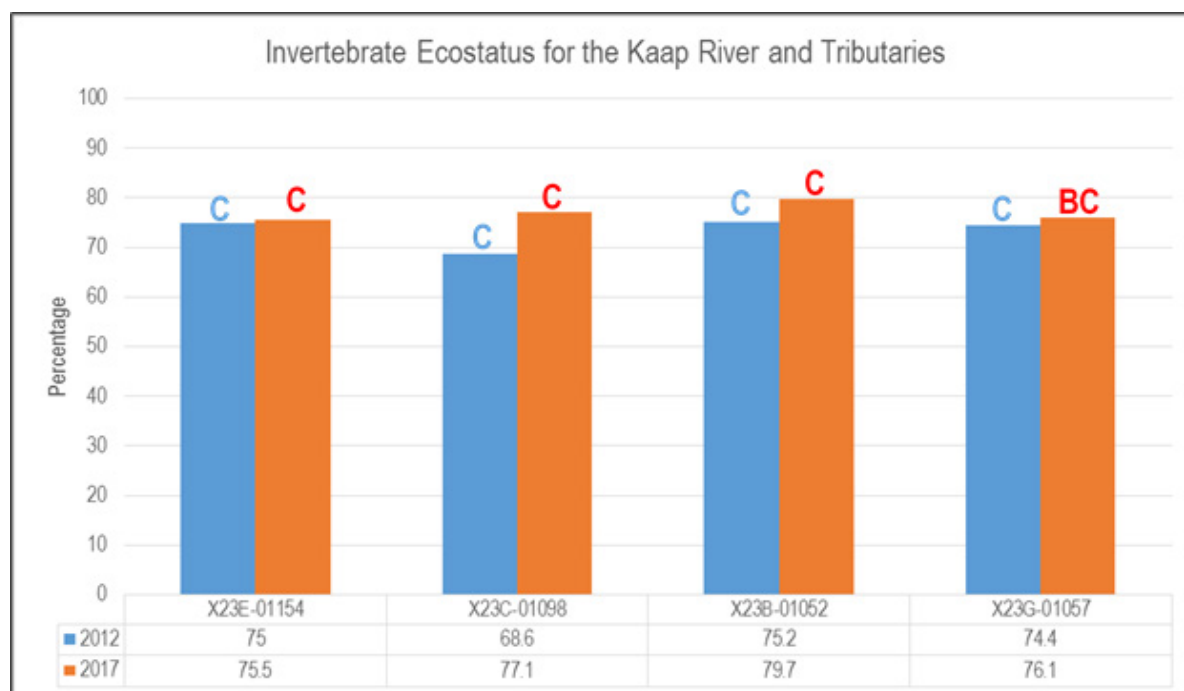
Figure 40: Invertebrate Ecostatus derived from the RIVDINT model summarised for the Kaap River and Tributaries, comparing 2012 to 2017.

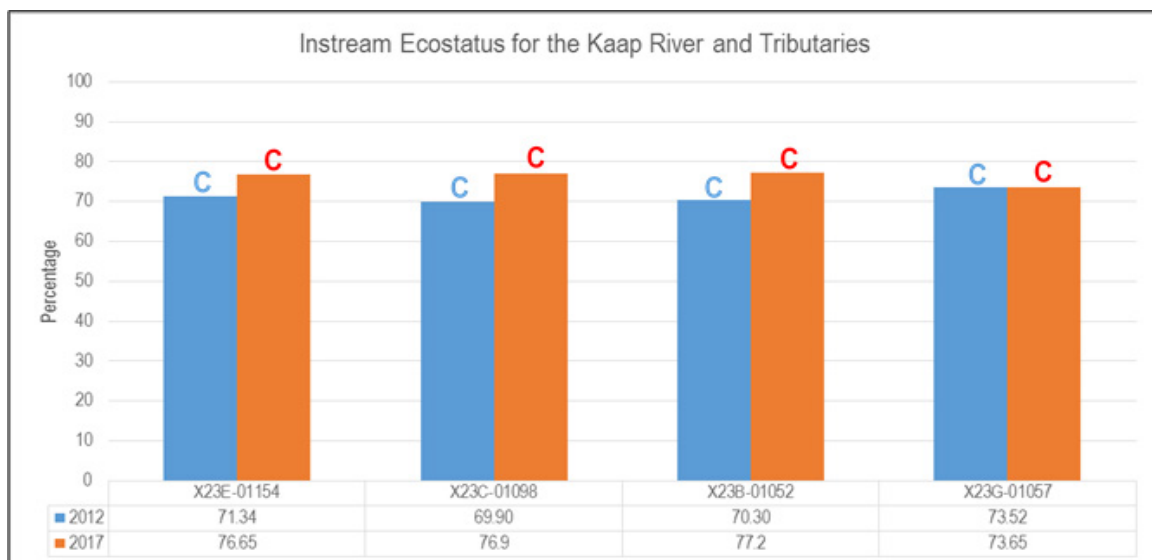
Figure 41: Instream Ecstatus derived from the RIVDINT model summarised for the Kaap River and Tributaries, comparing 2012 to 2017.

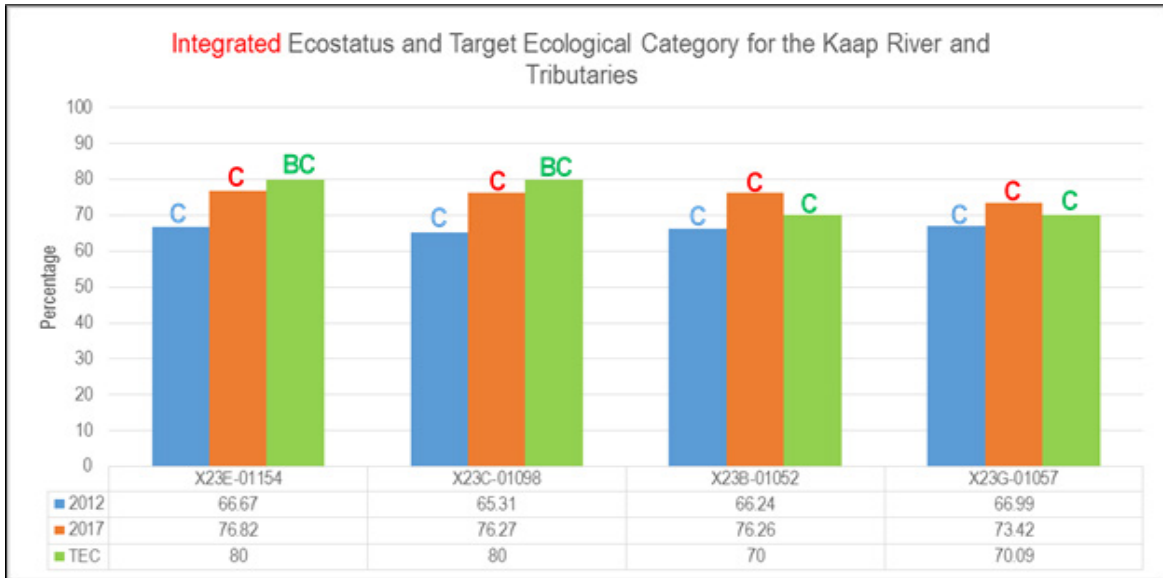
Figure 42: Integrated Ecostatus derived from the RIVDINT model summarised for the Kaap River and Tributaries, comparing 2012 to 2017.

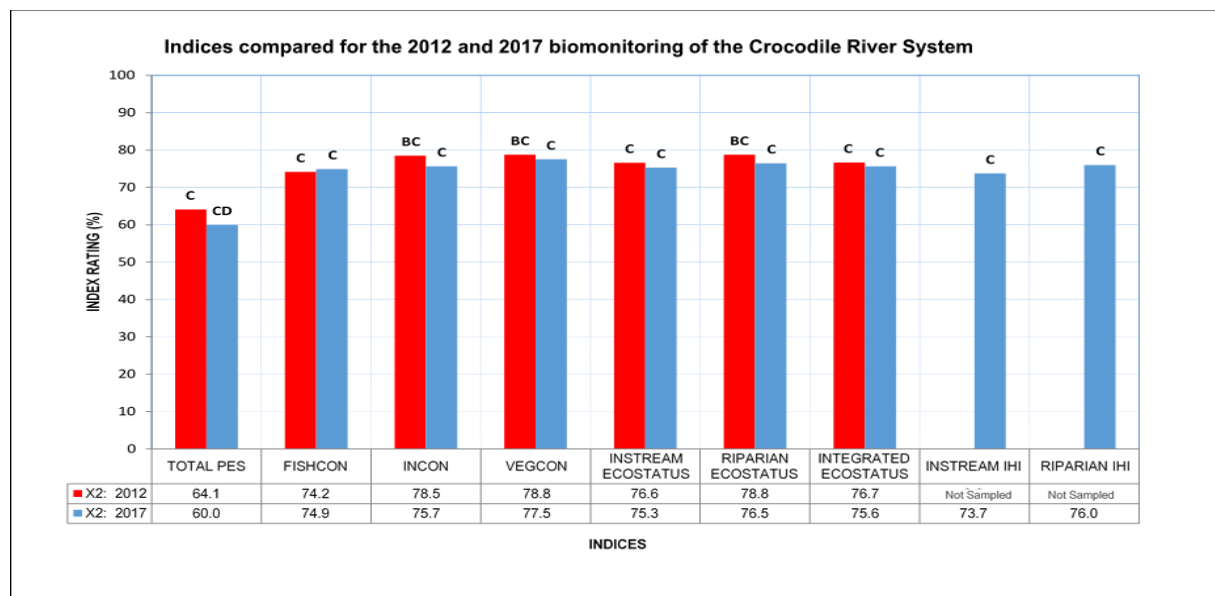
Figure 43: Summary of the Ecstatus for the Crocodile River catchment and a comparison between 2012 and 2017 biomonitoring.
