# **ANNUAL WATER QUALITY STATUS REPORT FOR THE INKOMATI-USUTHU WATER MANAGEMENT AREA**

**2014/15 financial year**

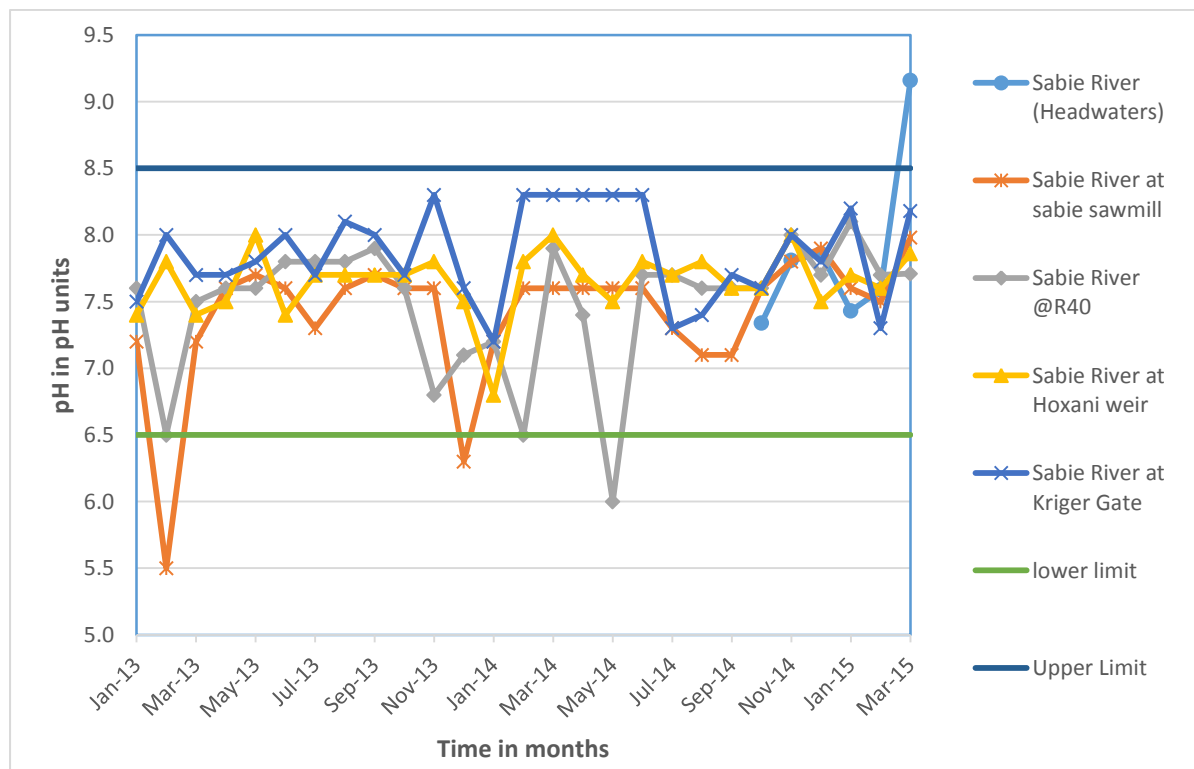
**Figure 4: pH levels measured in the main stem of the Sabie River.**

The pH in most of the monitoring points are within the acceptable limit, except four points outside of the acceptable range as depicted in figure 4 above. These outliers could not be attributed to any activity or geology in the area and is therefore attributed to human error.
