ANNUAL WATER QUALITY STATUS REPORT

FOR THE INKOMATI-USUTHU WMA
2019/20 FINANCIAL YEAR

ANNUAL WATER QUALITY STATUS REPORT FOR THE INKOMATI-USUTHU WATER MANAGEMENT AREA

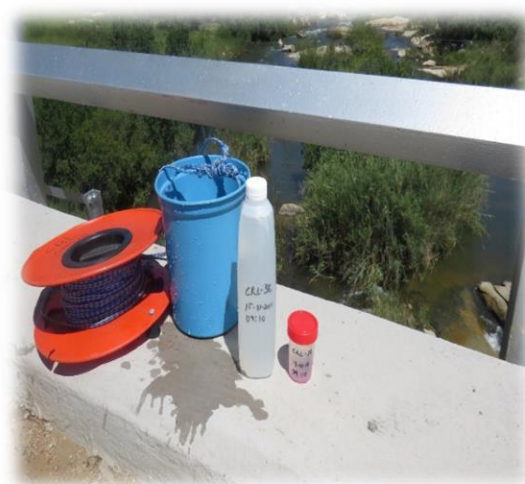
Figure 3: Chemical and Microbiological samples taken at Komati River downstream of Vygeboom Dam at R38 bridge using the bailer and the bucket

The water quality sample bottles were marked with the site code, date and time of collection using a permanent marker. Additives were only introduced in the microbial sample collecting bottles as they were pre-sterilized. The grab sample method was used for chemical and microbiological sampling. The caps of the bottles were not removed until the sample was ready to be taken. Some of the samples were taken on bridges using a bucket and bailer. The bucket was rinsed three times before collecting the sample and filling the sampling bottles.

One (1) litre chemical sample collecting bottles were rinsed three times before they were filled. The 300ml microbial sample collecting bottles were not rinsed since they were sterilized, ample air space was left in the sample bottle to facilitate mixing by shaking.

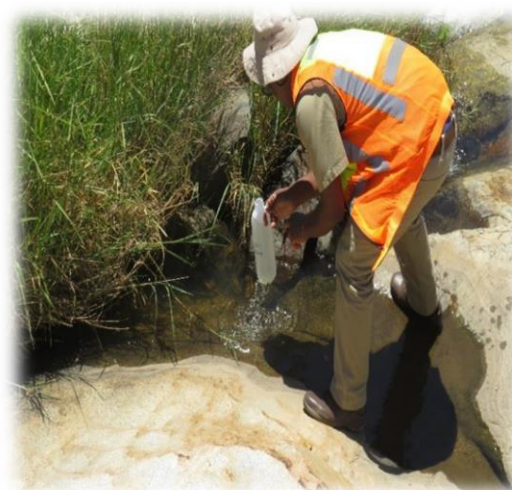
Figure 4: IUCMA official taking water quality chemical sample at tributary of Seekoeispruit in the Komati Catchment

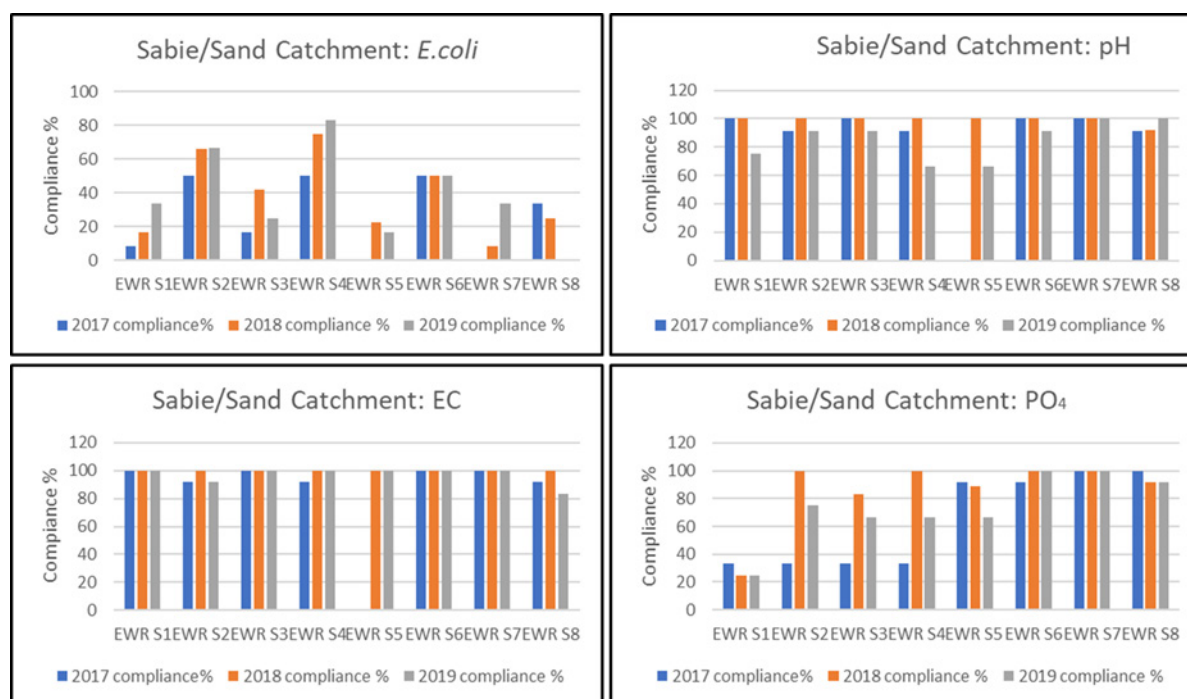
Figure 7: The compliance % of *E coli*, pH, EC and PO₄ concentrations on EWR sites in the Sabie/Sand Catchment for calendar years 2017, 2018 and 2019.

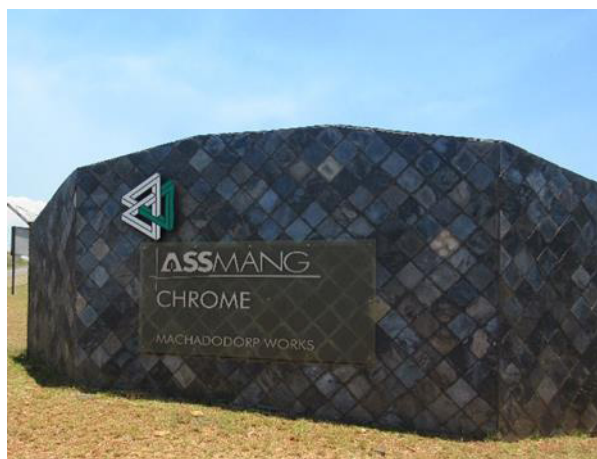
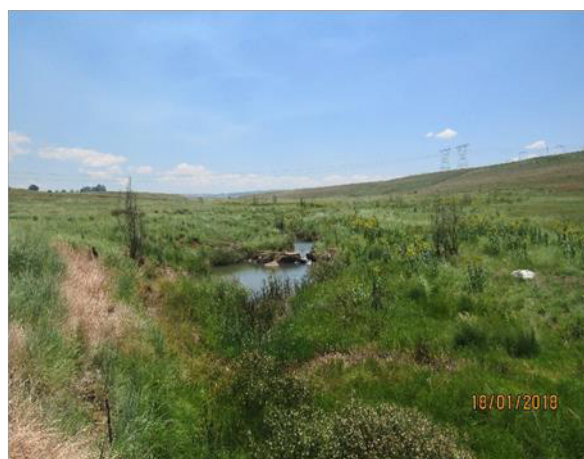
Cr (VI) is monitored at Leeuspruit to assess the impact from Assmang Chrome on the water resource, Cr (VI) complied with the RQOs of 0.014 (mg/l) throughout the reporting period except in April and May 2019 which exceeded the set RQO as indicated below.

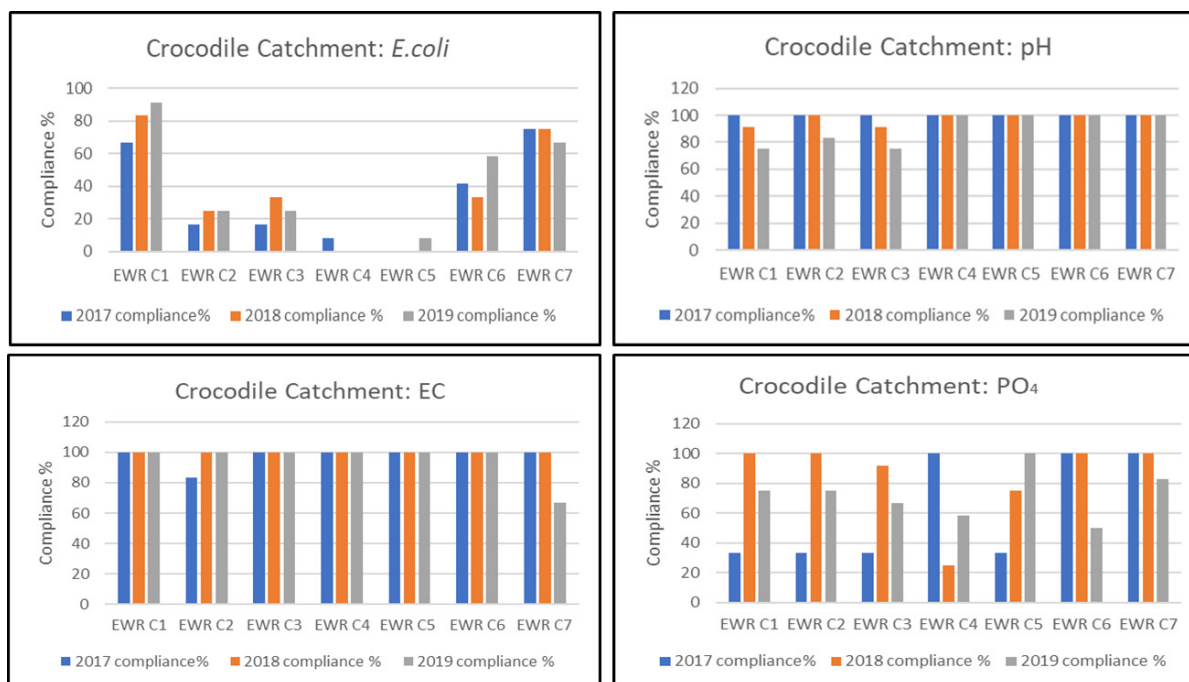
Figure 12: The % compliance of *E. coli*, pH, EC and PO_4 concentrations on EWR sites in the Crocodile Catchment for calendar years 2017, 2018 and 2019.

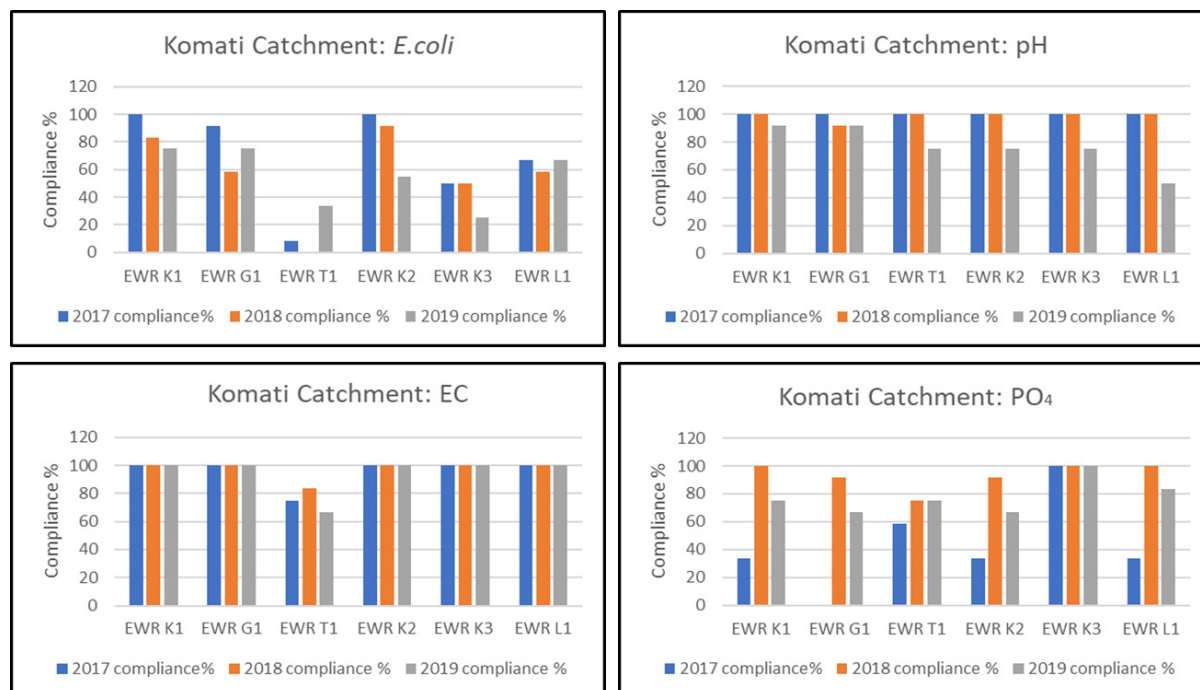
Figure 17: The compliance % of *E. coli*, pH, EC and PO₄ concentrations on EWR sites in the Komati Catchment for year 2017, 2018 and 2019.

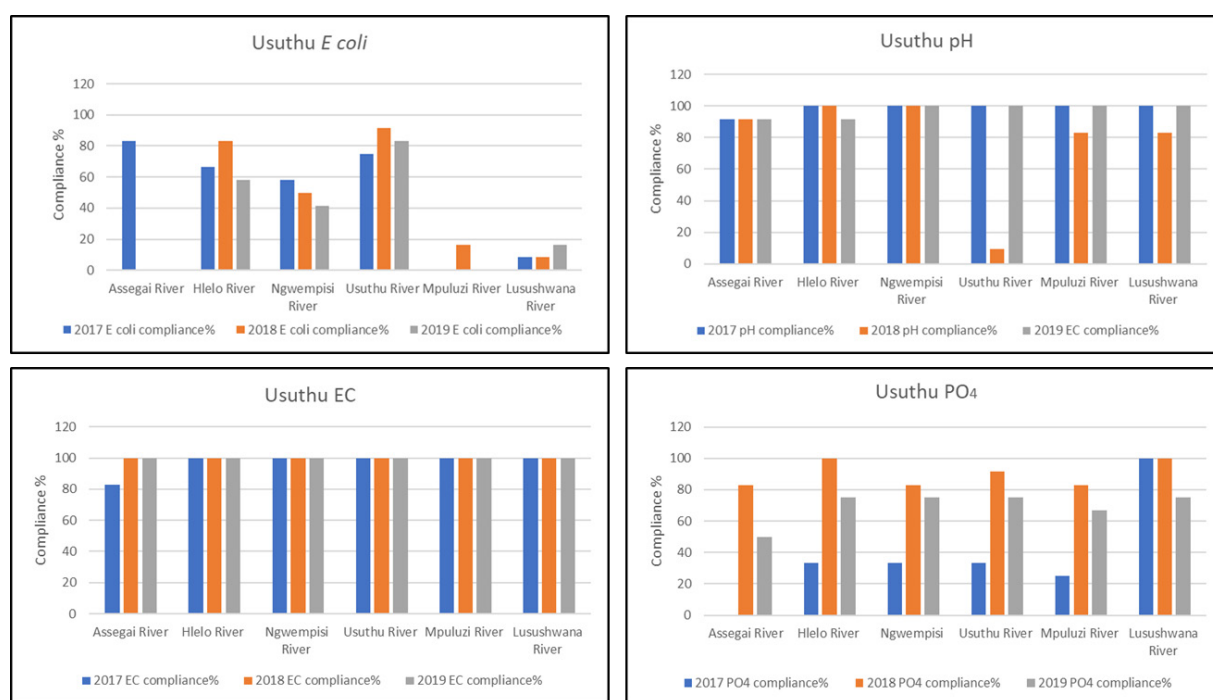
Figure 21: The compliance % of E coli, pH, EC and PO₄ concentrations on Usuthu Catchment Rivers for year 2017, 2018 and 2019.
