**INKOMATI-USUTHU**  
CATCHMENT MANAGEMENT AGENCY

# **ANNUAL WATER QUALITY STATUS REPORT**

**FOR THE INKOMATI-USUTHU WMA  
2020/21 FINANCIAL YEAR**

# ANNUAL WATER QUALITY STATUS REPORT WITHIN INKOMATI-USUTHU WMA

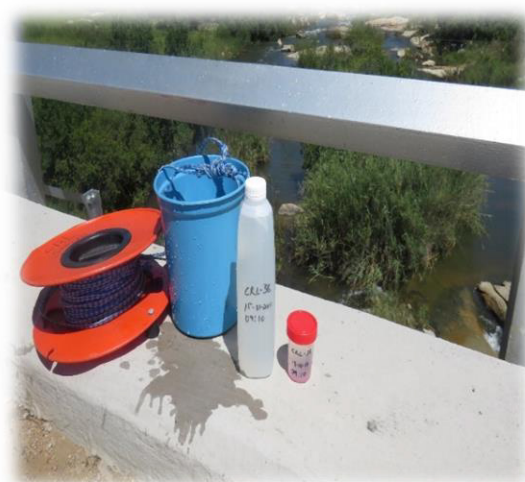
*Figure 3: Chemical and Microbiological samples taken at Komati River downstream of Vygeboom Dam at R38 bridge using the bailer and the bucket*

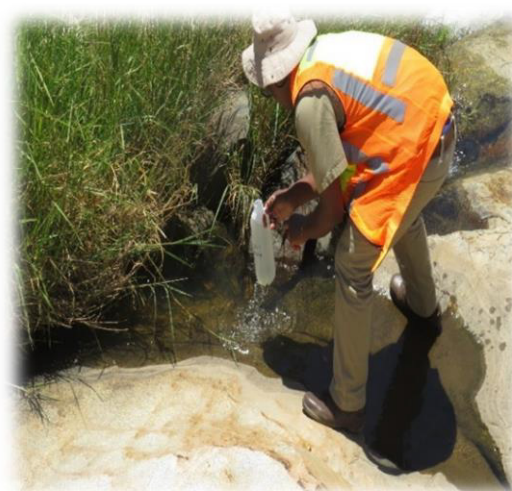
*Figure 4: IUCMA official taking water quality chemical sample at tributary of Seekoeispruit in the Komati Catchment*

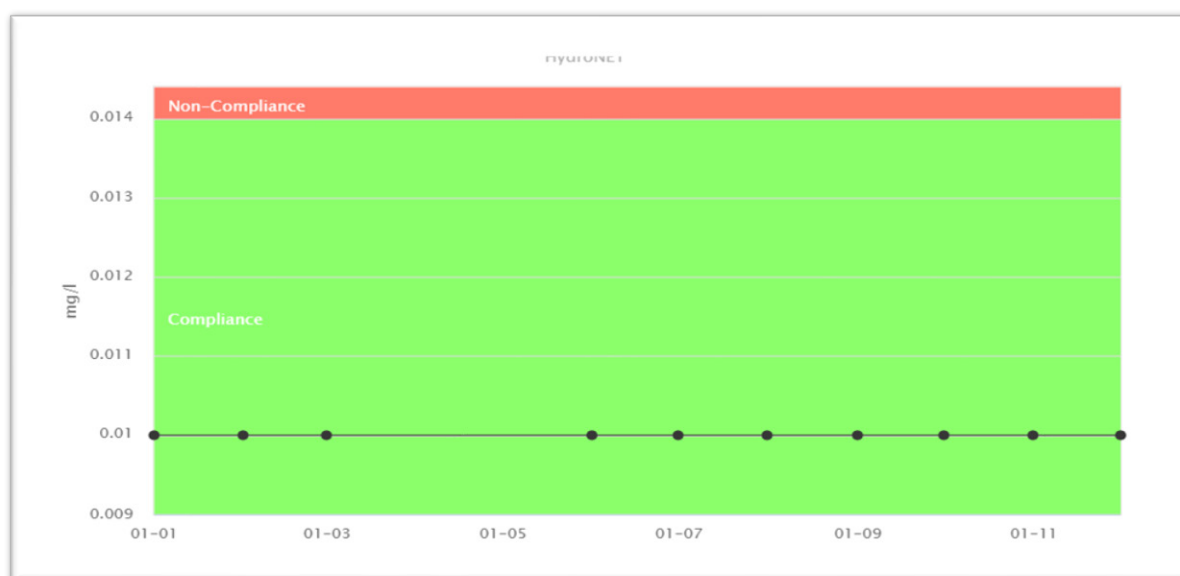
Cr (VI) is monitored at Leeuspruit to assess the impact from Assmang Chrome on the water resource, Cr (VI) complied with the RQOs of 0.014 (mg/l) throughout the reporting period as indicated below *Figure 12*.

**Figure 12:** Chromium (VI) trend chart at Leeuspruit
