**INKOMATI-USUTHU**  
CATCHMENT MANAGEMENT AGENCY

# **ANNUAL WATER QUALITY STATUS REPORT 2021/22**

## ANNUAL WATER QUALITY STATUS REPORT WITHIN INKOMATI-USUTHU WMA

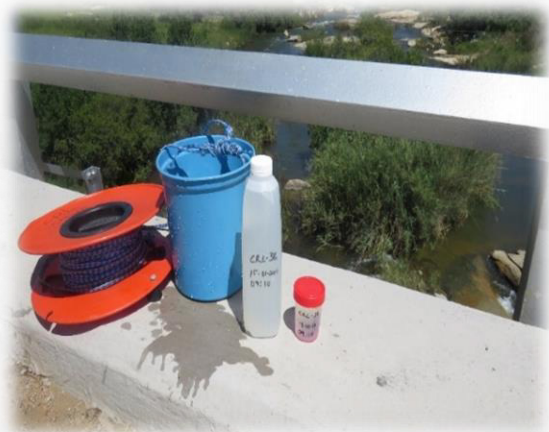
*Figure 3: Water quality samples taken at Komati River using the bailer and the bucket.*

Monthly physio-chemical and microbiological samples were taken using grab sample technique. Sampling bottles were marked with the site code, date and time of collection using a permanent marker. Some of the samples were taken on bridges using a bucket and bailer. The bucket was rinsed before collecting the sample and filling the sampling bottles.

One (1) litre physio-chemical sample bottles were rinsed three times before they were filled. The 300ml microbial sample collecting bottles were not rinsed since they were sterilized, ample air space was left in the sample bottle to facilitate mixing by shaking.

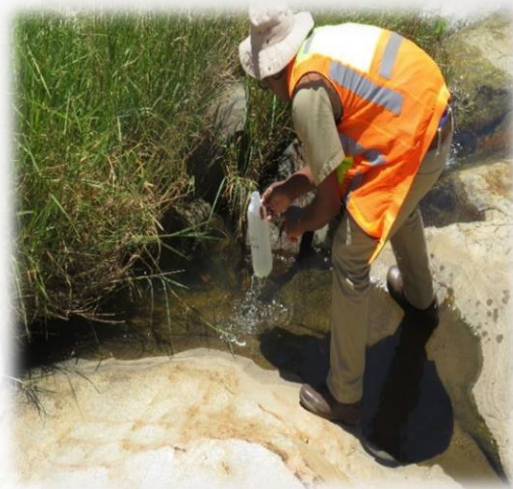
*Figure 4: IUCMA official taking water quality chemical sample at tributary of Seekoeispruit.*

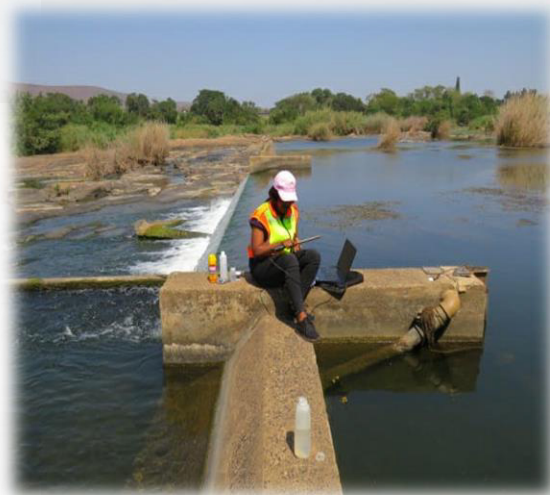
*Figure 5: IUCMA official downloading data from probe trough Win-Situ software at Komati River.*

Five water quality probes are installed within the WMA for continuous water quality monitoring. The parameters that are measured in continuous monitoring stations are actual conductivity ( $\mu\text{S}/\text{cm}$ ), temperature ( $^{\circ}\text{C}$ ) and salinity (PSU) after every 3 hours. Actual conductivity data is transmitted to Zednet via network and other variables are downloaded through Win-Situ software.

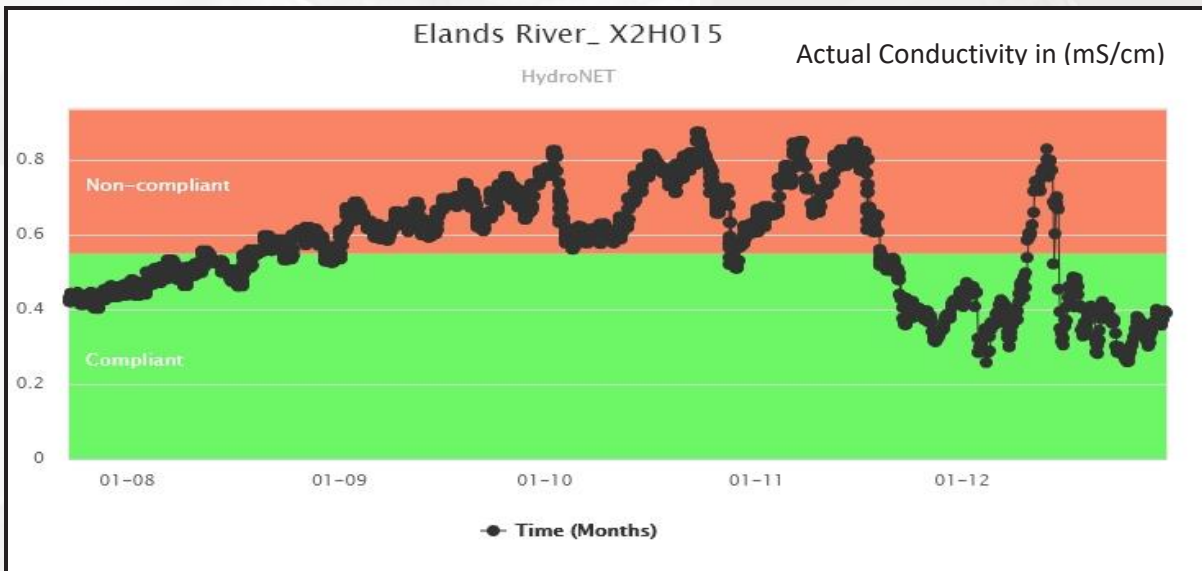
Below are the charts indicating the salinity (PSU), actual conductivity (µS/cm) and temperature (°C) that are measured in continuous monitoring at Lindenau station on Elands River ranging from 1 August 2021 to 31 December 2021.

Figure 13: Salinity, EC and Temperature trend charts at Elands River gauging station (X2H015)

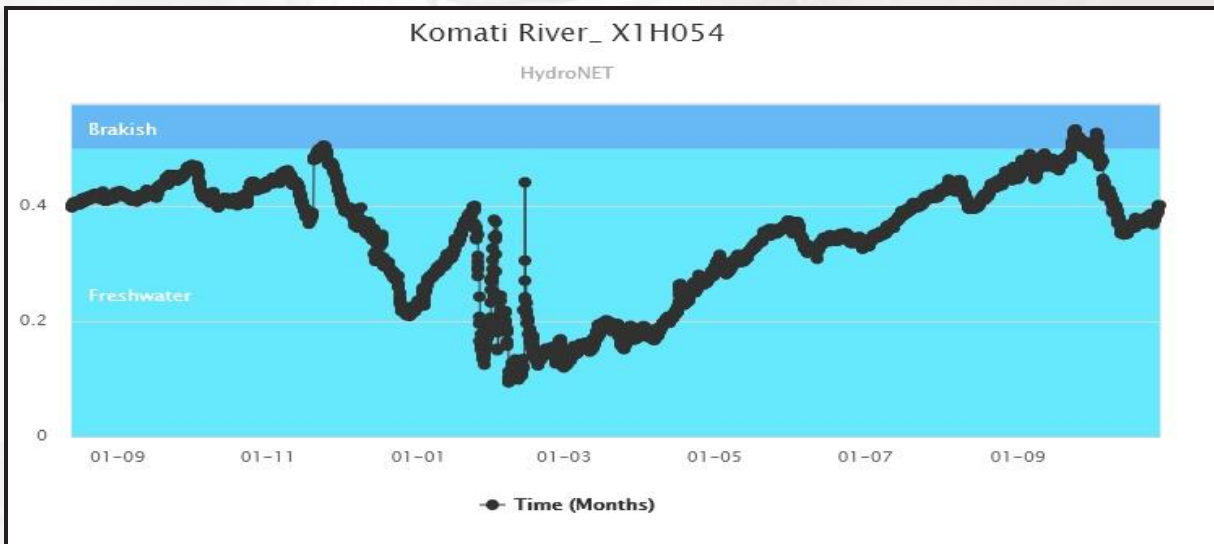
Figure 19: Salinity (PSU) trend charts at Komati River gauging stations (X1H001 and X1H054)

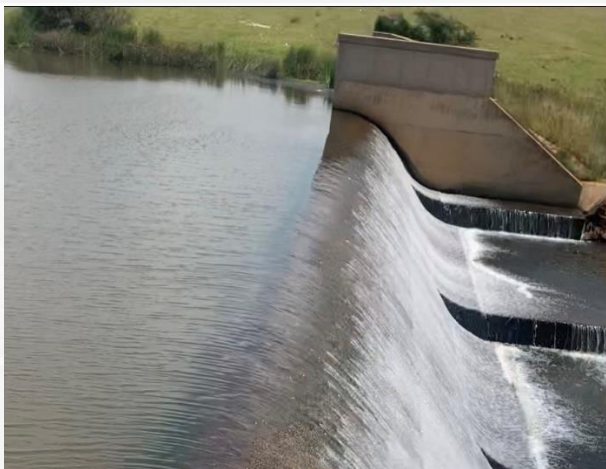
Based on the trophic status, it was safe to undertake recreational activities that required both full and/or partial contact at Boesmanspruit Dam as illustrated in *Figure 28* during the reported period.

Figure 28: A photo of Boesmanspruit Dam
