# ANNUAL RESOURCE QUALITY STATUS

## REPORT

THE INKOMATI-USUTHU CMA

2023/24 FINANCIAL YEAR

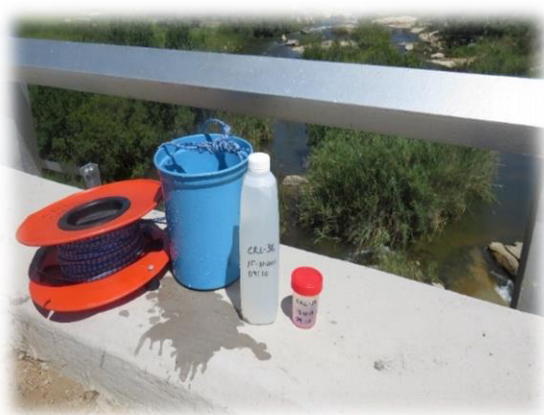
*Figure 3: Water quality samples taken at Komati River using the bailer and the bucket.*

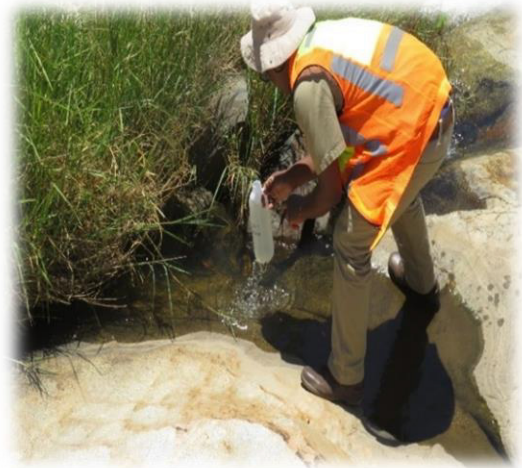
*Figure 4: IUCMA official taking water quality chemical sample at tributary of Seekoeispruit.*

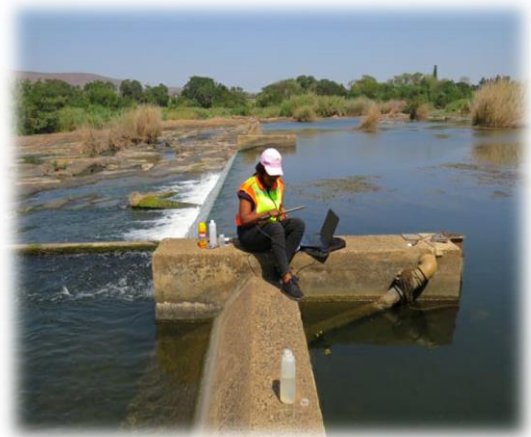
Six water quality probes are installed within the WMA for continuous water quality monitoring. The parameters measured in continuous monitoring stations are actual conductivity ( $\mu\text{S}/\text{cm}$ ), temperature ( $^{\circ}\text{C}$ ) and salinity (PSU) after every 3 hours. Actual conductivity data is transmitted to Zednet via network and other variables are downloaded through Win-Situ software.

*Figure 5: IUCMA official downloading data from probe through Win-Situ software.*

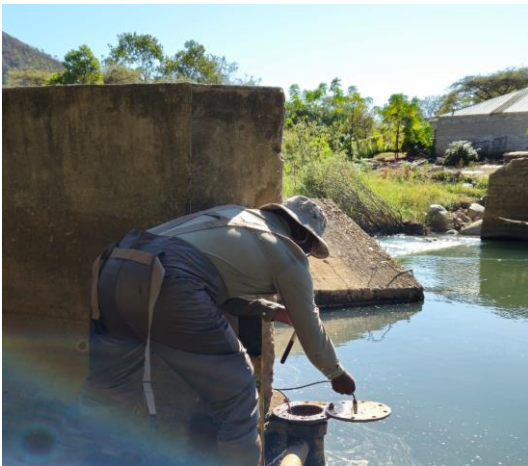
These comprise measurements that are taken and recorded on site such as temperature and Dissolved Oxygen measured on a monthly basis. Field measurements were taken on 23 Ecological Water Requirements sites and 10 international Obligation site(s) using the handheld EcoSense DO200A Dissolved Oxygen Meter.

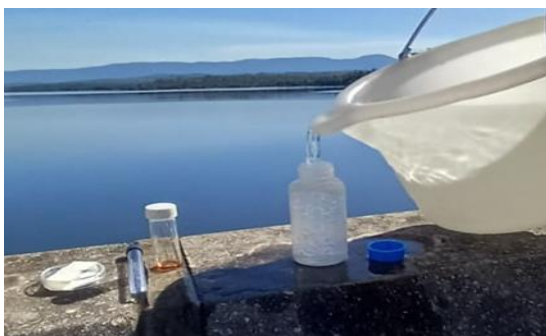
**Macro samples** were taken by decanting water from the integrated sample or subsurface grab sample into the blue-top bottle washed with phosphate free soap and the samples were stored in cooler box with ice cubes.

Figure 6: Filling of Macro sample.

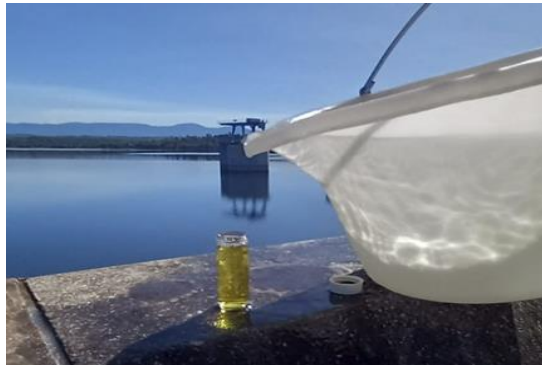
Samples for **identification of algae** were taken by decanting water from the integrated sample or subsurface grab sample into a small glass bottle with 2-4 drops of lugol preservative.

Figure 7: Filling of Algae identification sample.

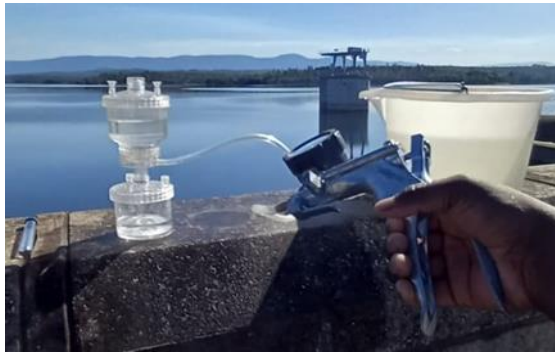
The **chlorophyll-*a*** samples were conducted using a filter unit, by unscrewing the top of the rinsed filter and carefully placing the filter paper inside the unit and screwing the top back. A volume of 250ml water from the integrated sample or subsurface grab sample was poured into the unit and water was drawn through the filter using a vacuum pump up to 500ml if possible. The total amount of water filtered was recorded. The filter was then opened gently, then the filter paper was carefully lifted and stored into a glass tube with ethanol.

**Total suspended solids** samples were taken using the same method as conducted for the Chlorophyll-*a* samples, but a weighed filter paper marked with a black dot was used and then stored in a petri dish.

Figure 8: Filtration of Suspended solids or chlorophyll-a sample(s).

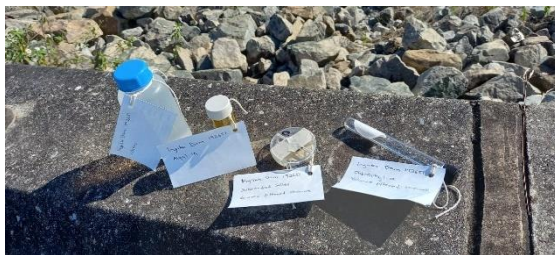
All samples were clearly marked on a tag with the sample description, date, time, dam ID code, name of the resource and volume filtered. The samples were stored in a dark container. The samples and onsite monitoring report sheets were then submitted to the Department of Water and Sanitation laboratory at Resource Quality Information Services (RQIS) for analysis.

Figure 9: Clearly marked samples for Eutrophication taken at Injaka Dam.

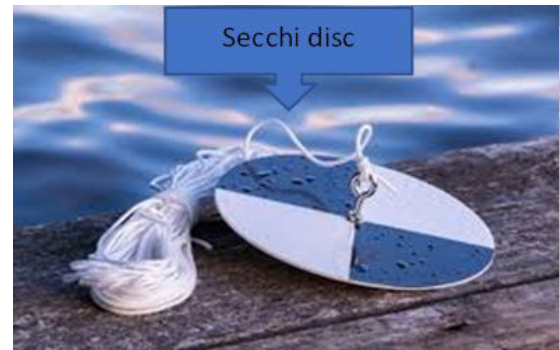
- The secchi disc is used to determine the clarity by lowering the disc into the water until it is out of sight and record the depth reading on the marked rope.

Figure 10: Secchi disc used to measure clarity.

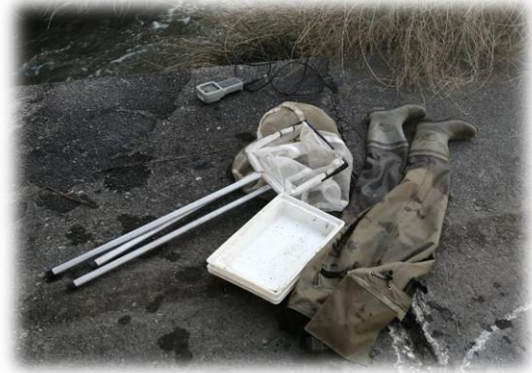
- Stones (and bedrock)-in-current was sampled for 2 minutes.
- Stones (and bedrock)-out-of-current was sampled for 1 minute.
- Marginal vegetation (both in- and out-of-current) was swept with a net for a total length of 2m.
- Aquatic vegetation (where present) was swept with a net for an area of 1m<sup>2</sup>.
- Gravel, sand, and mud was stirred and swept with a net for 1 minute.

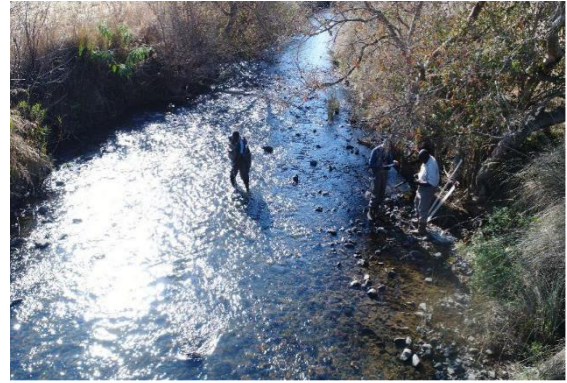
Fish were sampled at each site using an electric shocker. The data was collected in different velocity depth classes, and for each flow depth class the presence of features that provide cover for fish were considered. Information on the general habitat and cover preferences of fish species was obtained from the available literature and personal experience. Fish data collected in different velocity depth was kept separate for analysis and the results were recorded as a number of fish caught per time unit.

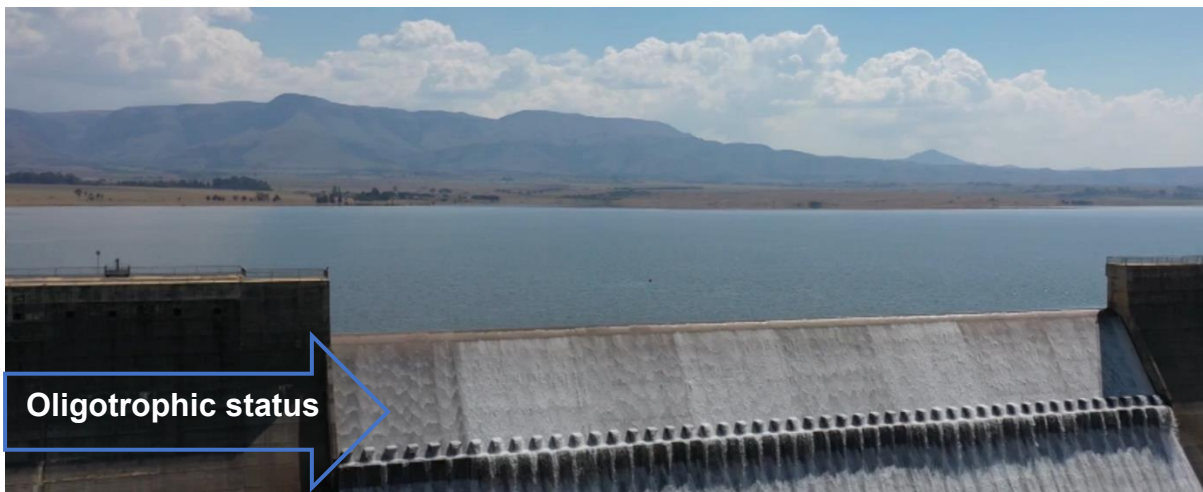
Below is the photo of Kwena Dam as an example in Crocodile Catchment indicating trophic status and nutrients level of the dam which implies low or no productivity in terms of plants (Water hyacinth) and algal growth.

Figure 90: A photo of Kwena Dam with low to no algal growth and macrophyte (Water hyacinth).

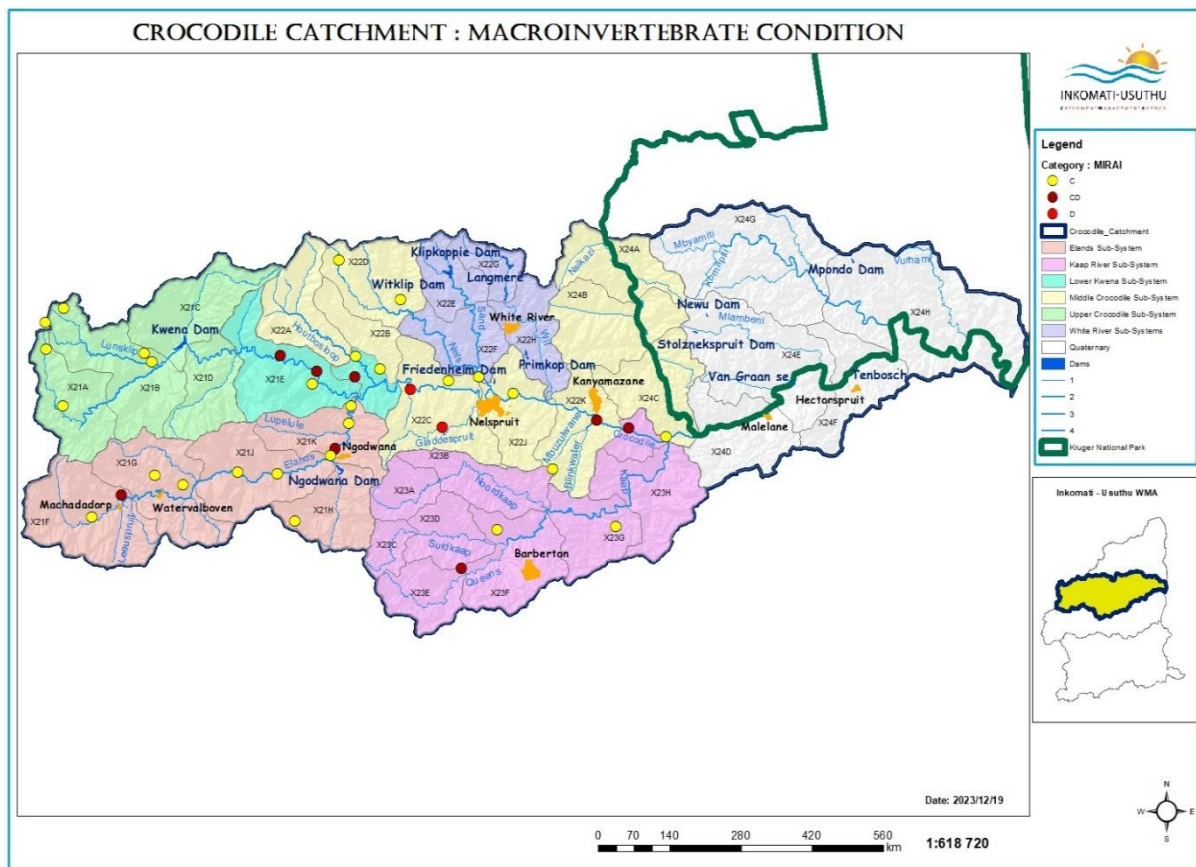
Figure 97 indicates that the Crocodile catchment is currently in a moderately modified condition (C), which is similar to the ecological condition found in previous surveys. However, some reaches of the catchment were in a close to moderately modified (CD) condition (*i.e.*, X21E-00943, X22K-01018, X21F-01100, X21H-01060 and X23E-01154) and in a largely modified (D) condition (*i.e.*, X22C-00990 and X22C-01004). This shows that the catchment is moderately modified, and the modifications can be attributed to the anthropogenic activities such as agriculture, forestry, residential areas, and industrial activities, occurring in the catchment.

Figure 97: Ecological Categories in the Crocodile Catchment reflecting macro-invertebrates condition for sites monitored in June 2023 survey.
