### Water Quality and Quantity Status

# Within Inkomati Usuthu WMA (Usuthu and Upper Komati Catchment)

By: Dr T Sawunyama Tariff Consultation August 2022

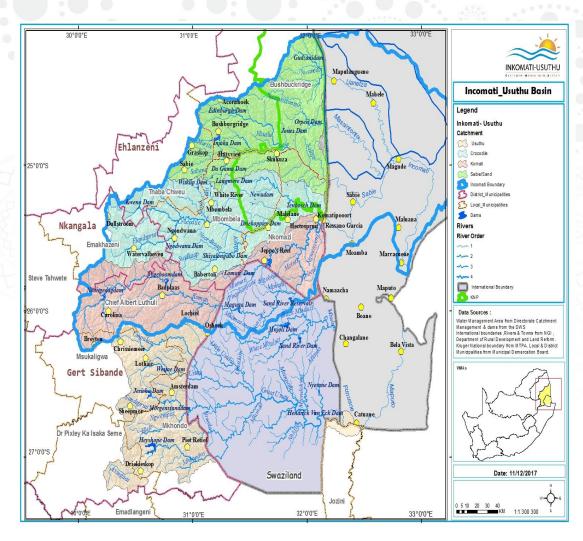
#### **INKOMATI-USUTHU WATER MANAGEMET AREA**

The WMA has four (4) main rivers which form the sub-division into 4-main catchments namely Crocodile, Sabie/Sand, Usuthu and Komati;

The IUCMA is geographically wholly located within Mpumalanga Province: 3
 Districts and 8 Local Municipalities;

The IUCMA is transboundary nature and forms part of the Incomati International River Basin shared between the Republic of Mozambique, the Kingdom of Swaziland and the Republic of South Africa.

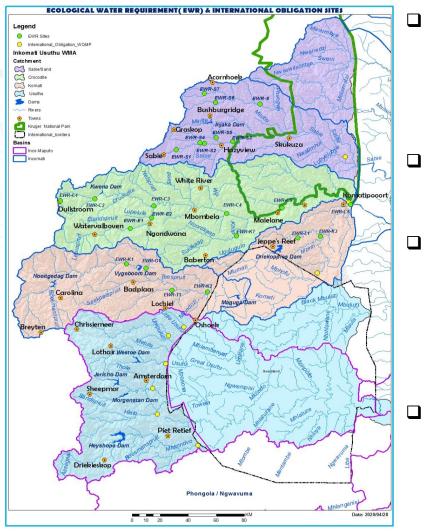
# INKOMATI- USUTHU WATER MANAGEMENT AREA

- The IUCMA currently monitors 269 water quality sites,
  31 river flow sites, 25 rainfall sites and 12 groundwater sites within Inkomati-Usuthu Water Management Area (these excludes 45 DWS managed sites).
- Water Quantity monitoring is done through real time monitoring probes and rainfall gauges.
  - Water Quality status is reported (April 2021-March 2022) on **32** Strategic monitoring sites :
    - -Twenty-three (**23**) Ecological Water Requirement (EWR) sites
    - -Ten (10) International Obligation (IO)
- Eutrophication monitoring is done through near-real time monitoring on the Cynlolakes digital application and the National Eutrophication Monitoring Programme (NEMP) on 10 Major Dams within the WMA.

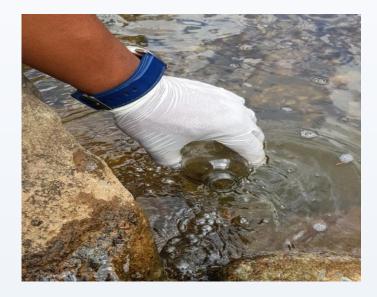
# Water Quality Status

#### **EWR SITE(S) COMPLIANCE STATUS : KOMATI CATCHMENT**

EWR Site	рН		EC (mS/m)		PO <sub>4</sub> (mg/l)		<i>E coli</i> (cfu/100ml)	
	Ecospec	Results	RQOs	Results	RQOs	Results	RQOs	Results
EWR K-1	6.0 - 8.6	7.6-8.2	50	19.4	0.02	<0.010	130	271
EWR G-1	6.0 - 8.6	7.3-8.3	N/A	30.0	0.02	<0.010	130	288
EWR T-1	6.0 - 8.6	7.6-8.2	N/A	20.4	0.125	0.058	130	1421
EWR K-2	6.2 - 9.0	7.8-8.2	55	20.5	0.02	<0.010	130	386
EWR K-3	6.5 - 8.5	7.3-8.5	85	128.5	0.125	<0.010	130	544
EWR L1	5.7 - 8.3	7.3-8.2	40	24.4	0.075	<0.010	130	552

E. coli is an indication of feacal contamination o the water resources from municipal WWTWs.

- Water Quality in the Upper Komati and Usuthu is generally good but punctuated by microbial (*E. coli*) pollution and salts (electrical conductivity) indicated non-compliance at various sites.
- □ Eutrophication status for all the dams within the WMA is good
- □ It is recommended that the land use activities impacting on water resources quality be efficiently controlled through Source Directed Controls (SDC) as per the provision(s) of the National Water Act No

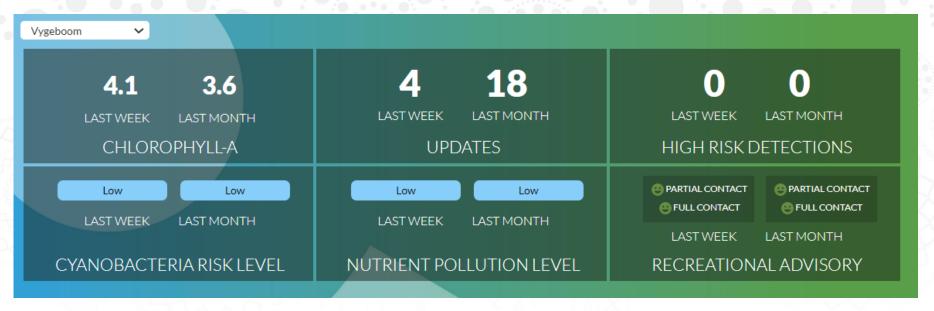
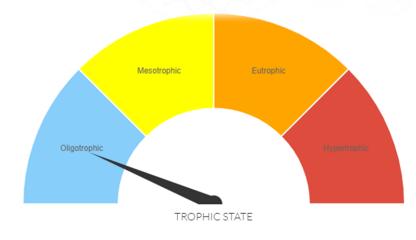
## CYANOLAKES DIGITAL EUTROPHICATION MONITORING: VYGEBOOM DAM

Vygeboom Dams' trophic status on the 21<sup>st</sup> of July 2022 stands at **Oligotrophic**, meaning it is low in nutrients and not productive in terms of aquatic and animal plant life.

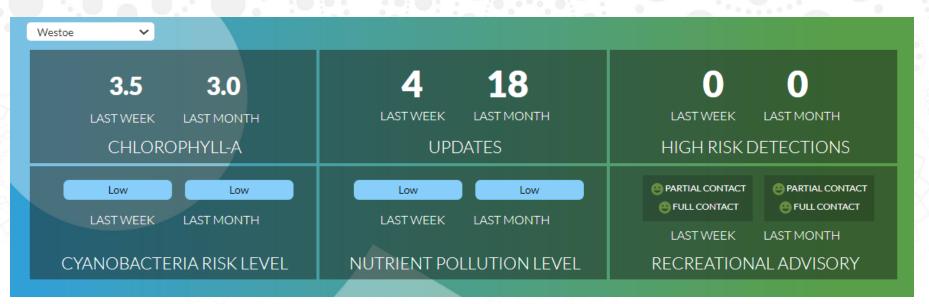
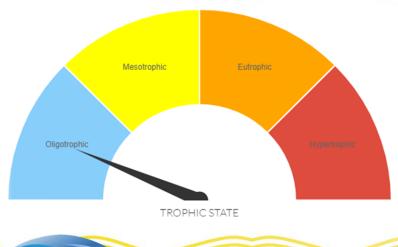
### CYANOLAKES DIGITAL EUTROPHICATION MONITORING: WESTOE DAM

Westoe Dams' trophic status on the 21<sup>st</sup> of July 2022 stands at **Oligotrophic**, meaning it is low in nutrients and not productive in terms of aquatic and animal plant life.

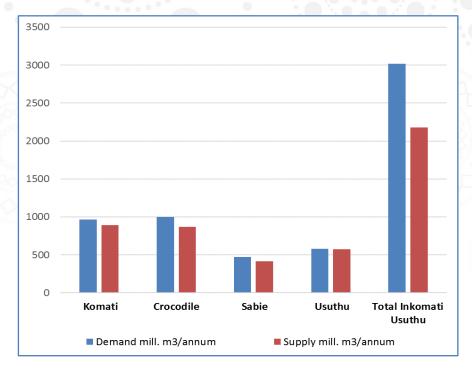
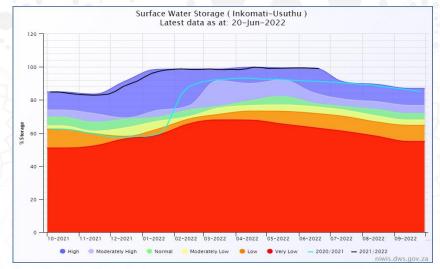
# SURFACE WATER RESOURCES STATUS

The WMA water resource status is high (rivers and dams levels) compared to the three previous hydrological years and no water use restrictions were implemented to all sectors in the previous financial year as most dams reached 100.0 % full

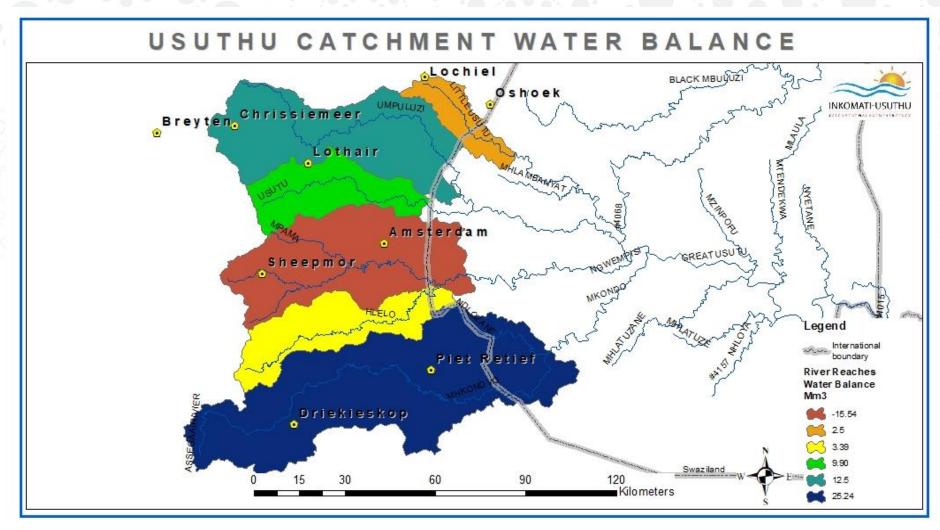
# SURFACE WATER RESOURCES STATUS

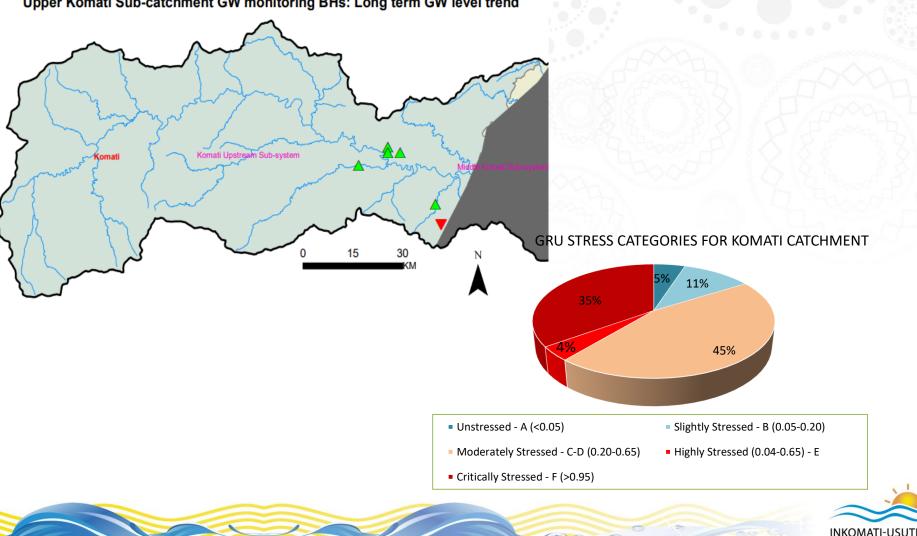
Upper Komati Sub-catchment GW monitoring BHs: Long term GW level trend

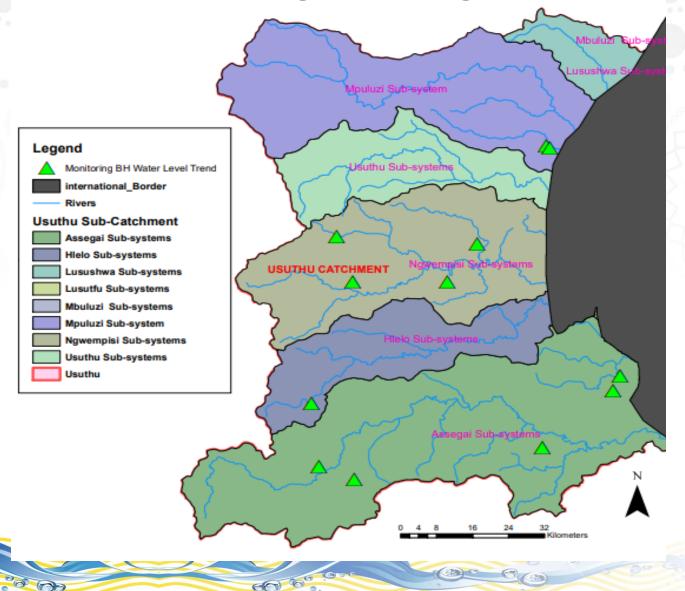
#### Usuthu GW Monitoring Boreholes: Long term GW level trend
