# **Water Quality and Quantity Status**

**Within Inkomati Usuthu WMA  
(Crocodile and Lower Komati Catchment)**

**Tariff Consultation**

**July 2022**

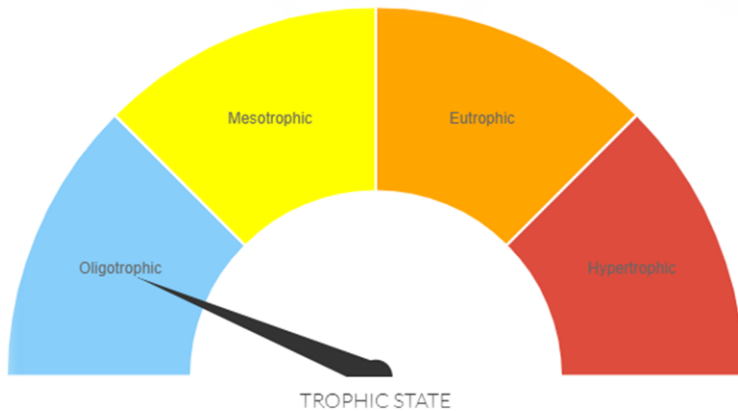
# CYANOLAKES DIGITAL EUTROPHICATION MONITORING: KWENA DAM

Kwena Dams' trophic status on the 21<sup>st</sup> of July 2022 stands at **Oligotrophic**, meaning it is low in nutrients and not productive in terms of aquatic and animal plant life.

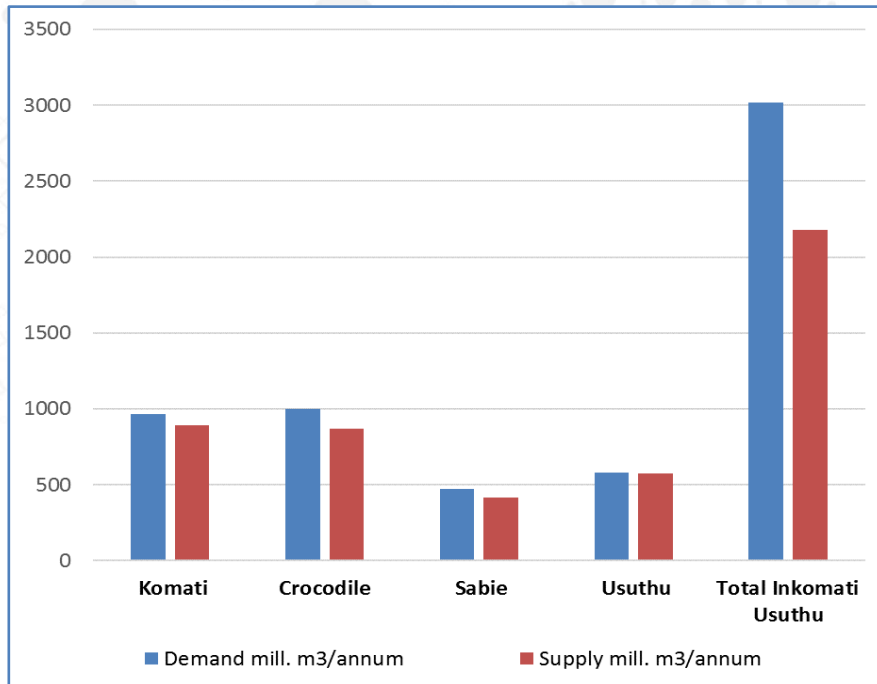
# SURFACE WATER RESOURCES STATUS

- The WMA water resource status is high (rivers and dams levels) compared to the three previous hydrological years and no water use restrictions were implemented to all sectors in the previous financial year as most dams reached 100.0 % full

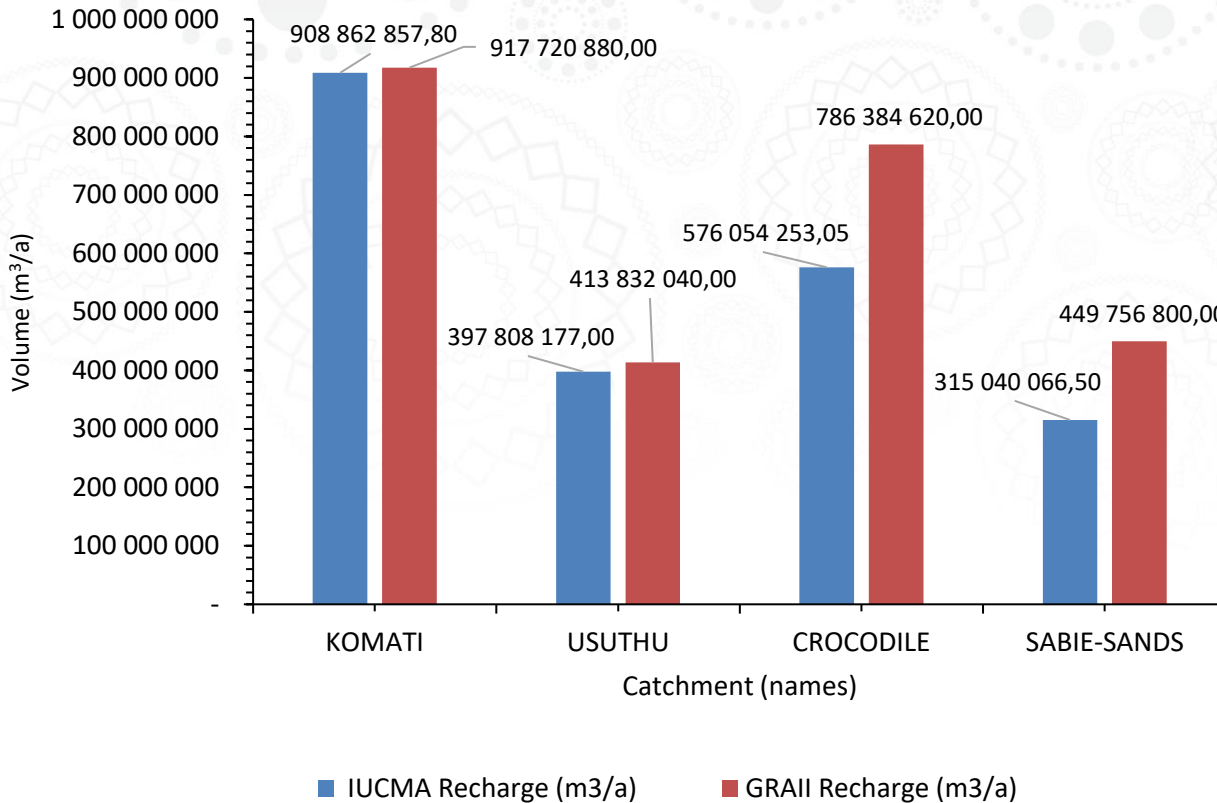
Groundwater Recharge Inkomati-Usuthu WMA

Since 2006 estimates (GRA II), groundwater recharge has dropped by approximately:

- ❑ **9 Mm<sup>3</sup>/a** for Komati,
- ❑ **16 Mm<sup>3</sup>/a** for Usuthu,
- ❑ **210 Mm<sup>3</sup>/a** for Crocodile,
- ❑ **135 Mm<sup>3</sup>/a** Sabie-Sand.
