INKOMATI-USUTHU
CATCHMENT MANAGEMENT AGENCY

Annual Resource Quality Status Report

Inkomati-Usuthu Water Management Area
2022/23 Financial Year

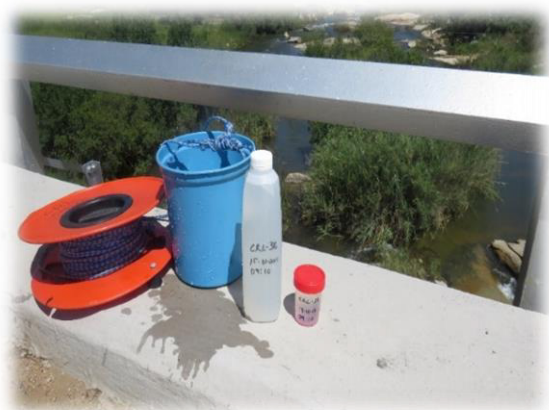
Figure 3: Water quality samples taken at Komati River using the bailer and the bucket.

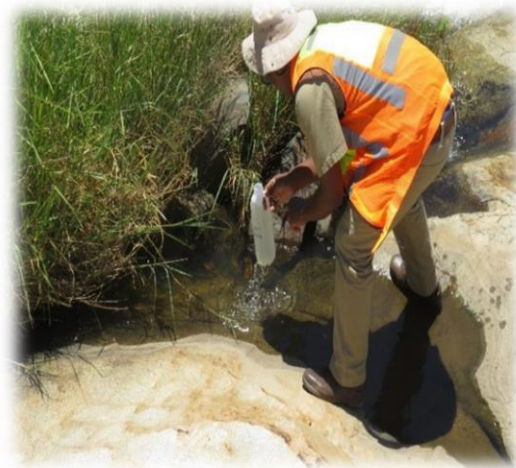
Figure 4: IUCMA official taking water quality chemical sample at tributary of Seekoiespruit.

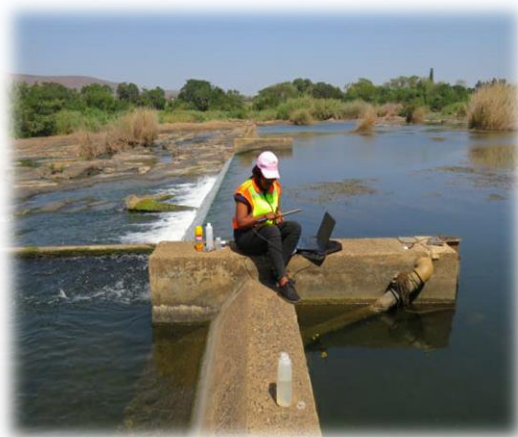
Five water quality probes are installed within the WMA for continuous water quality monitoring. The parameters measured in continuous monitoring stations are actual conductivity ($\mu\text{S}/\text{cm}$), temperature ($^{\circ}\text{C}$) and salinity (PSU) after every 3 hours. Actual conductivity data is transmitted to Zednet via network and other variables are downloaded through Win-Situ software.

Figure 5: IUCMA official downloading data from probe through Win-Situ software.

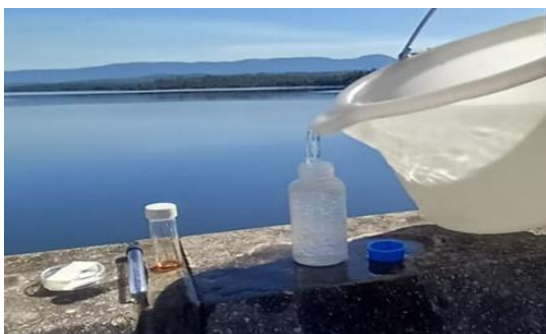
Macro samples were taken by decanting water from the integrated sample or subsurface grab sample into the blue-top bottle washed with phosphate free soap and the samples were stored in cooler box with ice cubes.

Figure 6: Filling of Macro sample.

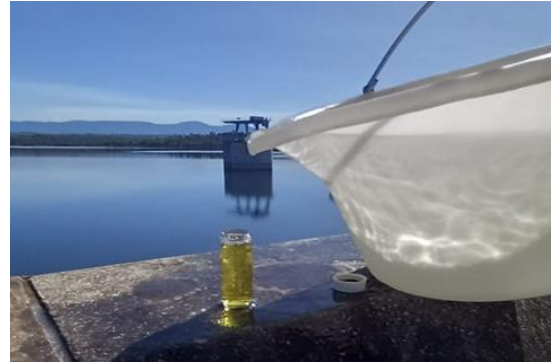
Samples for **identification of algae** were taken by decanting water from the integrated sample or subsurface grab sample into a small glass bottle with 2-4 drops of Iugol preservative.

Figure 7: Filling of Algae identification sample.

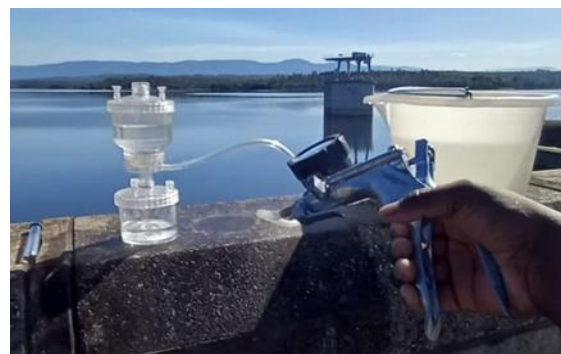
The **chlorophyll-a** samples were conducted using a filter unit, by unscrewing the top of the rinsed filter and carefully placing the filter paper inside the unit and screwing the top back. 250ml of the water from the integrated sample or subsurface grab sample was poured into the unit and water was drawn through the filter using a vacuum pump up to 500ml if possible. The total amount of water filtered was recorded. The filter was then opened gently, then the filter paper was carefully lifted and stored into a glass tube with ethanol.

Total suspended solids samples were taken using the same method as conducted for the Chlorophyll-a samples, but a weighed filter paper marked with a black dot was used and then stored in a petri dish.

Figure 8: Filtration of Suspended solids or chlorophyll-a sample(s).

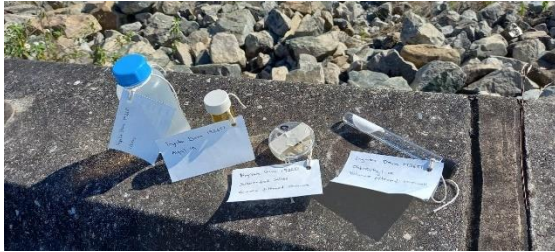
All samples were clearly marked on a tag with the sample description, date, time, dam ID code, name of the resource and volume filtered. The samples were stored in a dark container. The samples and onsite monitoring report sheets were then submitted to the Department of Water and Sanitation laboratory at Resource Quality Information Services (RQIS) for analysis.

Figure 9: Clearly marked samples for Eutrophication taken at Injaka Dam.

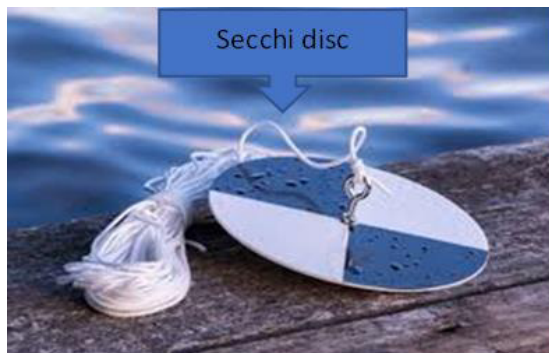
- Estimated visual area on the total surface area covered by algal blooms or invasive water plants.
- Other observation potentially related to eutrophication i.e., Odour problems, fish kill, wind speed and direction.
- The secchi disc is used to determine the clarity by lowering the disc into the water until it is out of sight and record the depth reading on the marked rope.

Figure 10: Secchi disc used to measure clarity.

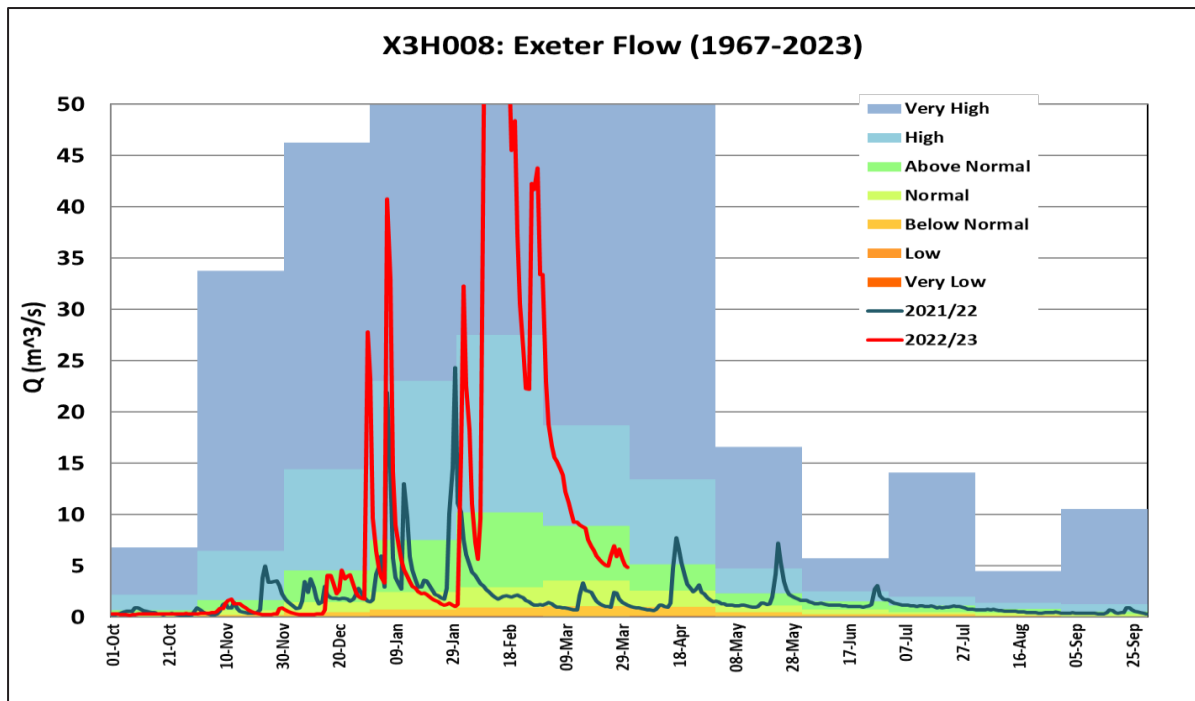
Figure 16: Sand River at Exeter- riverflow level historical analysis.

The observed mean discharge from the Sand River at Exeter was very high for most of the reporting period. There was no specific trend followed when compared with the previous hydrological year (Figure 16), while the station’s Jan – March 2023 flow statistics are shown in Table 2.

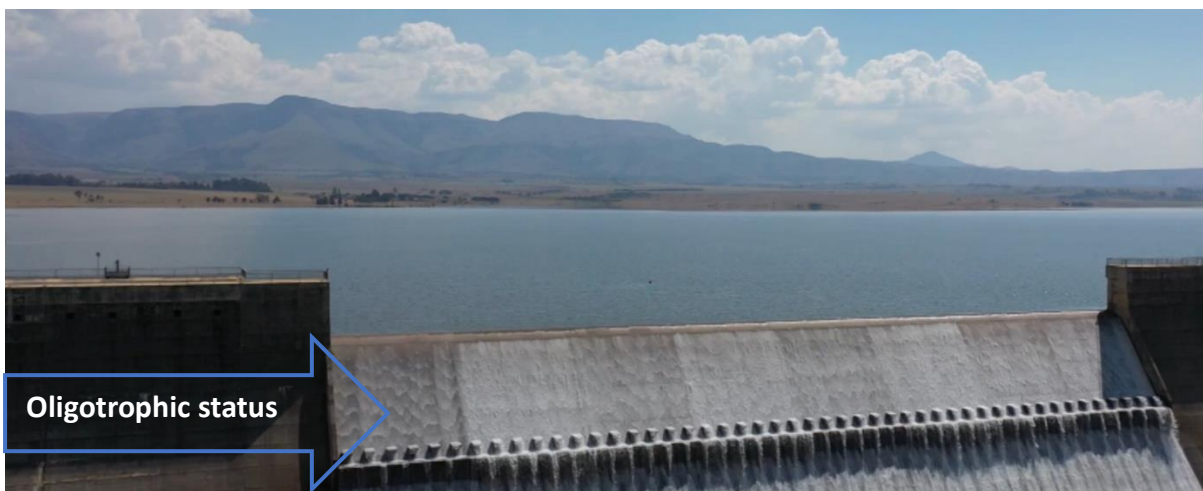
Below is the photo of Kwena Dam as an example in Crocodile Catchment indicating trophic status and nutrients level of the dam which implies low or no productivity in terms of plants (Water hyacinth) and algal growth.

Figure 60: A photo of Kwena Dam with low to no algal growth and macrophyte (Water hyacinth).
