INKOMATI-USUTHU

CATCHMENT MANAGEMENT AGENCY

WATER QUALITY AND QUANTITY STATUS

USUTHU CATCHMENT

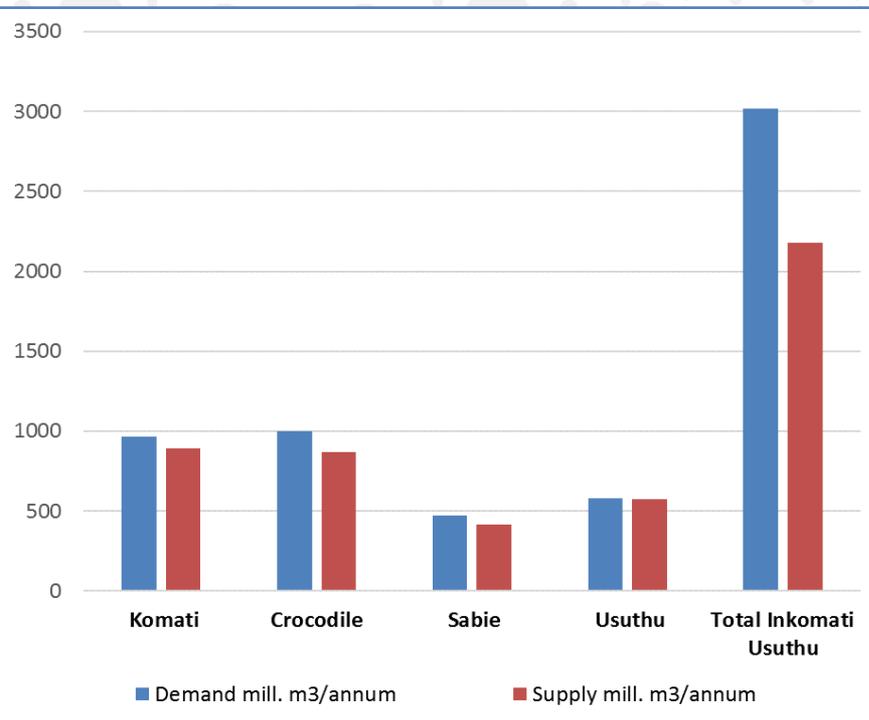
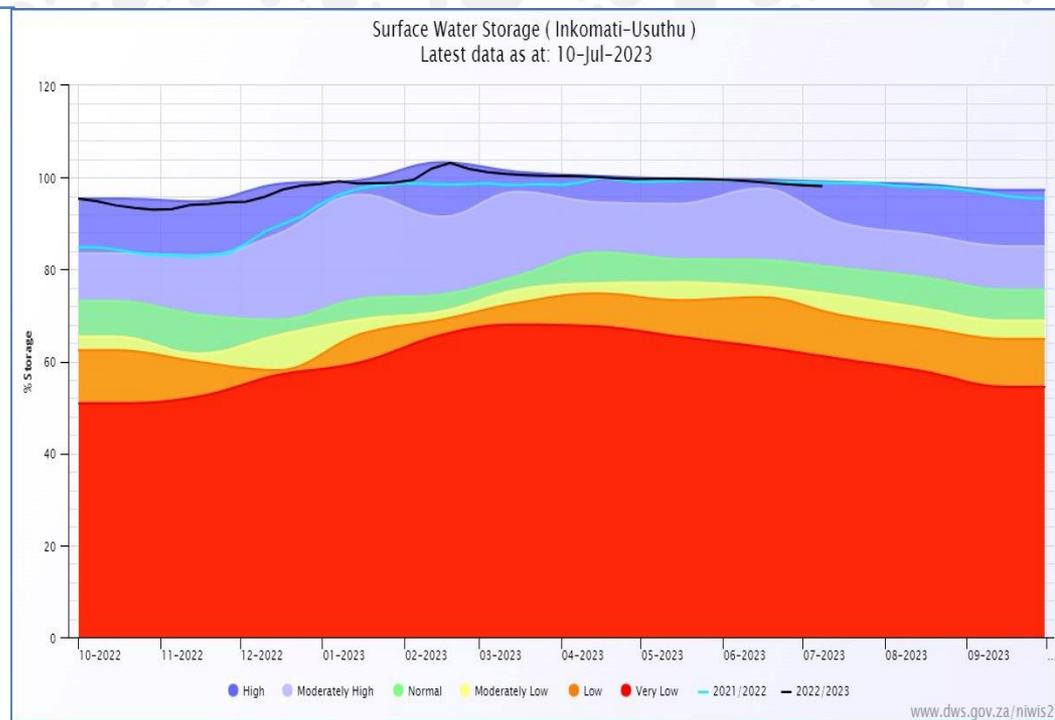
SURFACE WATER RESOURCES STATUS

All dams are above normal, an indication of excess water in the system for annual allocations to different sectors through to next rain season. Effects will be more felt by users relying directly on river flows as the river levels will be dropping until next rainy season.

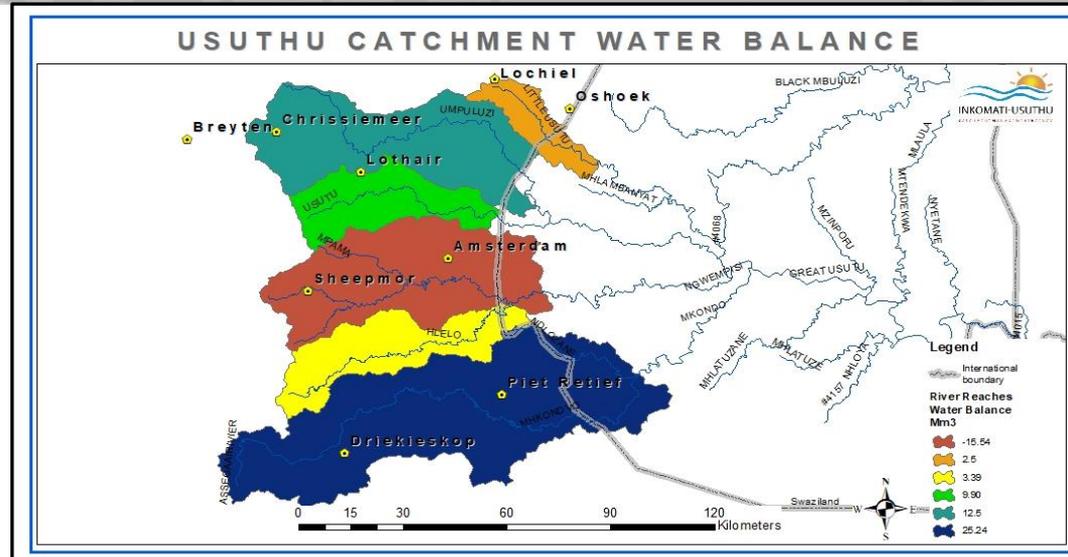
USUTHU SURFACE WATER BALANCE

The Usuthu system has excess water except the Ngwempisi sub-system (Sheepmore and Amsterdam towns), where water balance is negative. The Amsterdam is currently being built to mitigate the issue of assurance of supply to Amsterdam town.

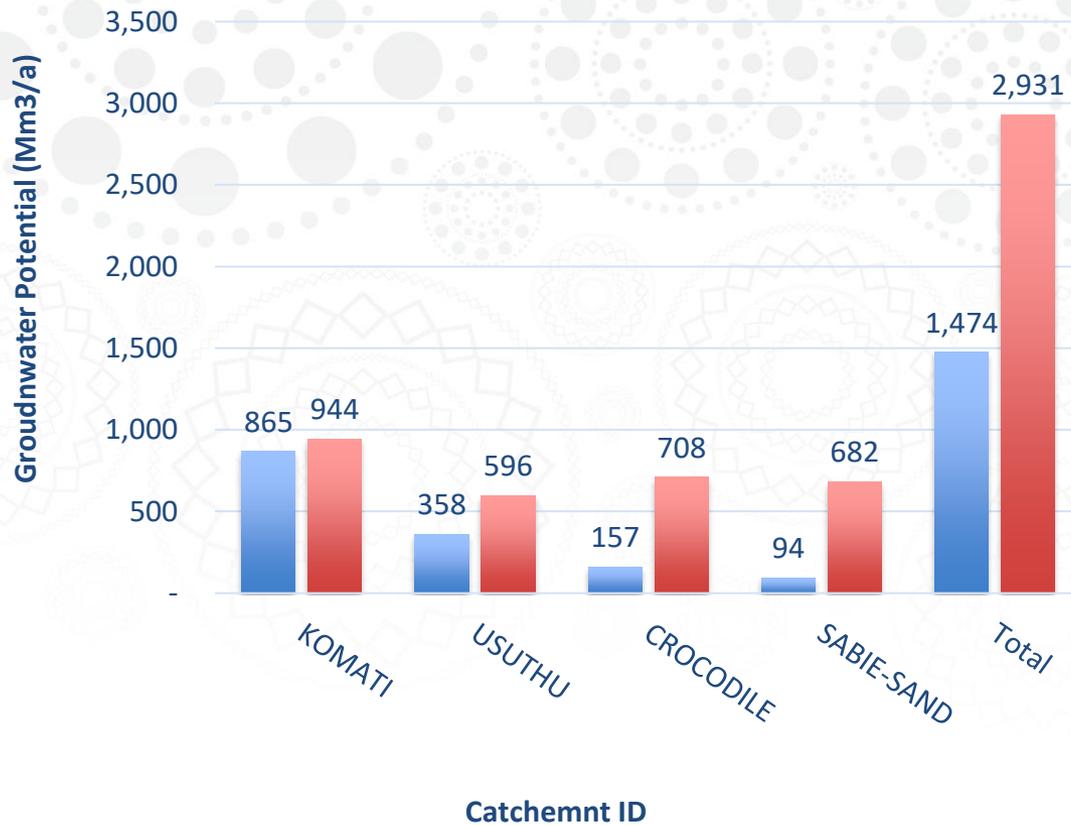
GROUNDWATER RESOURCES STATUS

Since 2006 estimates (GRA II), groundwater potential has dropped by approximately:

40% for Usuthu

- 2022 IUCMA Resource Potential
- 2006 GRAII Resource Potential

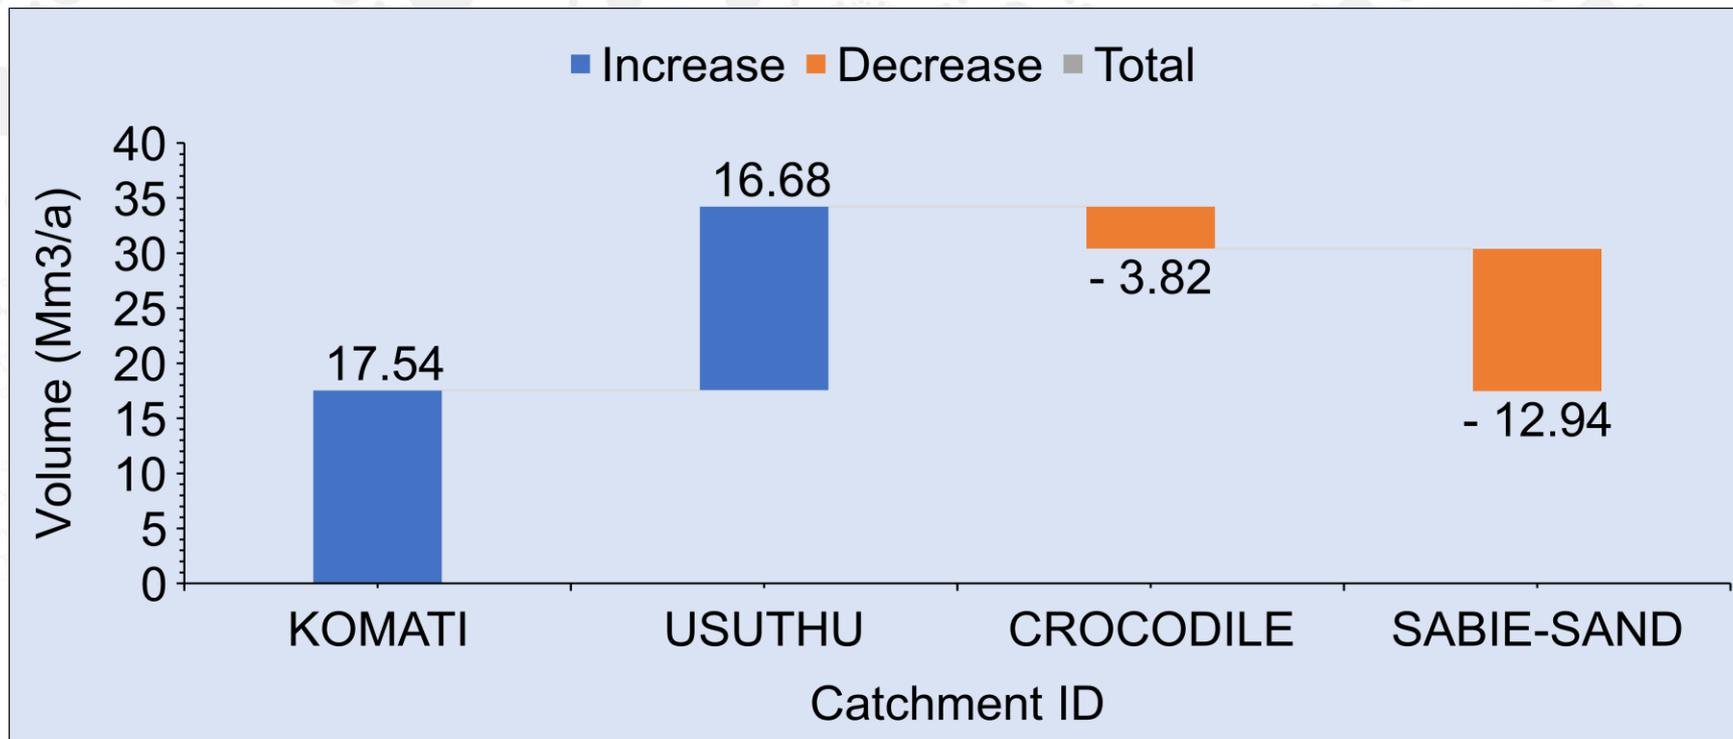
GROUNDWATER STORAGE CHANGE

- In general, change in groundwater storage for Usuthu is positive due to minimal stress on the groundwater availability.
- The recharge exceeds the groundwater use in Usuthu Catchment thus groundwater potential is positive.

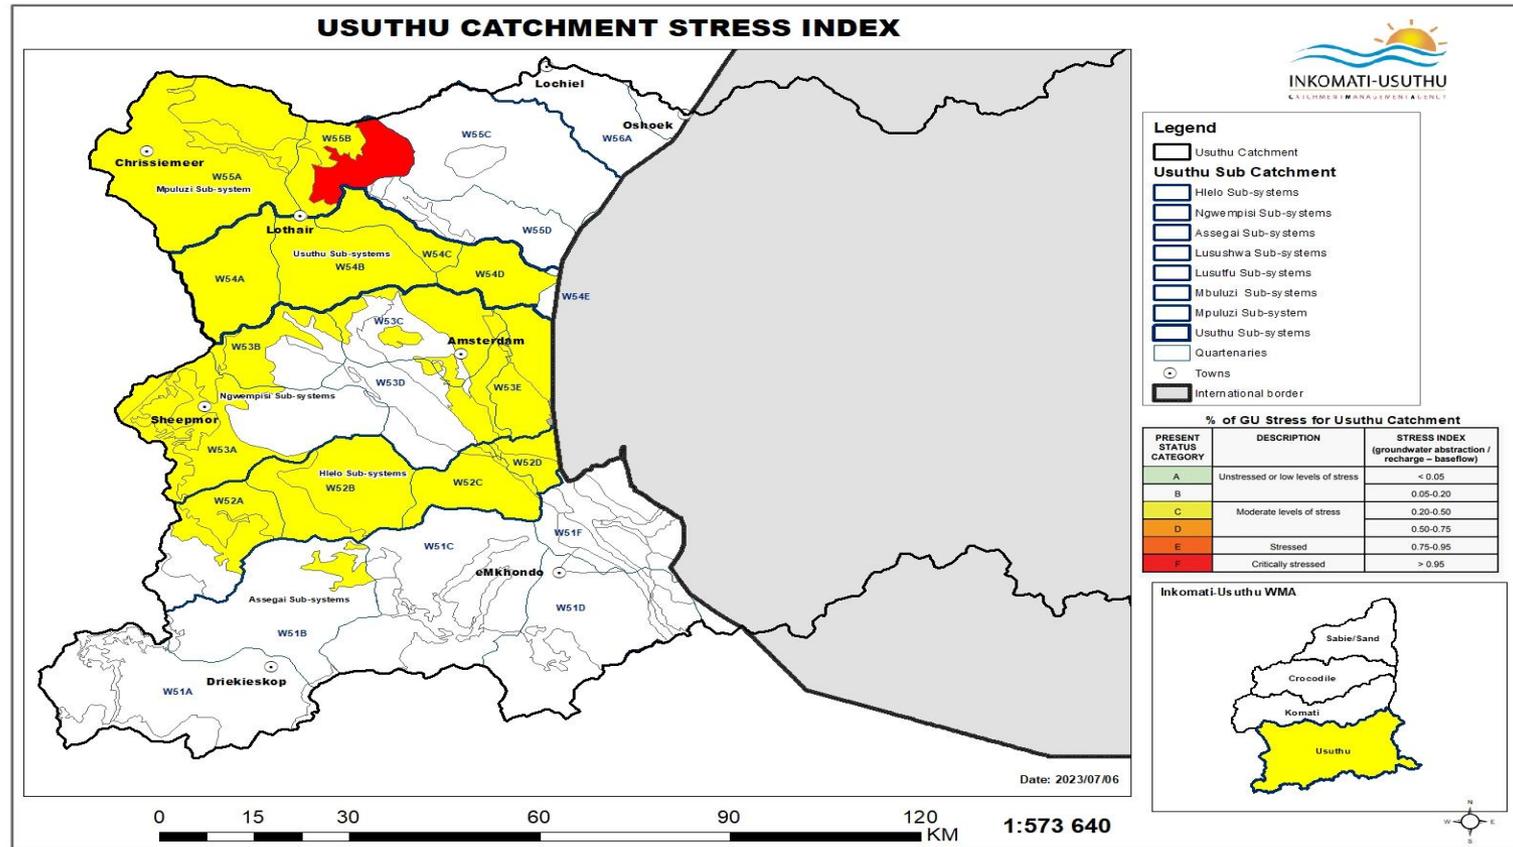
USUTHU GROUNDWATER STRESS INDEX CONDITION

In the Usuthu catchment the groundwater resources are still adequate, just as surface water resources and socio-economic developments must be promoted in these areas.

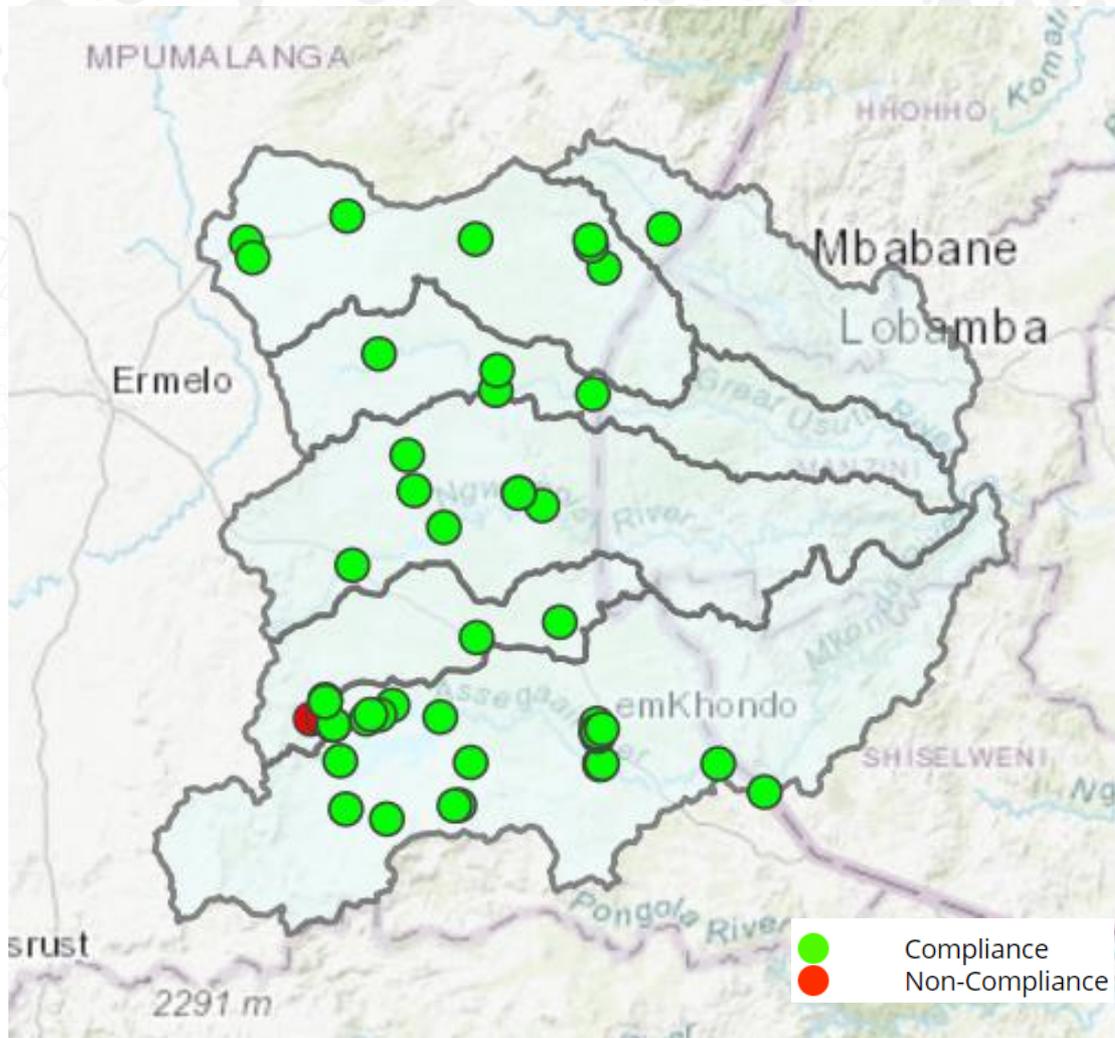
WATER QUALITY STATUS: PH

pH complied with the TWQR throughout the reporting time within the Usuthu Catchment, **except** for Ntanta and Wokolo Streams at Nooitgesein due to coal mining activities within the which where acid in in December 2022.

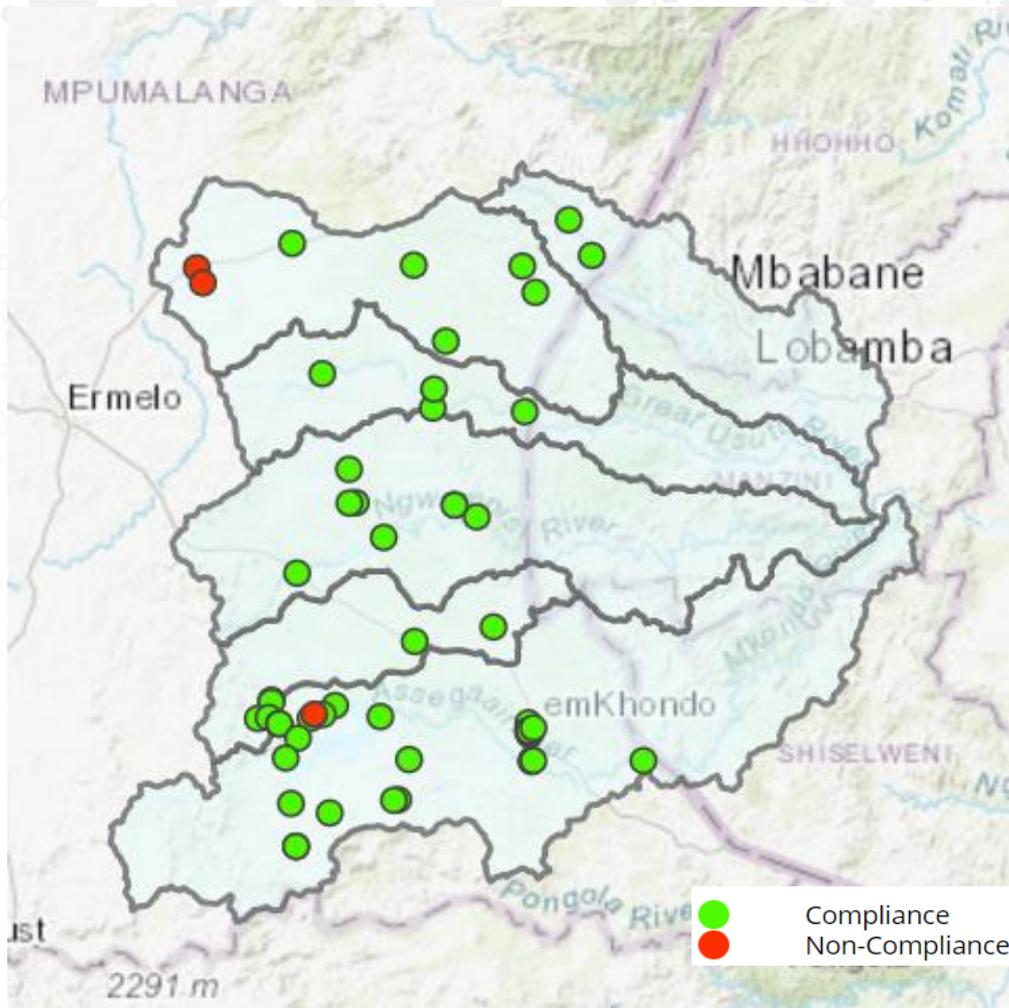
WATER QUALITY STATUS: ELECTRICAL CONDUCTIVITY

Electrical Conductivity (EC) **complied** with the TWQR within the Usuthu Catchment, **except** for Chrissiessmeer lake, Egude River (Driefontein area, known as Saul Mkhizeville), Klipmisselspruit downstream of the WWTWs and tributary of Klipmisselspruit downstream of industrial area (eMkhondo area).

- The identified issue of concern concerns Chrissiessmeer lake, Egude River (Driefontein area, known as Saul Mkhizeville) and Klipmisselspruit and its tributaries (eMkhondo area) where salts and nutrients, mostly downstream of WWTWs pose a challenge (EC & PO₄).
- Eutrophication status for all the dams within the WMA is good.
- Municipalities, mines to implement long term solution to resolve noncompliant poorly operated and maintained WWTW's and its associated infrastructure i.e., sewer pump stations, manhole.
- It is recommended that the land use activities impacting on water resources quality be efficiently controlled by all relevant stakeholders / users through Source Directed Controls (SDC) as per the provision.

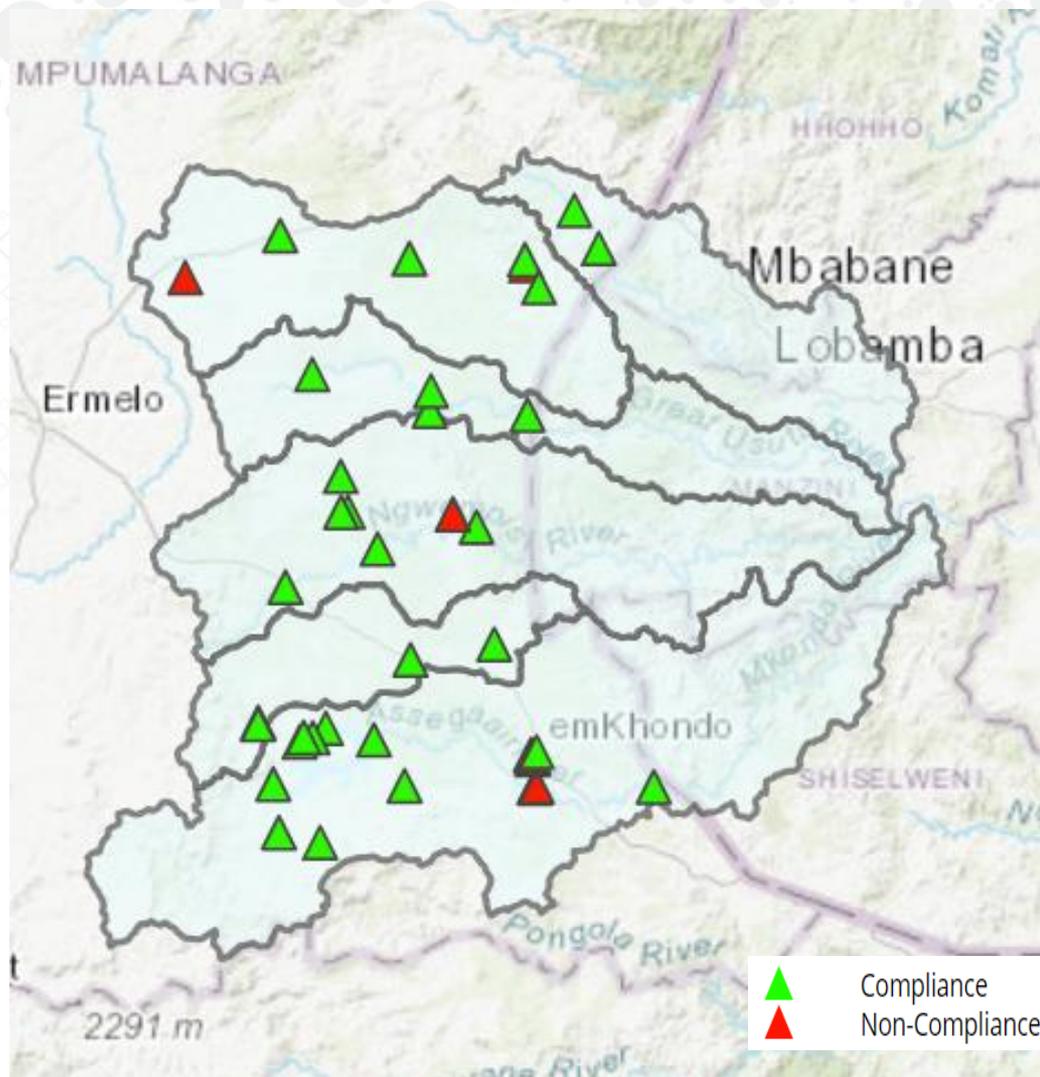
WATER QUALITY STATUS: PHOSPHATE

PO₄ **complied** with the TQWR throughout the reporting time within the Catchment, **except** for Chrissiessmeer lake (Chrissiesmeer), Thole River (Amsterdam), Klipmisselspruit and its tributaries (eMkhondo) due to poor operation and maintenance of WWTWs and its associated infrastructure as well as poor sanitation services.

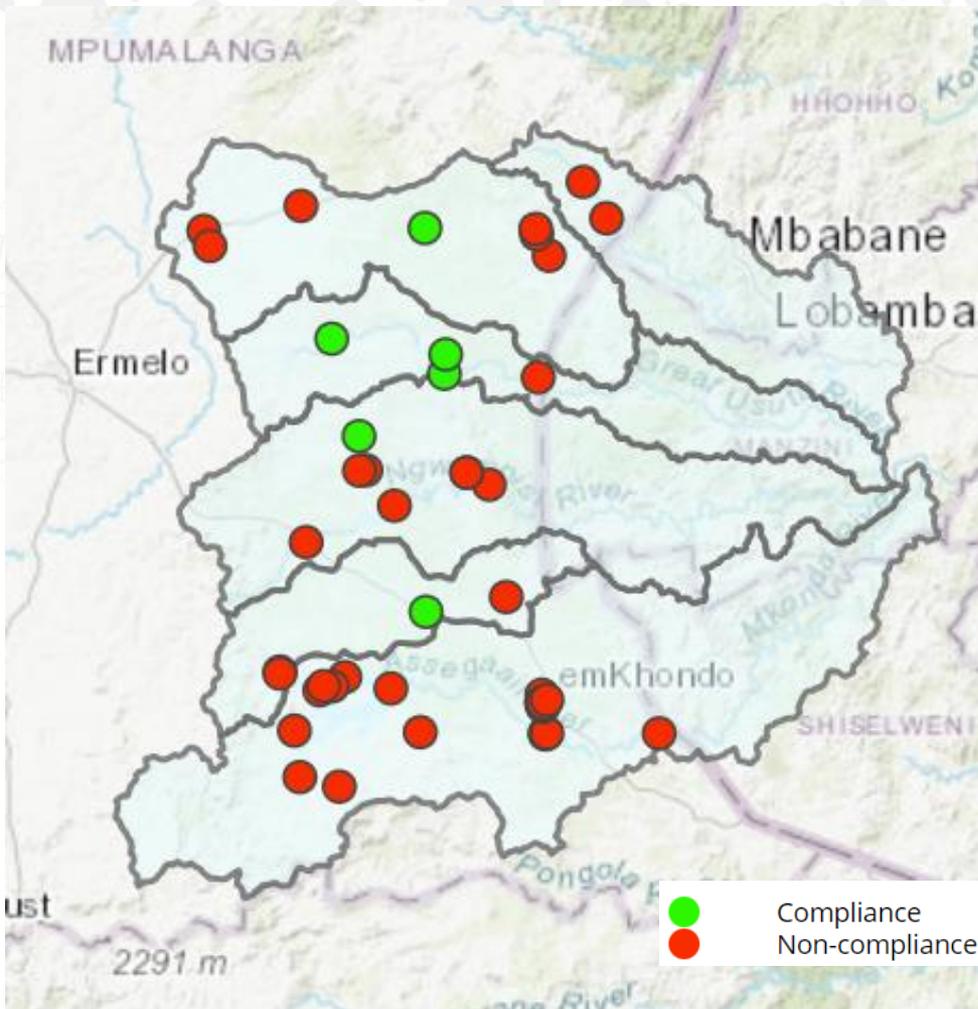
WATER QUALITY STATUS: E COLI

E. coli counts **did not comply** with the set TWQR for most of the monitoring sites. High concentrations within residential areas due to the WWTW which discharge partially treated effluent, overflowing sewer pump stations and illegal waste dumping. Compliance was observed at the Westoe Dam, one point in the Mpuluzi River system, two points in the Usuthu River system and one point in the Ngwempisi and Hlelo River systems.

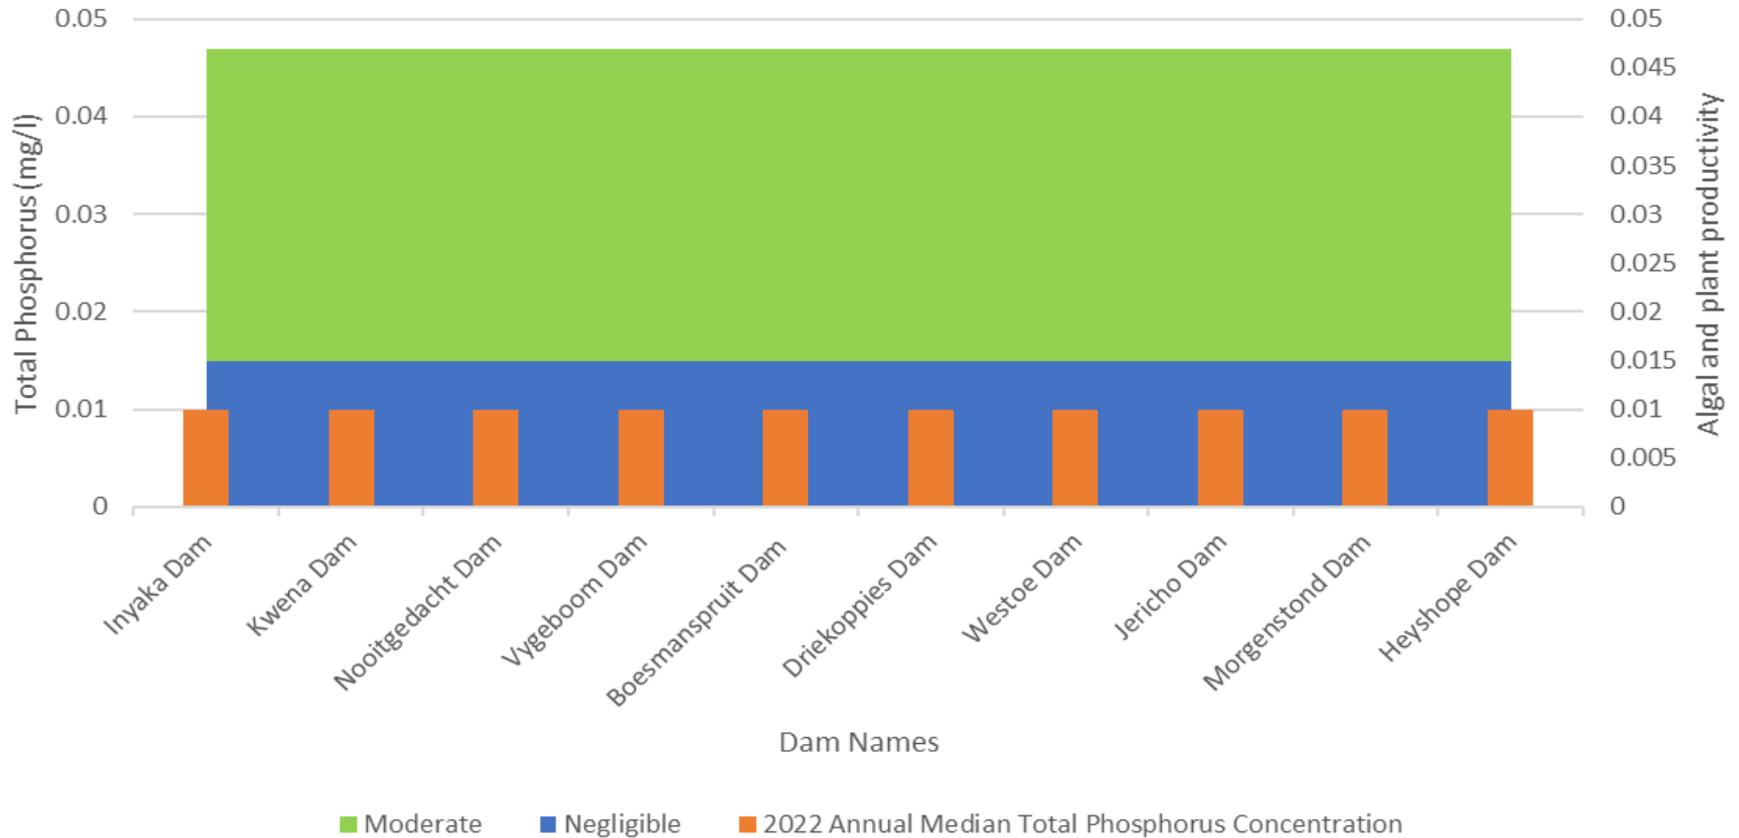
EUTROPHICATION STATUS: TOTAL PHOSPHORUS

Annual Median Total Phosphorus
