ANNUAL WATER QUALITY STATUS REPORT FOR THE INKOMATI-USUTHU WMA 2017/18 FINANCIAL YEAR

ANNUAL WATER QUALITY STATUS REPORT FOR THE INKOMATI-USUTHU WATER MANAGEMENT AREA

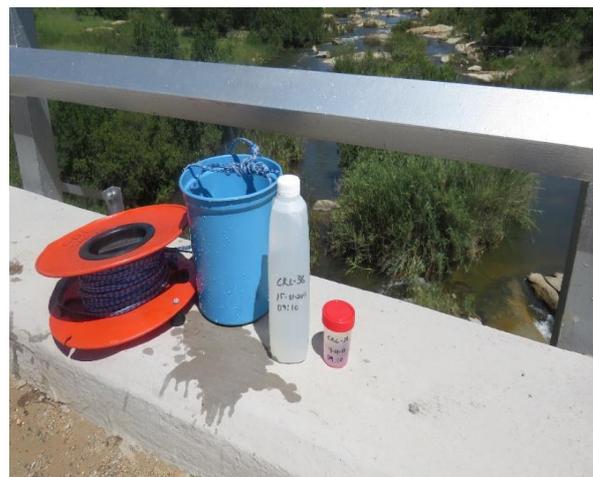
Figure 3: Chemical and Microbiological samples taken at Komati River downstream of Vygeboom Dam@R38 bridge using the bailer and the bucket (photo taken by Andile Nkosi)

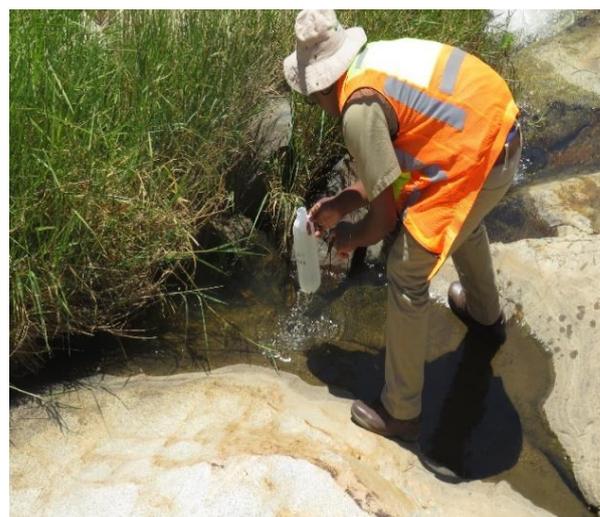
Figure 4: IUCMA official taking water quality chemical sample at tributary of Seekoiespruit in Komati Catchment (photo taken by Andile Nkosi)

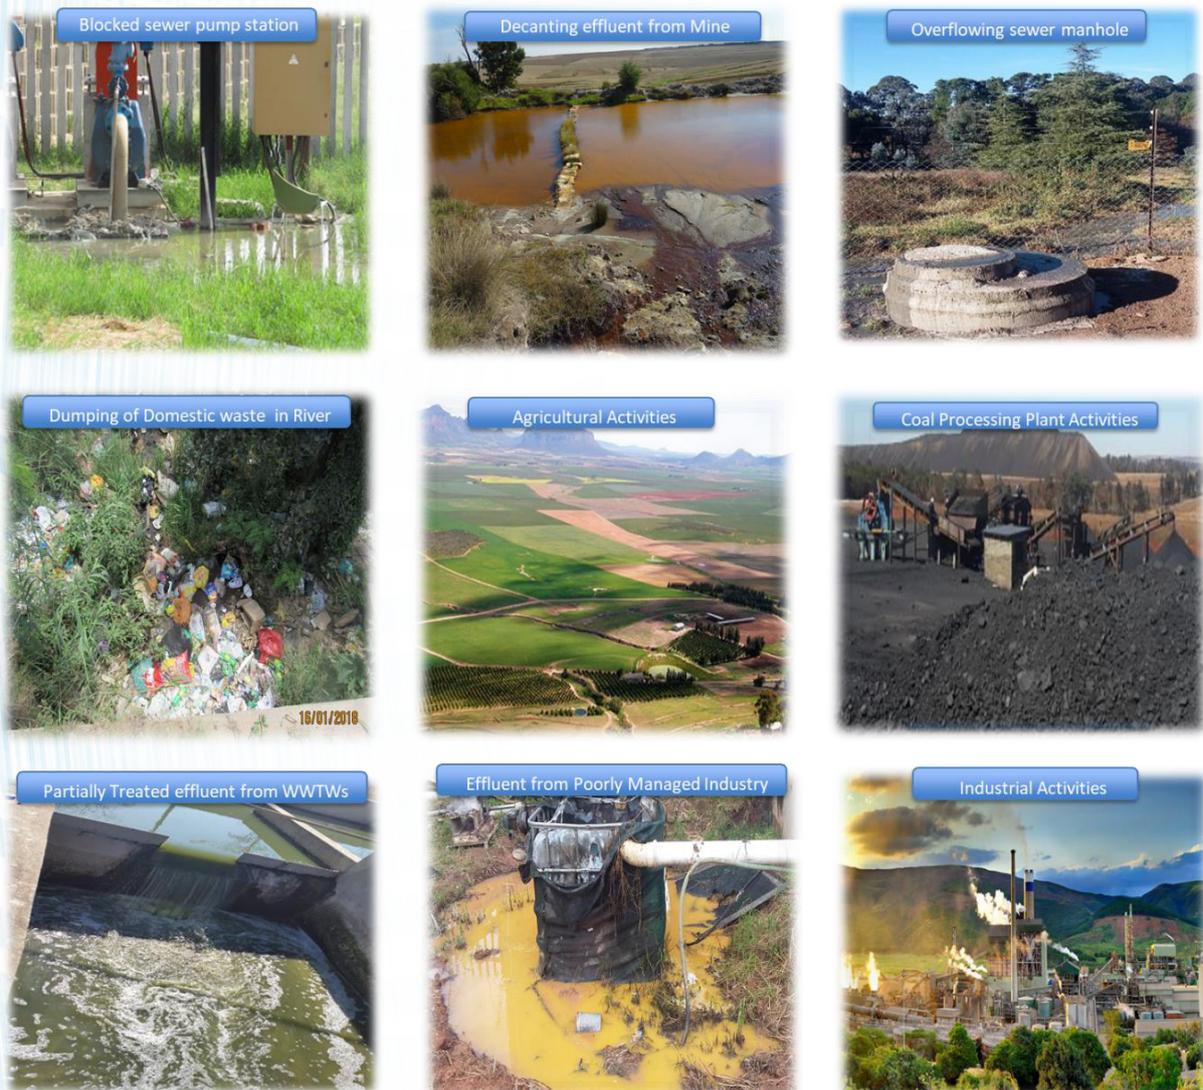
Figure 13: Some of the Impacts affecting Water quality within Water Management Area

The presence of *E. coli* bacteria in water resource is a huge challenge throughout the entire water management area. It is therefore recommended that the activities contributing *E. coli* be prioritised for Compliance, Monitoring and Enforcement.
