**DETAILED MONITORING  
OF RIVER CONDITIONS  
IN THE UPPER SABIE  
RIVER CATCHMENT  
2014**

# DETAILED MONITORING OF RIVER CONDITIONS IN THE UPPER SABIE RIVER CATCHMENT

**April 2014**

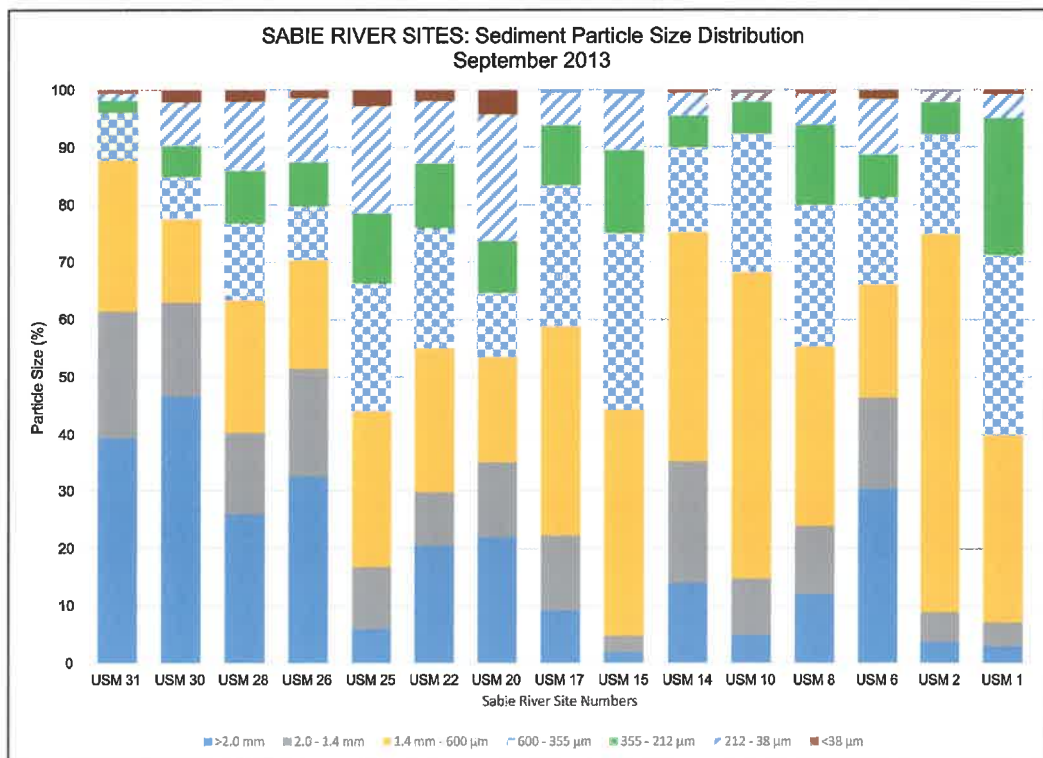
**Figure 5-1:** Particle size distribution of sediment samples at sites sampled in the Sabie River from Sabie Headwaters (USM 31) to Aand-de-Vliet (USM 1).

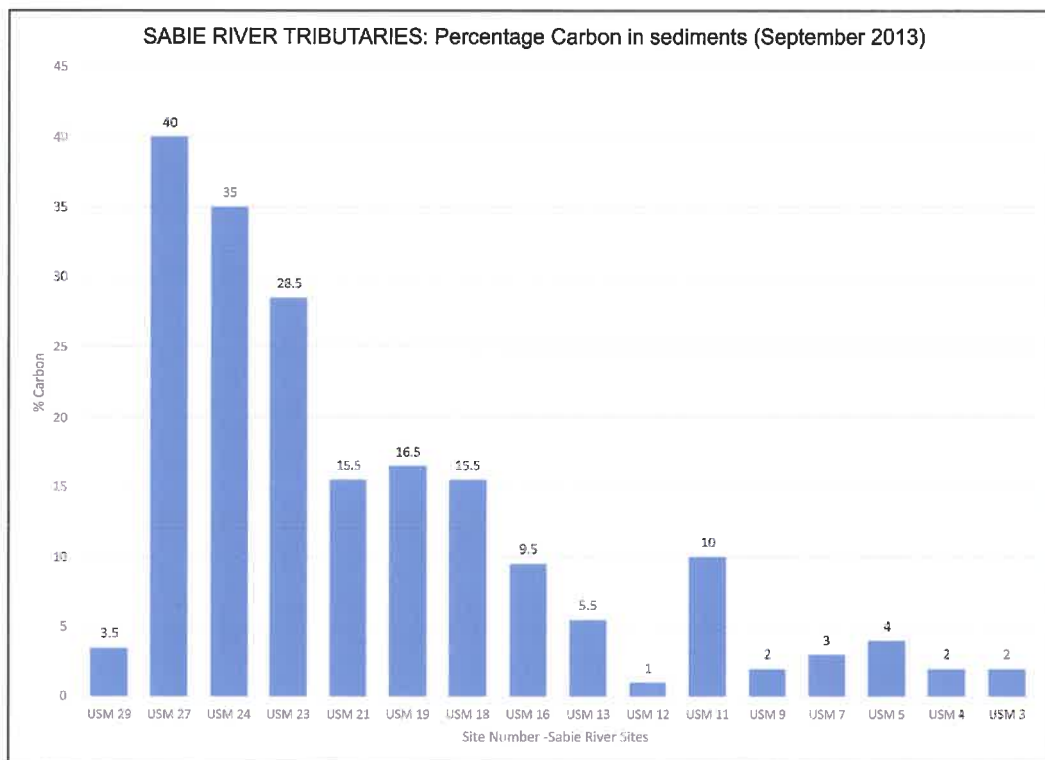
**Figure 5-4:** The percentage carbon along the tributaries of the Sabie River illustrated per sampling point from Sabie Headwaters (USM 31) to Mac-Mac (USM 3).

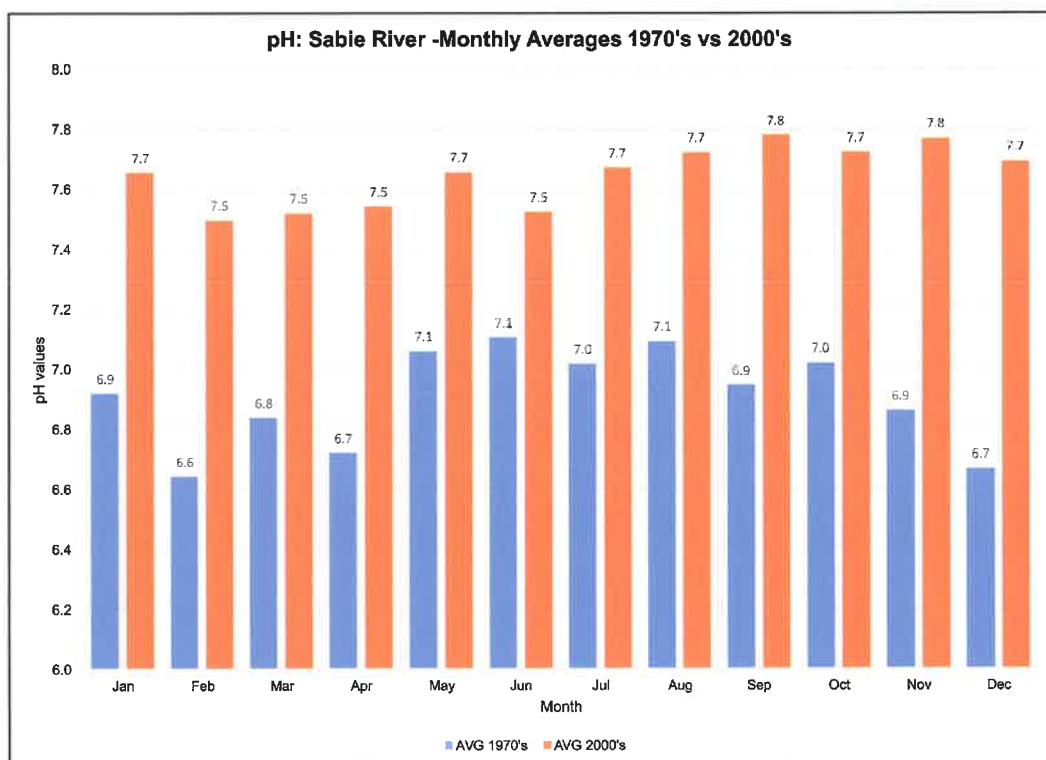
**Figure 5-6:** A comparison of the average monthly pH levels measured at the Sabie Falls gauging station during the 1970's compared to the 2000's. The 70's data includes monthly averages from October 1976 to December 1979, and the 2000's records from January 2000 to December 2009.

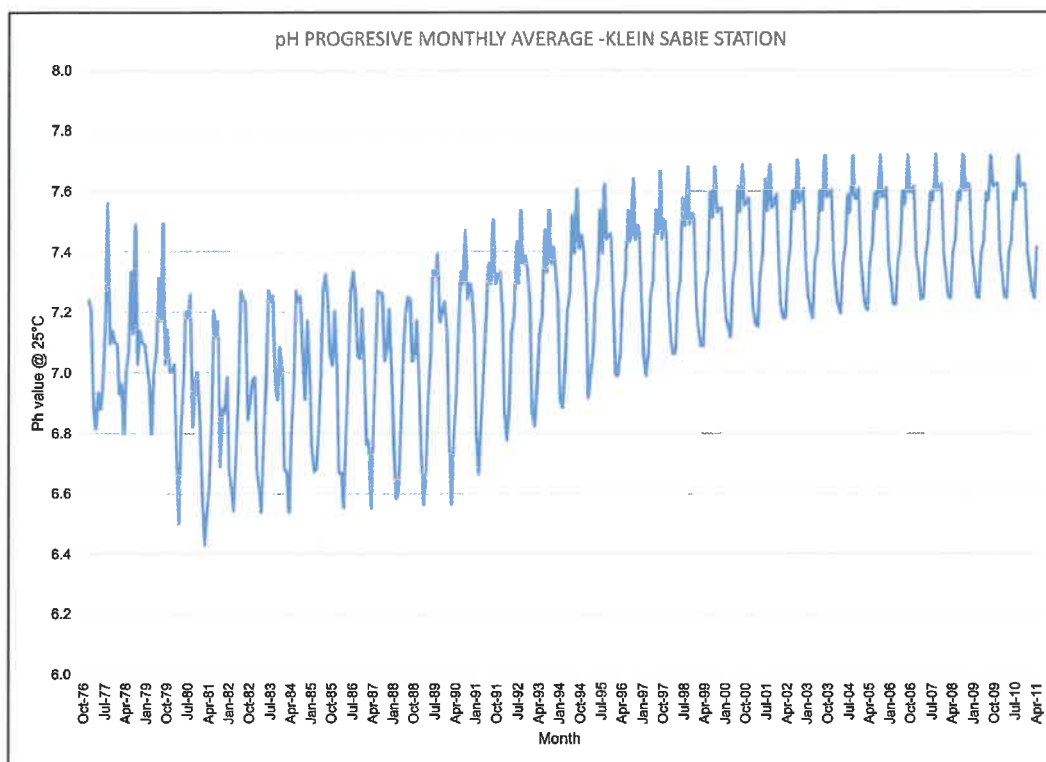
The pH values measured at the Klein Sabie gauging station, illustrated in Figure 5-7, demonstrate trends similar the results from the Sabie Falls station (Figure 5-5). At the Klein Sabie site, measured pH values increase during low flow conditions and decrease during high flow conditions (Figure 5-7). Highest seasonal pH values were measured over August shifting towards July and more recently in August. The lowest pH values were recorded in March and February. Relatively low pH values were measured in the Klein Sabie River during the high flow season from March 1980 to February 1990, after which there is a steady increase in pH (Figure 5-7).

**Figure 5-7:** The progressive monthly average pH values measured at the Klein Sabie River Gauging station at Sabie Falls, from October 1976 to April 2011.

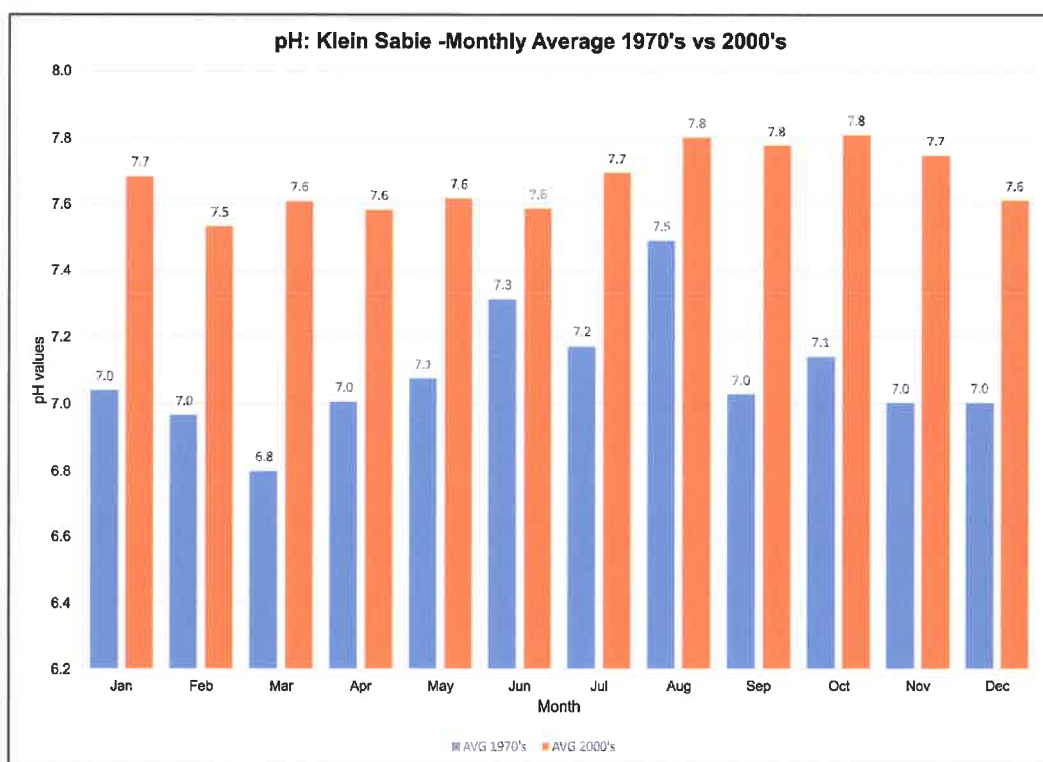
**Figure 5-8:** A comparison of the average monthly pH levels measured at the Klein Sabie gauging station during the 1970's compared to the 2000's. The 70's data includes monthly averages from October 1976 to December 1979, and the 2000's records from January 2000 to December 2009.

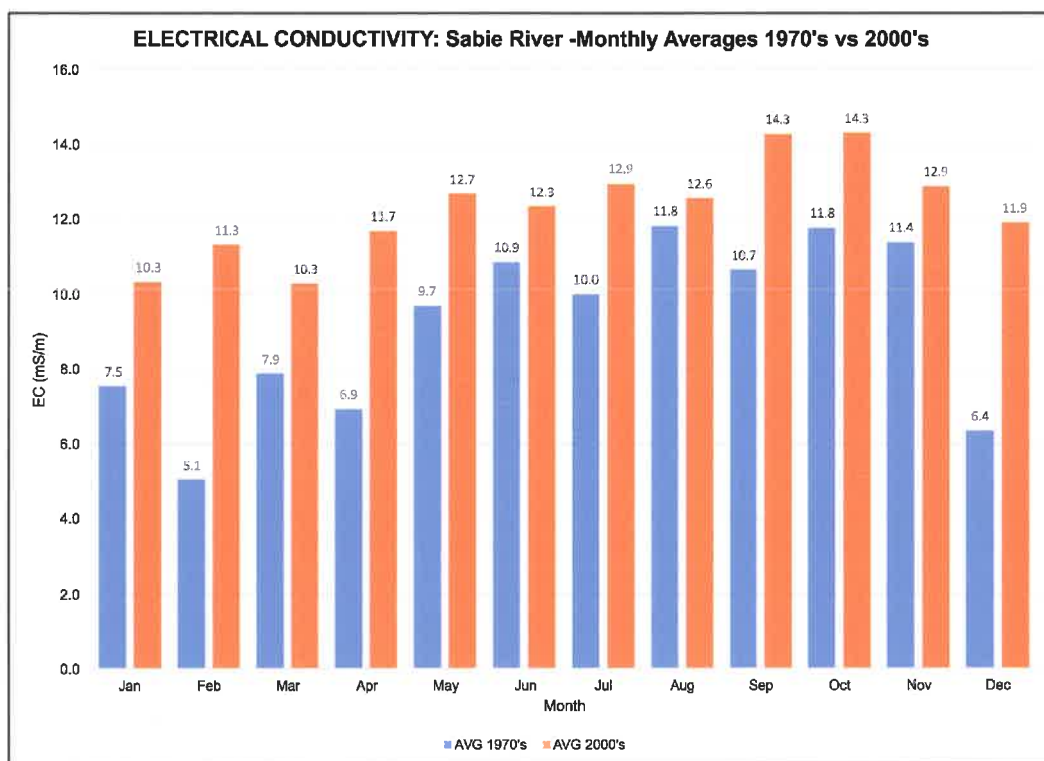
**Figure 5-12:** A comparison of the average monthly electrical conductivity levels measured at the Sabie Falls gauging station during the 1970's compared to the 2000's. The 70's data includes monthly averages from October 1976 to December 1979, and the 2000's records from January 2000 to December 2009.

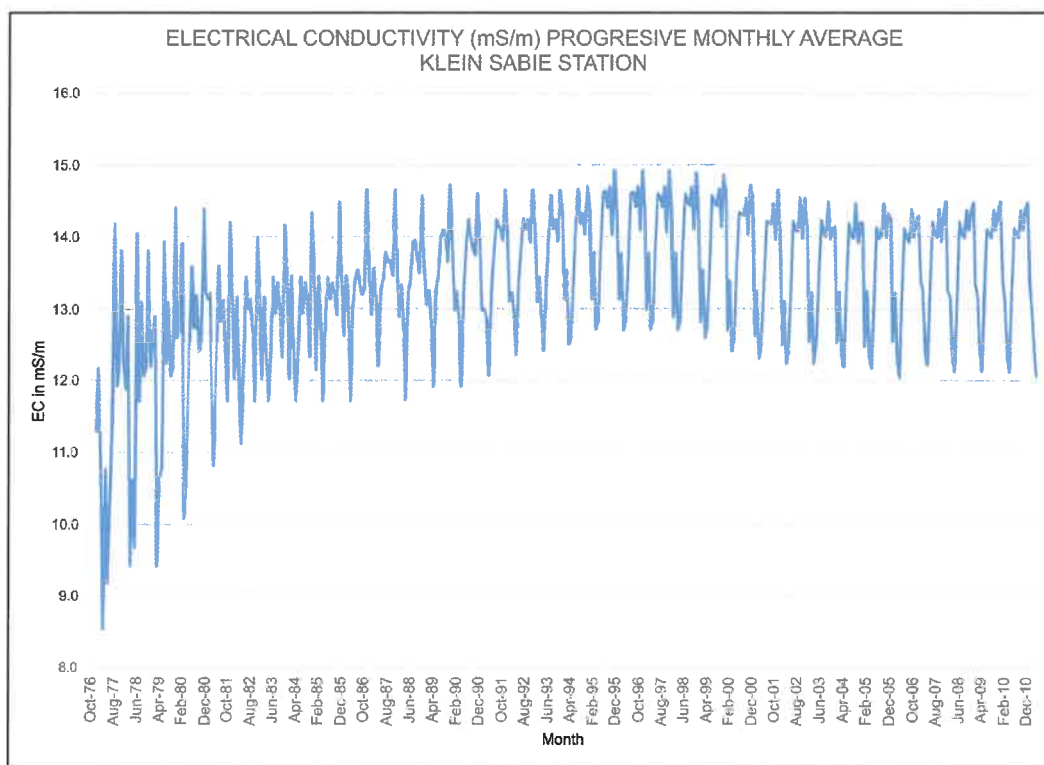
In the Klein Sabie River, electrical conductivity is initially low (1970's) but rapidly increased. Electrical conductivity increase in the Klein Sabie River during low flow conditions and decrease during high flow conditions (Figure 5-13). Highest seasonal EC values were measured over June, September and December. The lowest EC values fell between the months of March, April and October. The historical results indicate a steady increase in EC up to 1999, after which it stabilises.

**Figure 5-13:** The progressive monthly average electrical conductivity values measured at the Klein Sabie Gauging station at Sabie Falls, from October 1976 to April 2011.

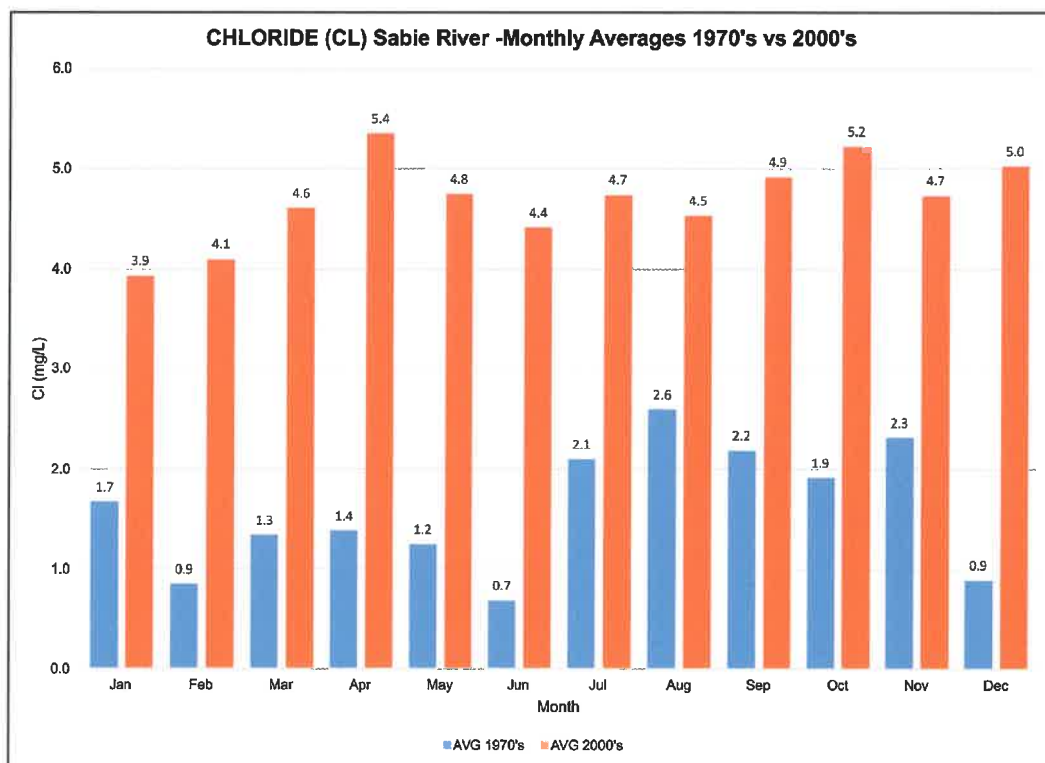
This increase is also illustrated in Figure 5-17.

**Figure 5-17:** A comparison of the average monthly chloride levels measured at the Sabie Falls gauging station during the 1970's compared to the 2000's. The 70's data includes monthly averages from October 1976 to December 1979, and the 2000's records from January 2000 to December 2009

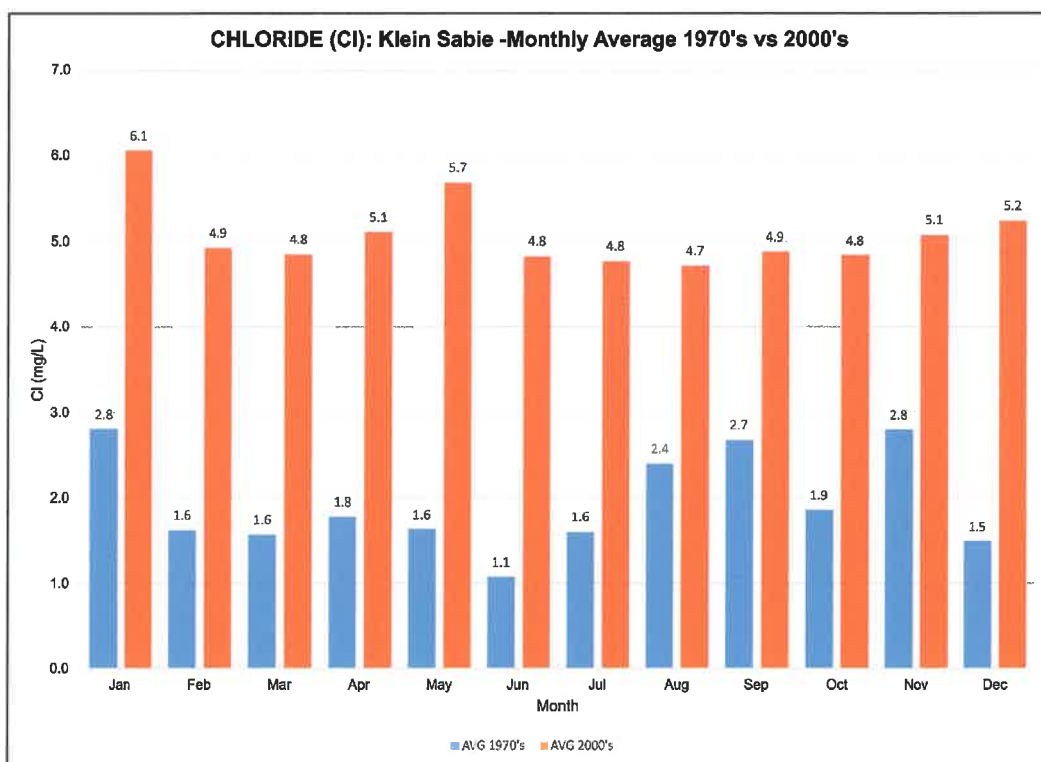
**Figure 5-19:** A comparison of the average monthly chloride levels measured at the Klein Sabie gauging station during the 1970's compared to the 2000's. The 70's data includes monthly averages from October 1976 to December 1979, and the 2000's records from January 2000 to December 2009.

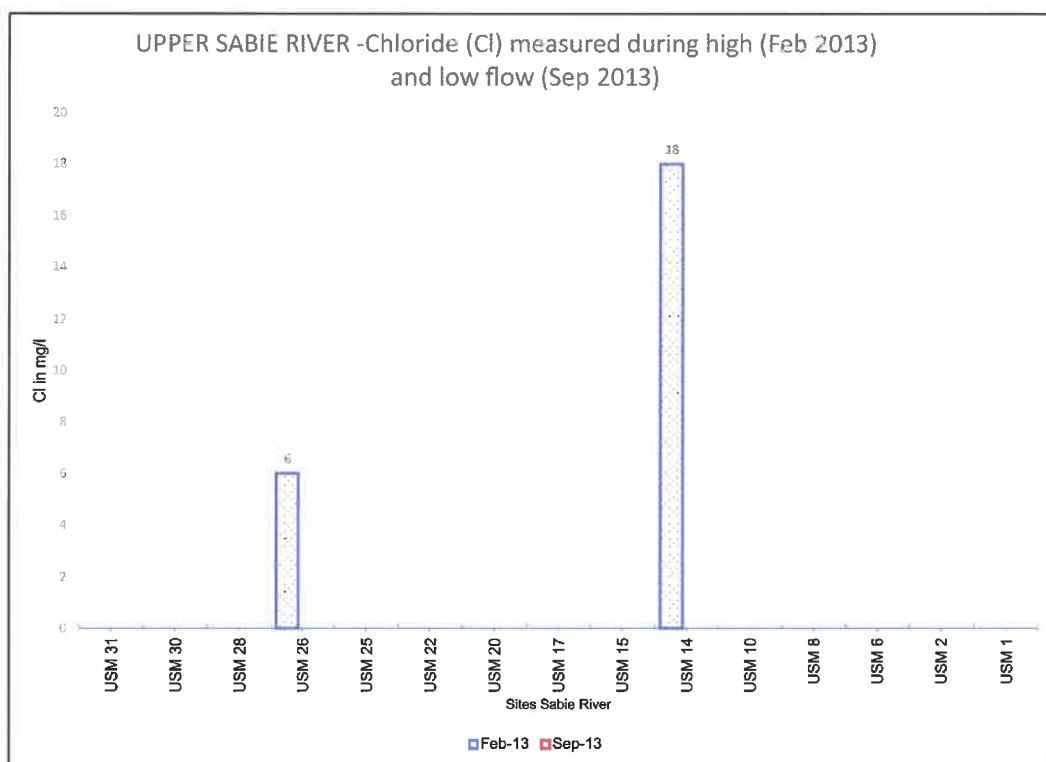
Only detectable chloride levels 5 mg/l are recorded by the laboratory. There were only two sites, namely the Below Horseshoe Falls (USM 26) and Rietfontein Mine (USM 14) sites where such levels were recorded during high flow conditions (February 2013) as reflected in the graph below.

**Figure 5-20:** Chloride (Cl) values for sites located on the Sabie River. Site USM 31 is located in the headwaters and USM 1 at Aand-de-Vliet.

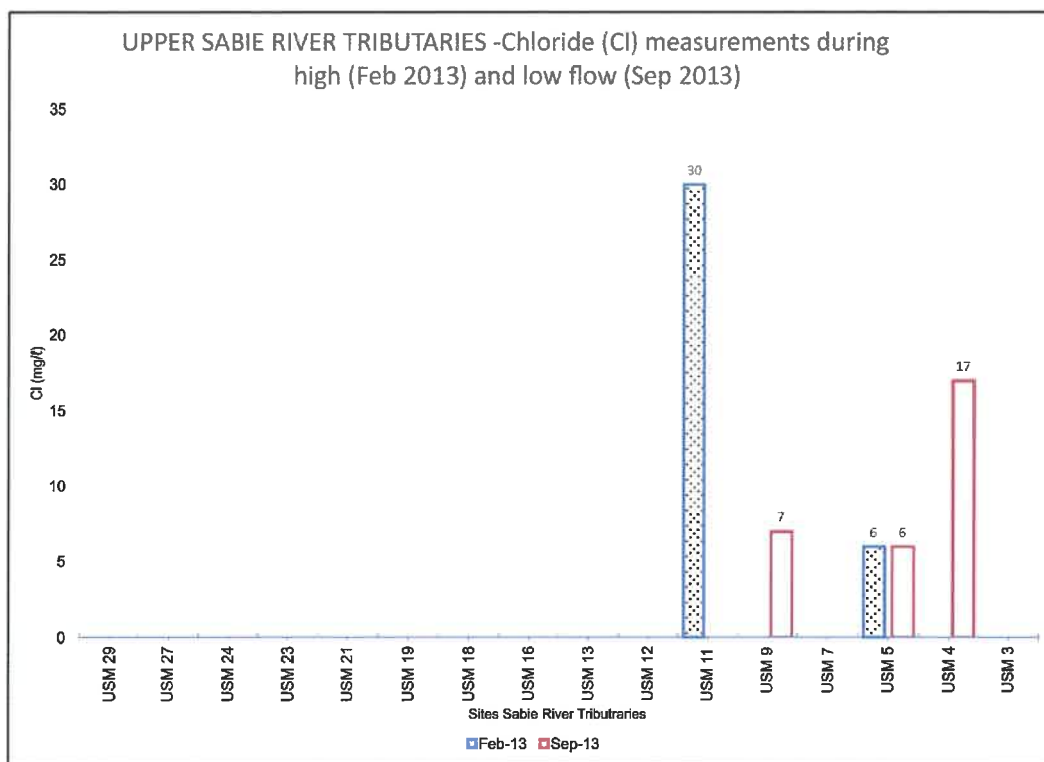
Detectable chloride levels 5 mg/l were measured during high flow conditions in the DR de Wet stream (USM 11) and Buffelspruit (USM 5) tributaries of the Sabie River, and in the Goudstroom (USM 9), Buffelspruit (USM 5) and Sabaan (USM 4) rivers during low flow conditions.

**Figure 5-21:** Chloride (Cl) values for sites located on the main tributaries of the Sabie River. Site USM 29 is located in the headwaters at Jantjebos and USM 3 in the Mac-Mac River at Brandwag.

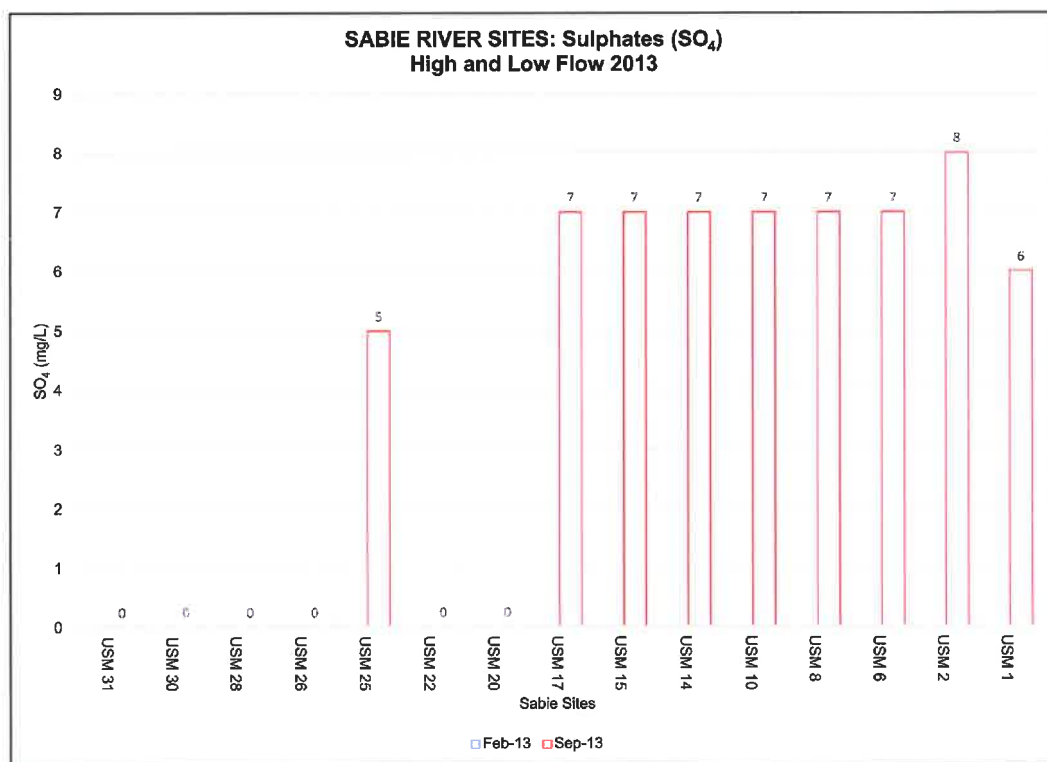
**Figure 5-24:** Sulphate (SO<sub>4</sub>) values for sites located on the Sabie River. Site USM 31 is located in the headwaters and USM 1 at Aand-de-Vliet.

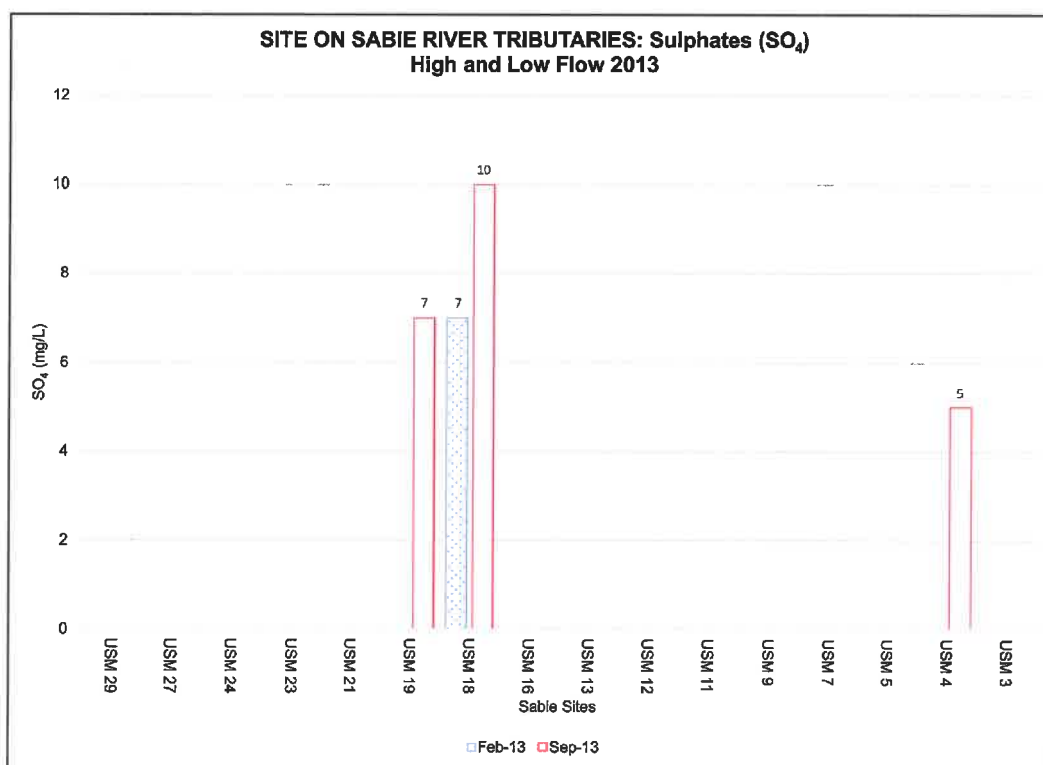
**Figure 5-25:** Sulphate (SO<sub>4</sub>) values for sites located on the main tributaries of the Sabie River. Site USM 29 is located in the headwaters at Jantjiebos and USM 3 in the Mac-Mac River at Brandwag.

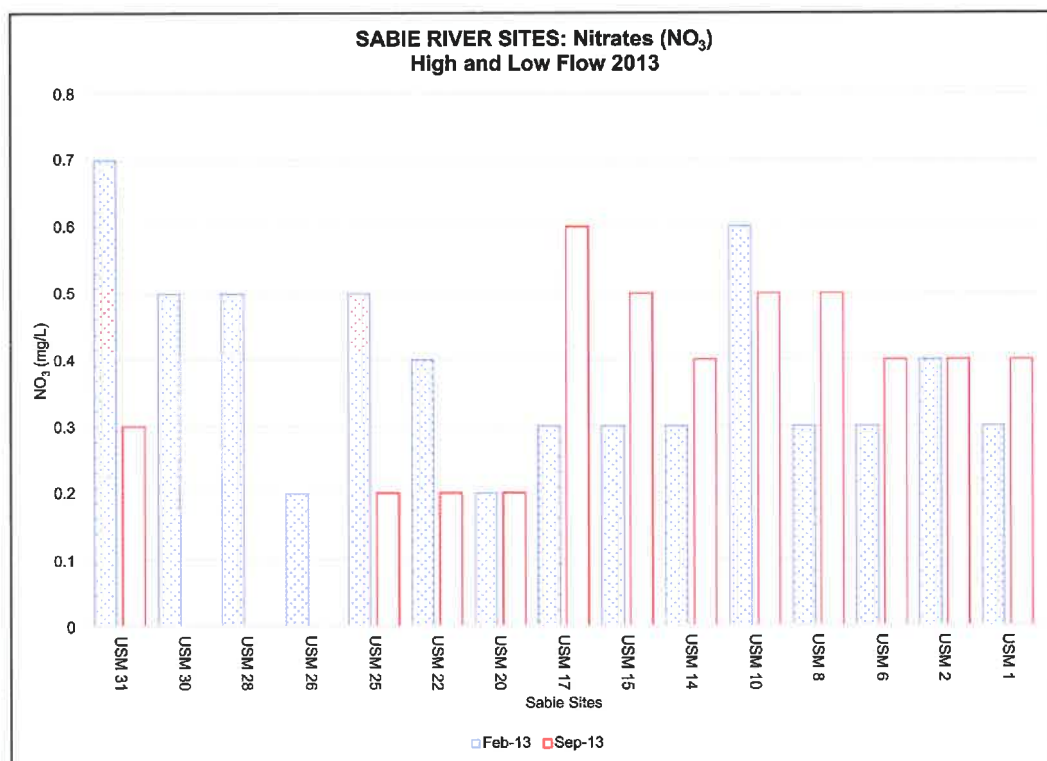
**Figure 5-27:** Nitrate (NO<sub>3</sub>) values for sites located on the Sabie River. Site USM 31 is located in the headwaters and USM 1 at Aand-de-Vliet.

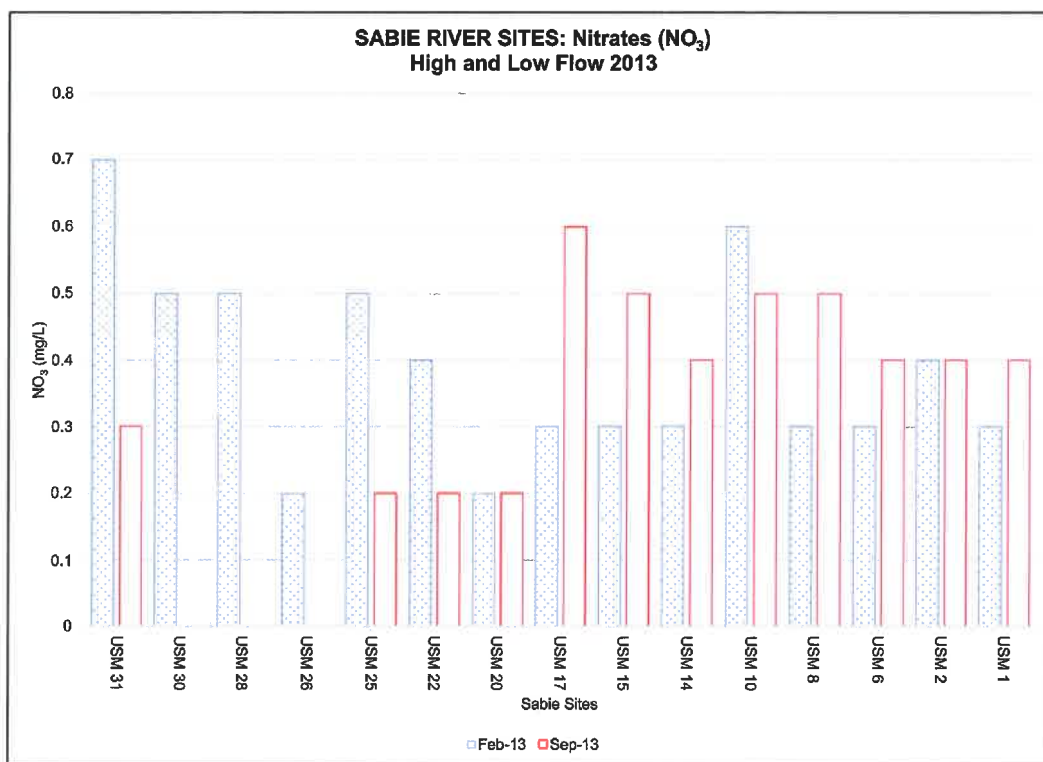
**Figure 5-27:** Nitrate (NO<sub>3</sub>) values for sites located on the Sabie River. Site USM 31 is located in the headwaters and USM 1 at Aand-de-Vliet.

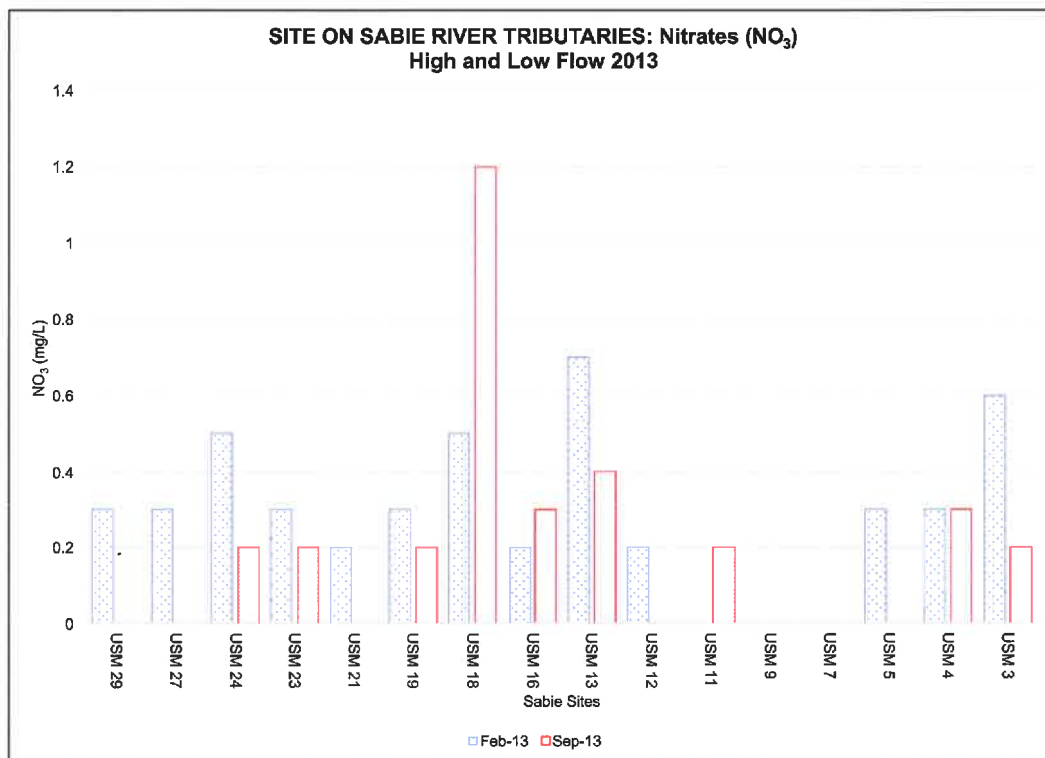
**Figure 5-28:** Nitrate (NO<sub>3</sub>) values for sites located on the main tributaries of the Sabie River. Site USM 29 is located in the headwaters at Jantjebos and USM 3 in the Mac-Mac River at Brandwag.

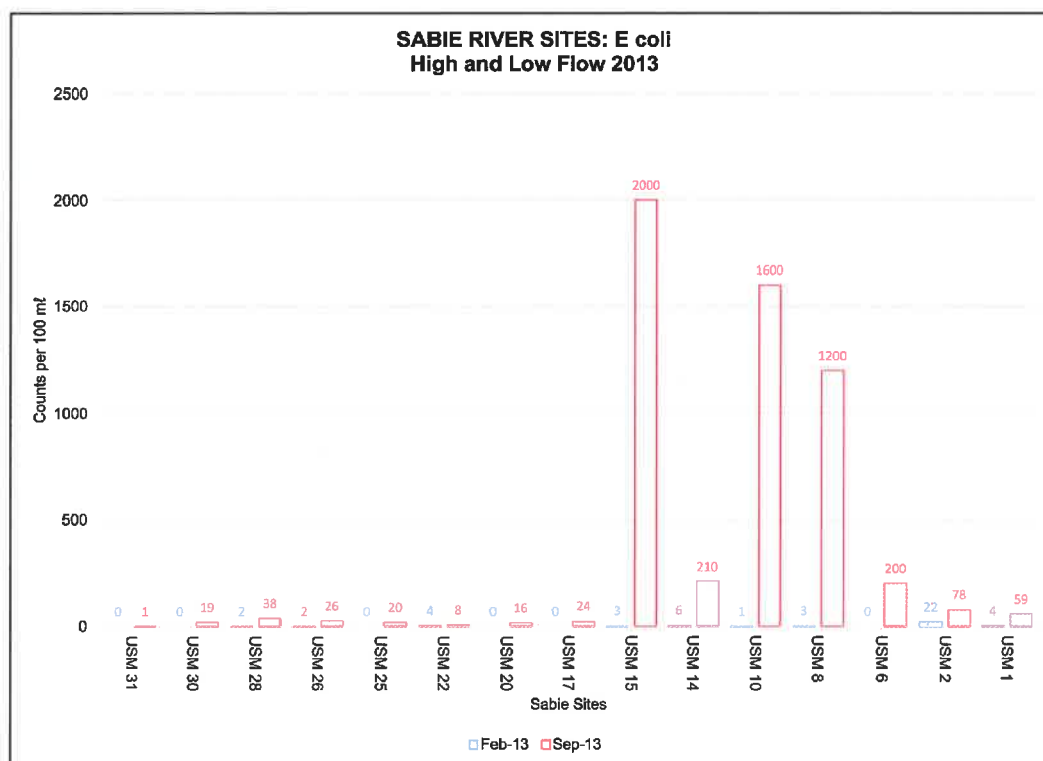
**Figure 5-29:** E coli values for sites located on the Sabie River. Site USM 31 is located in the headwaters and USM 1 at Aand-de-Vliet.

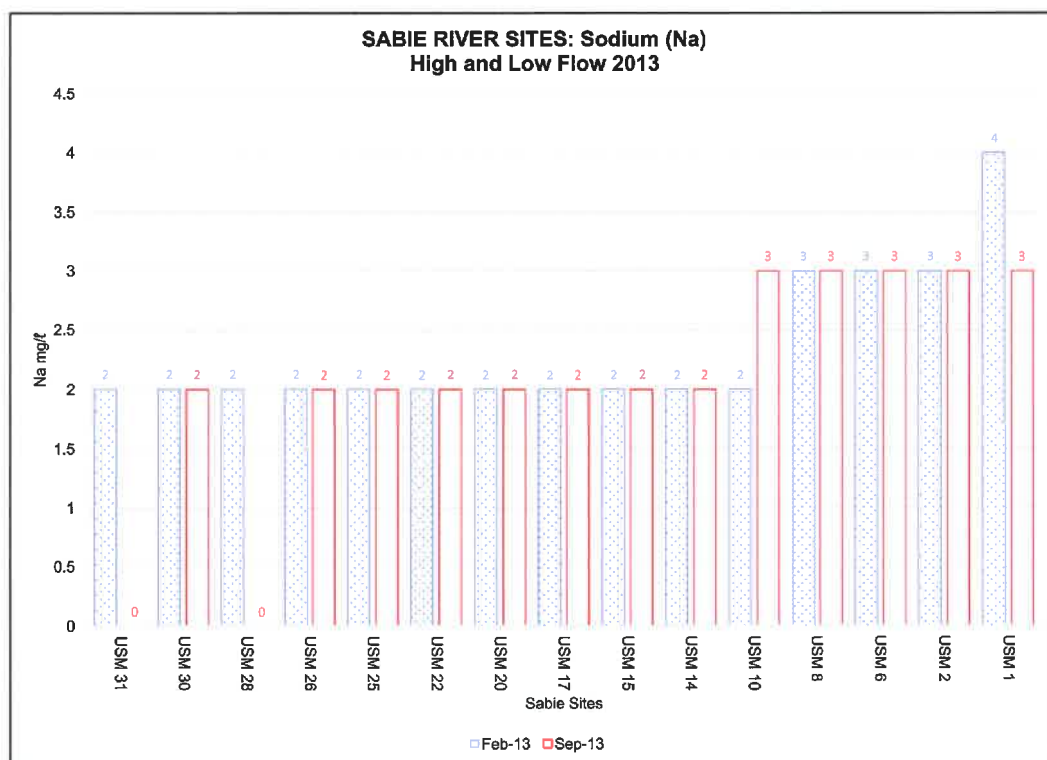
**Figure 5-32:** Graphical illustration of the sodium measurements for sites located on the Sabie River. Site USM 31 is located in the headwaters and USM 1 at Aand-de-Vliet.

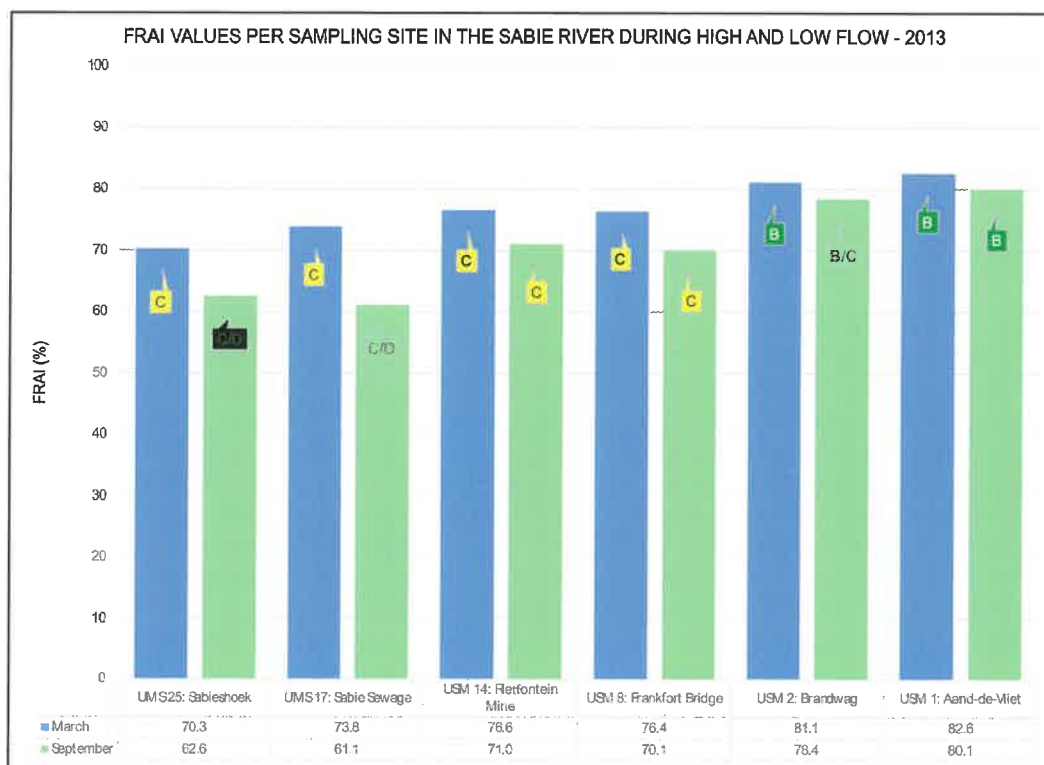
Figure 5-41: Combined graph for the March and September 2013 FRAI values of the biomonitoring sites located in the Upper Sabie River.

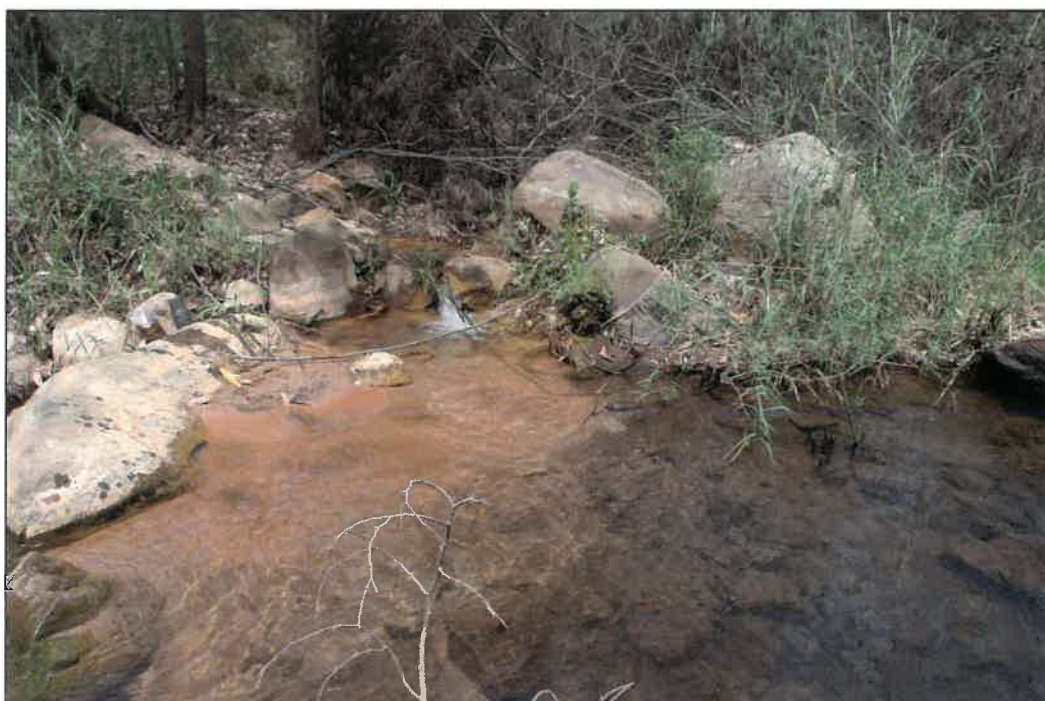
**Figure 6-1:** A tributary from an active mine just downstream from the town of Sabie depositing fine sediments into the Sabie River during low flow conditions (G Diedericks, 18 September 2013).

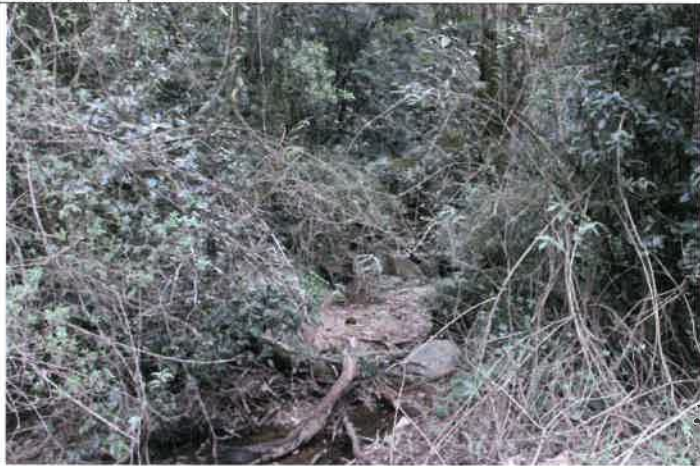
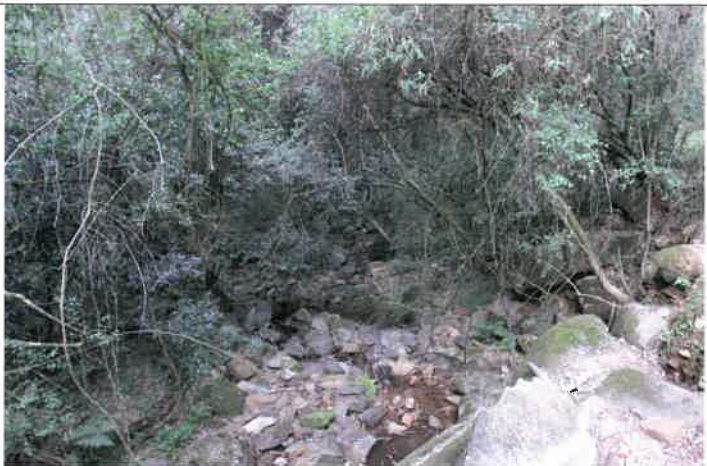
Figure A-113: Upstream view of the Sabie River at Headwaters (USM 31), taken on 18 September 2013 (G Diedericks).	Figure A-114: Downstream view of the Sabie River at Headwaters (USM 31), taken on 18 September 2013 (G Diedericks).
