**ADOPT-A- RIVER PROGRAMME PHASE II:  
DEVELOPMENT OF AN IMPLEMENTATION PLAN  
WATER RESOURCE QUALITY  
SITUATION ASSESSMENT**

# ADOPT-A- RIVER PROGRAMME PHASE II: DEVELOPMENT OF AN IMPLEMENTATION PLAN WATER RESOURCE QUALITY SITUATION ASSESSMENT

Department of Water Affairs  
Resource Quality Services

October 2009

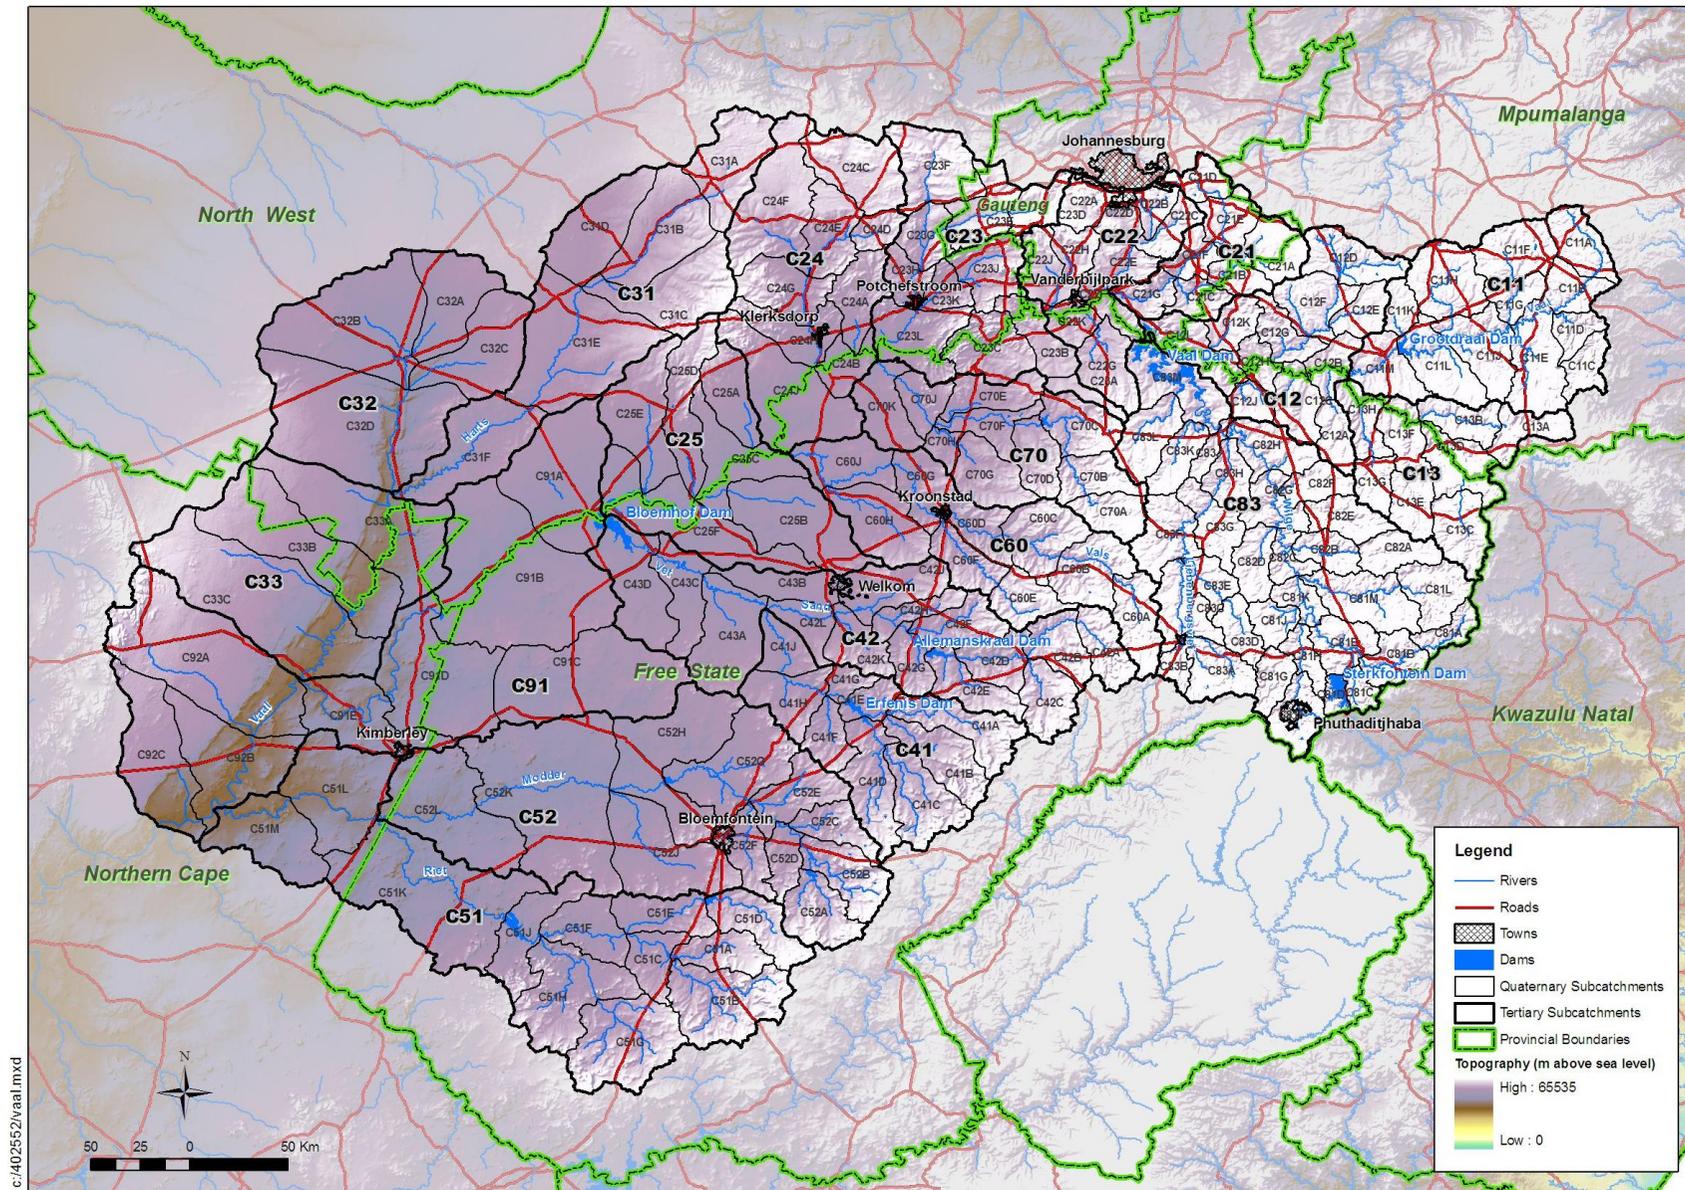
Figure 2.1 Map of the Vaal River catchment showing the major sub-catchments and rivers

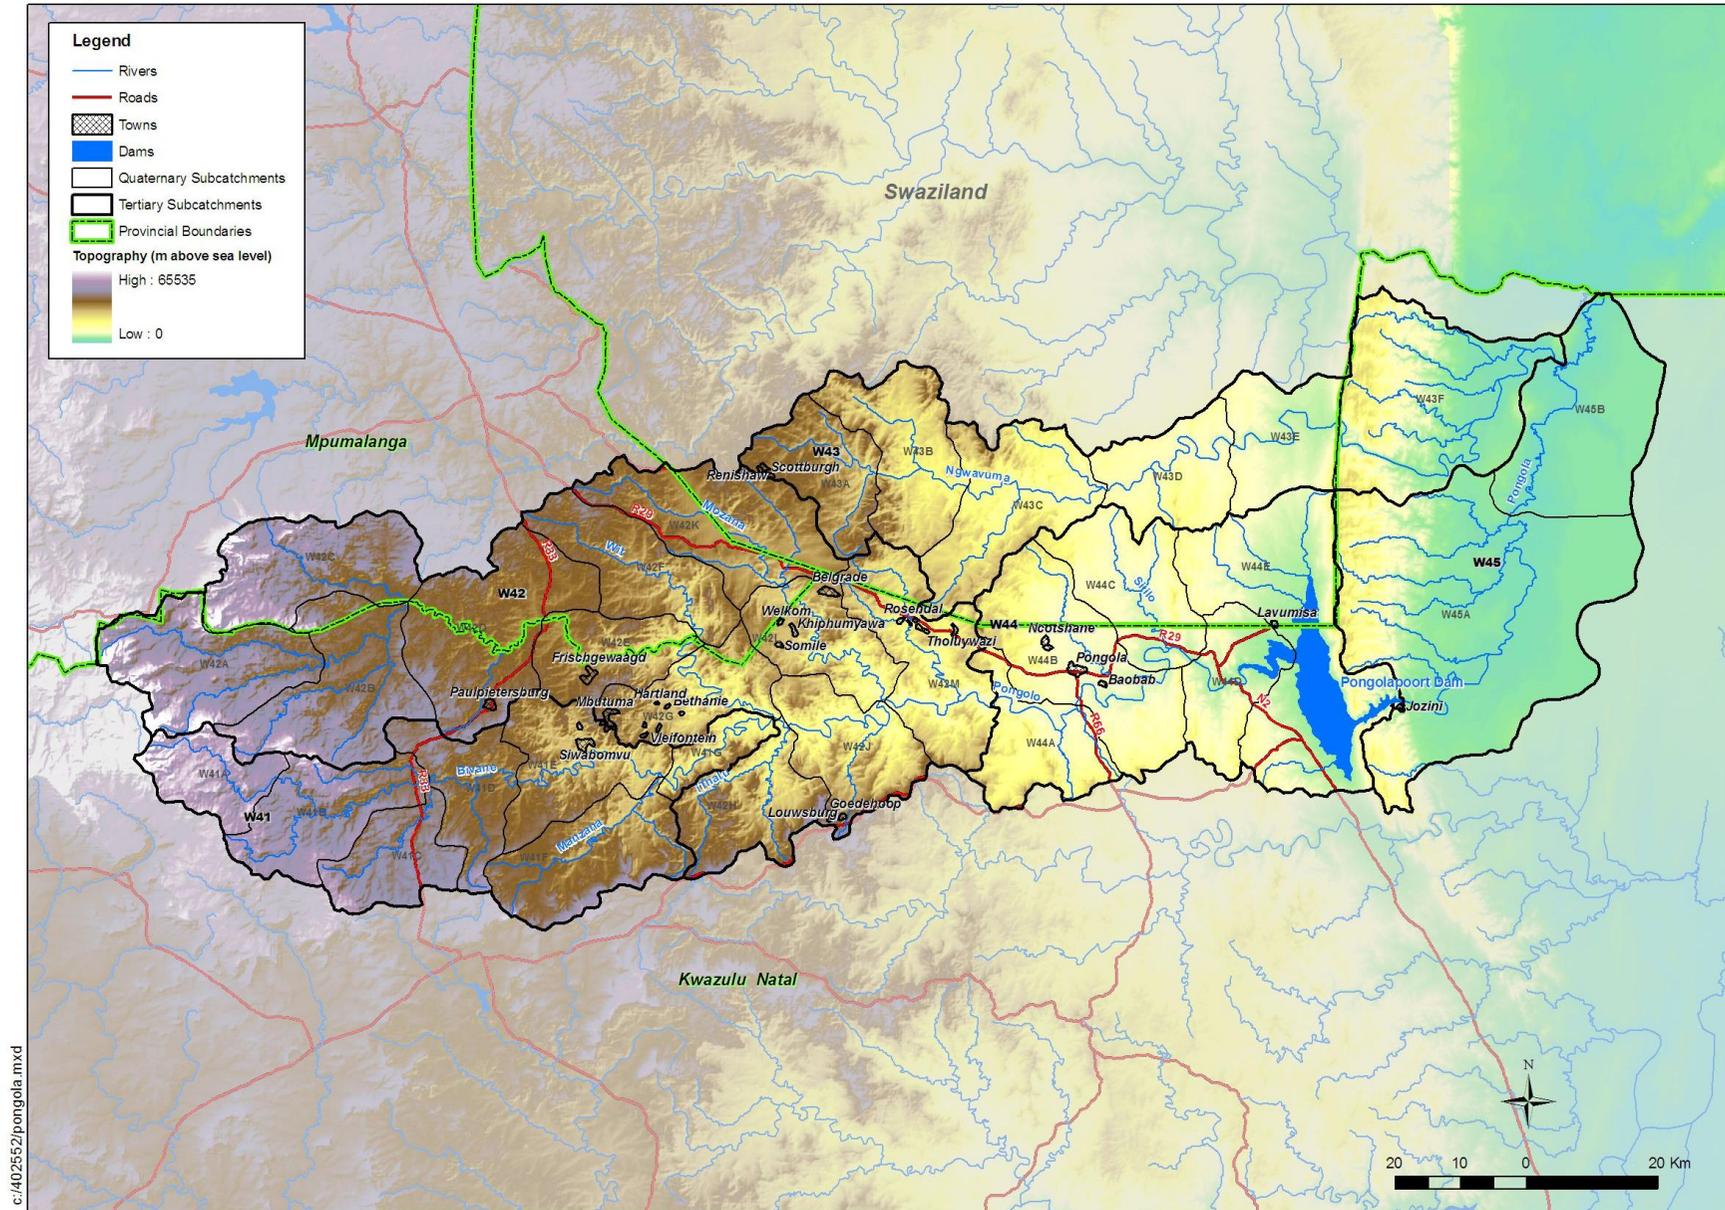
Figure 3.1 Map of the Pongola River catchment showing the major sub-catchments and rivers

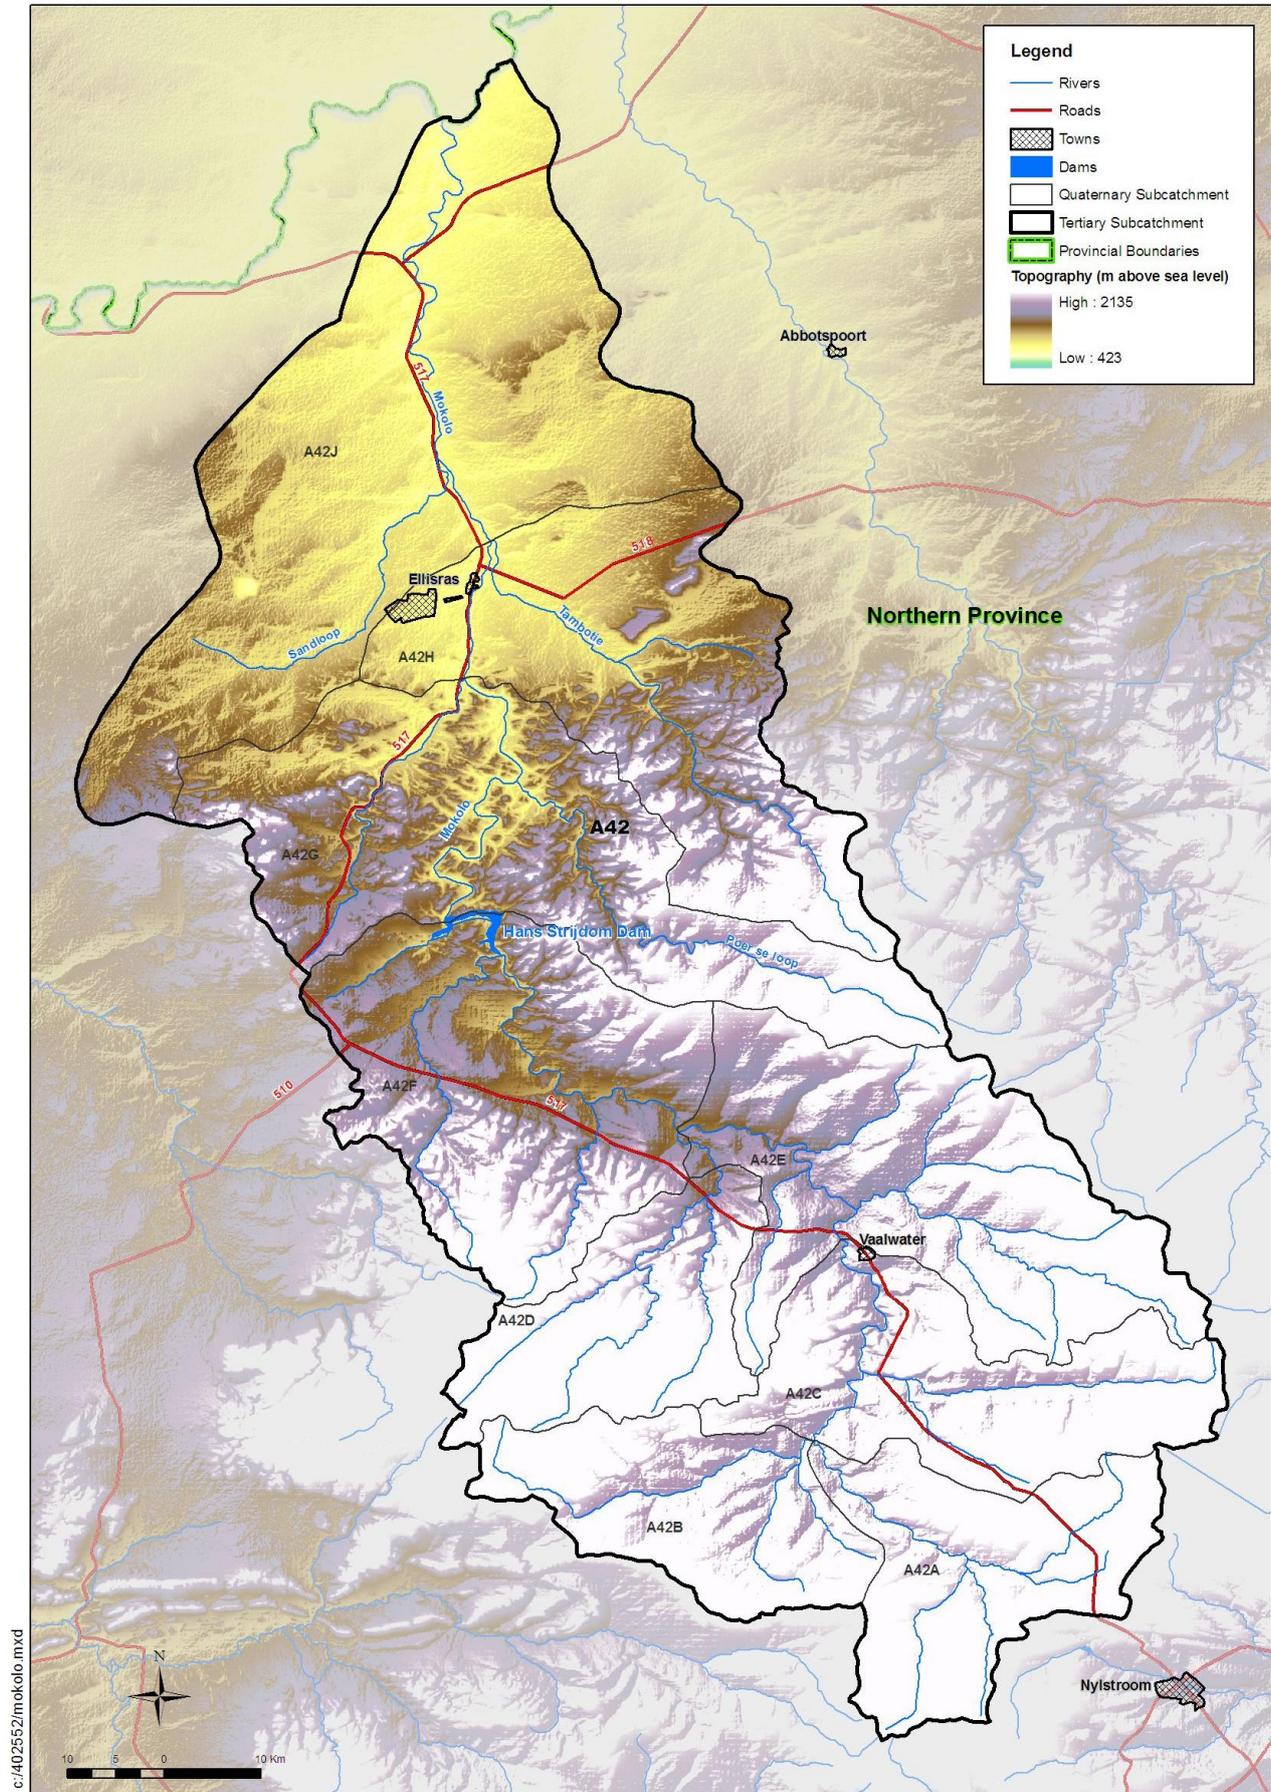
Figure 4.1 Map of the Mokolo River catchment showing the major sub-catchments and associated rivers

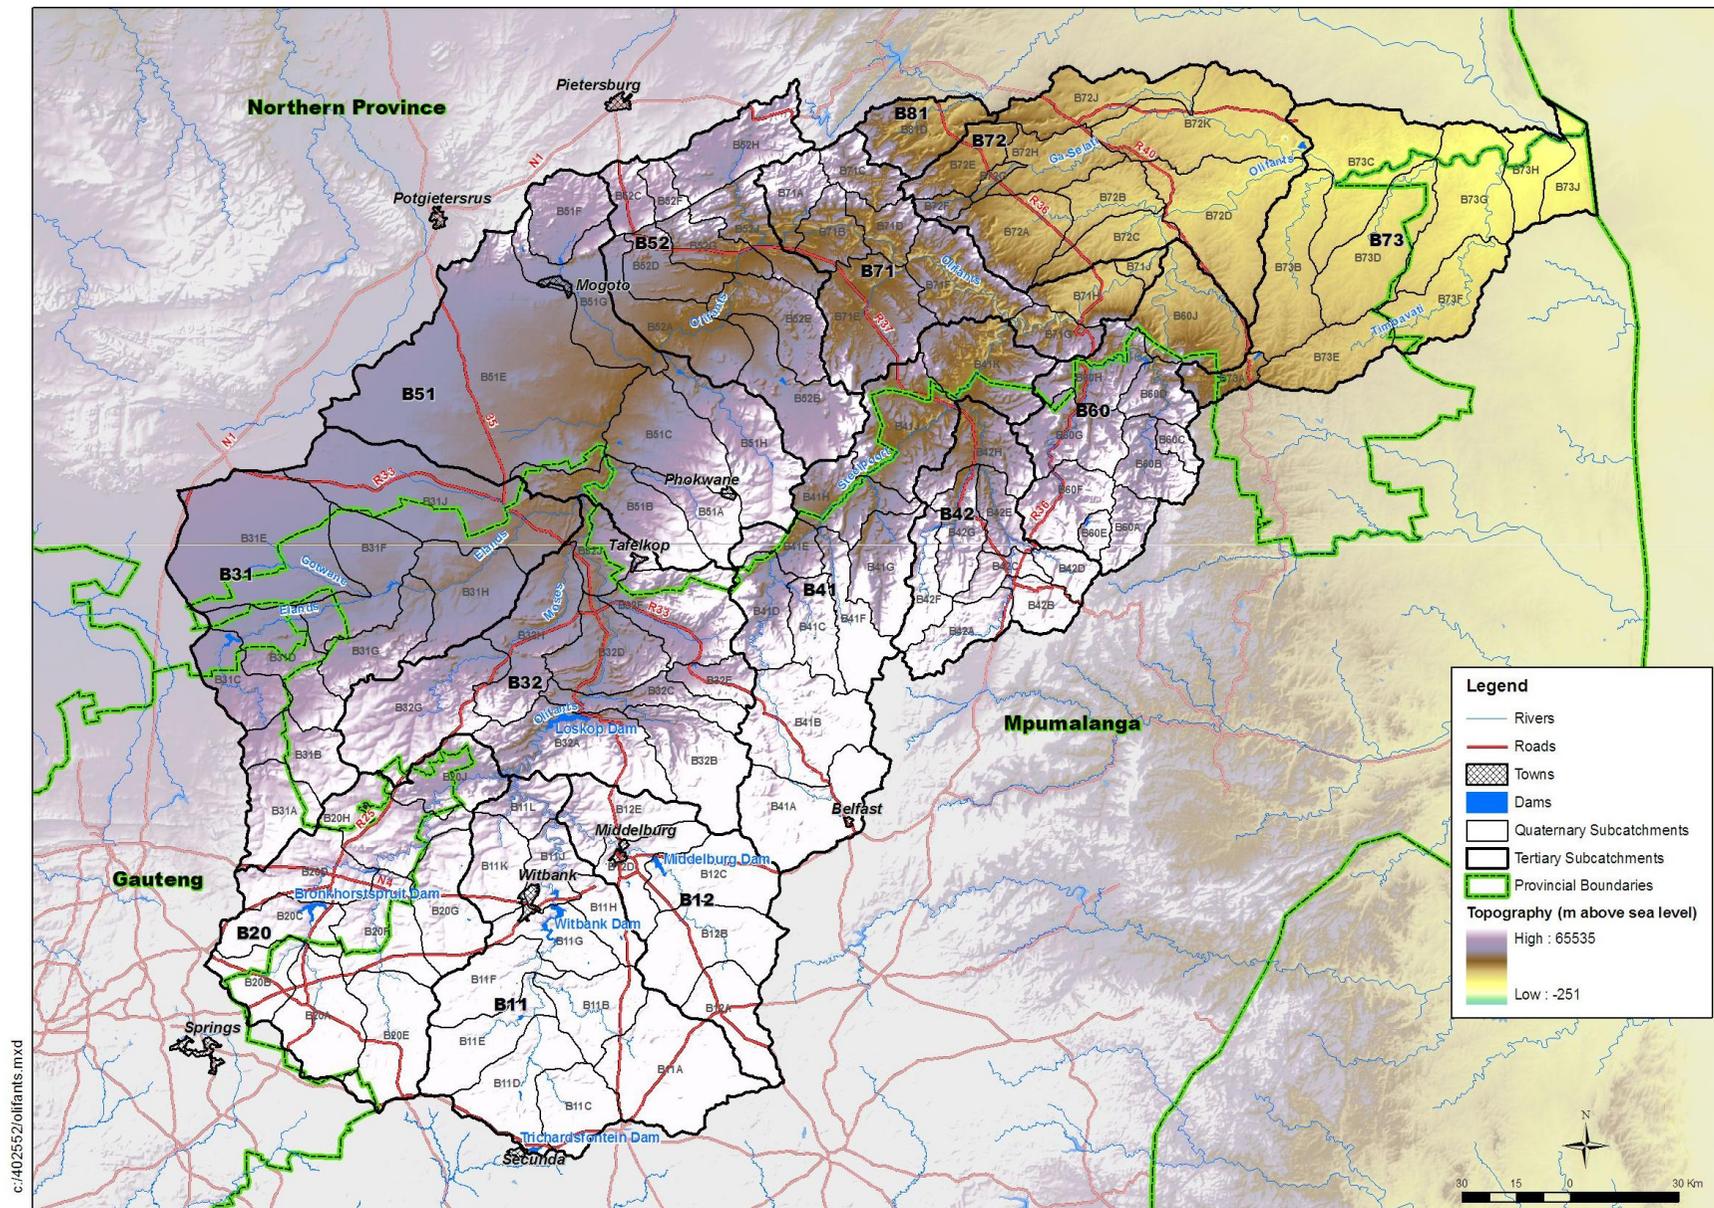
Figure 5.1 Map of the Olifants River catchment showing the main sub-catchments and rivers

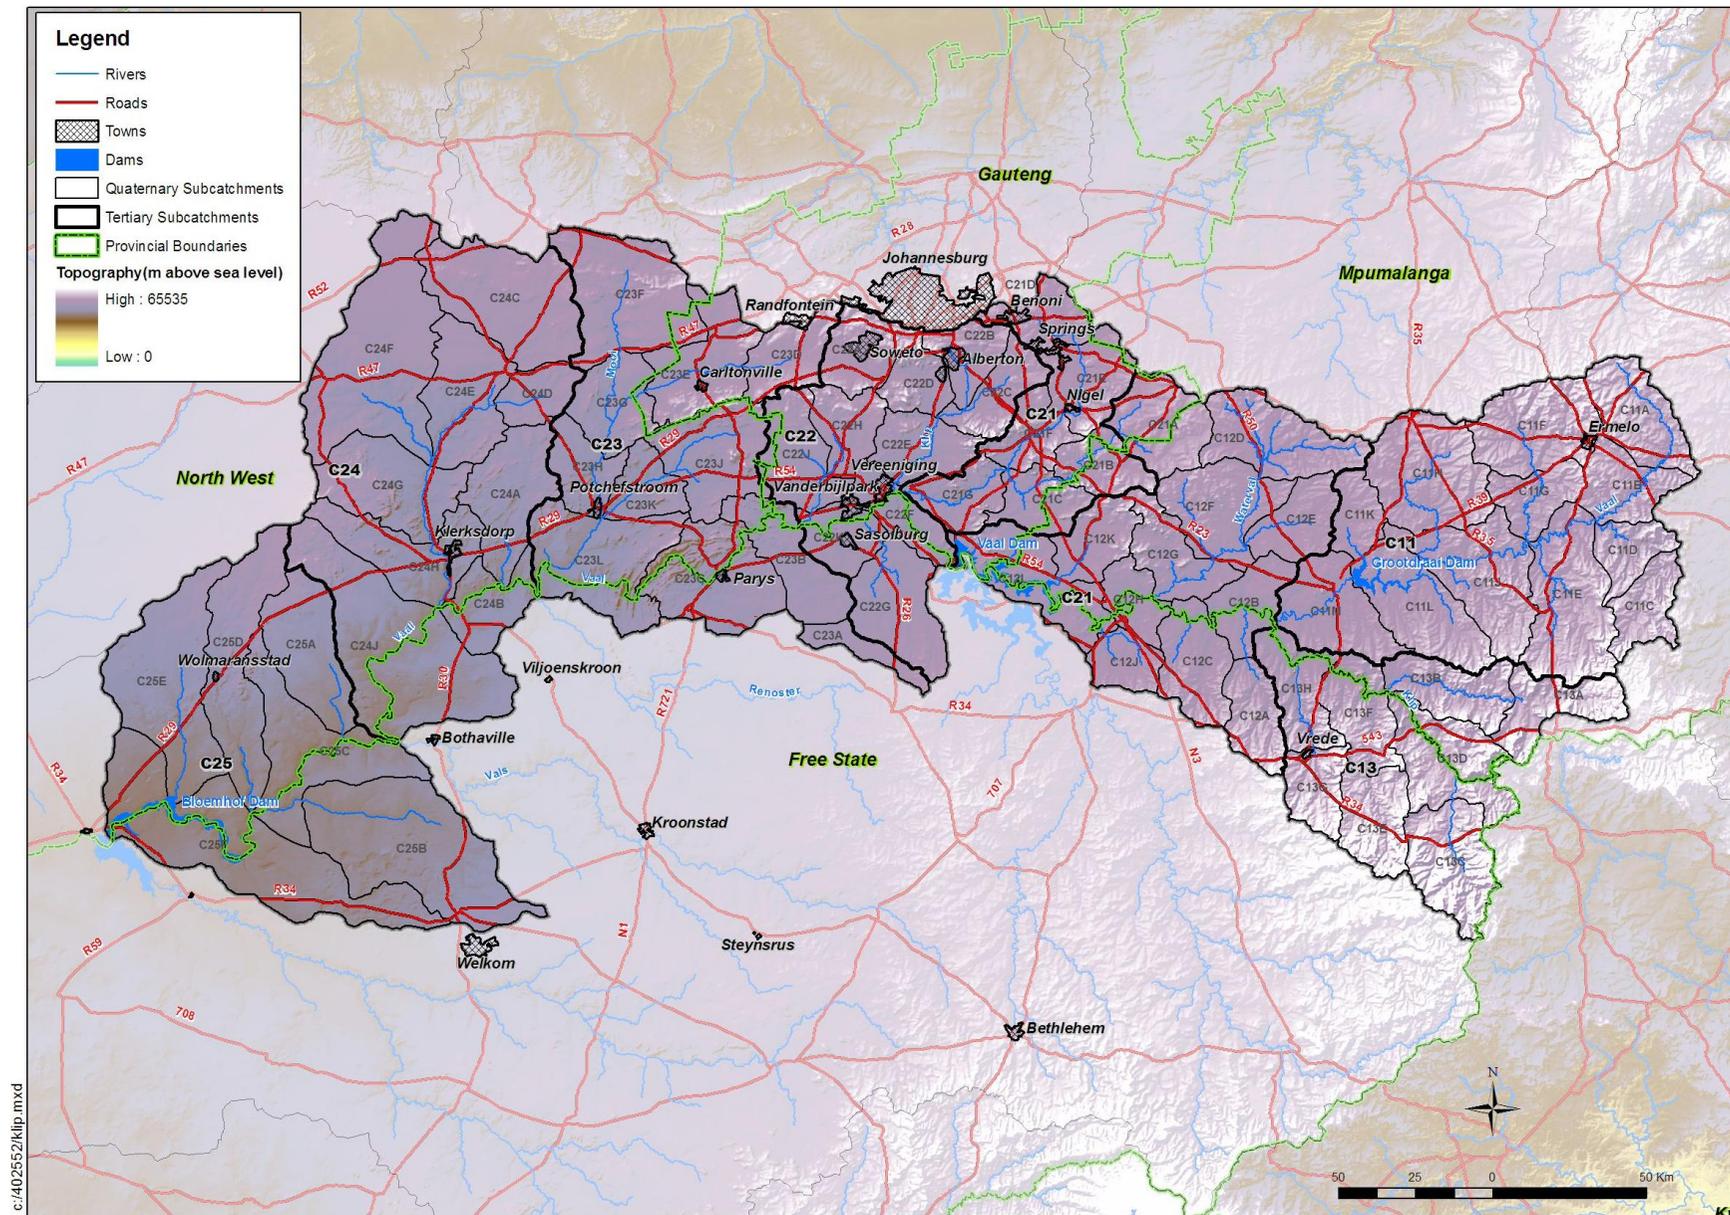
Figure 6.1 Map of the Klip and Wonderfonteinspruit catchments

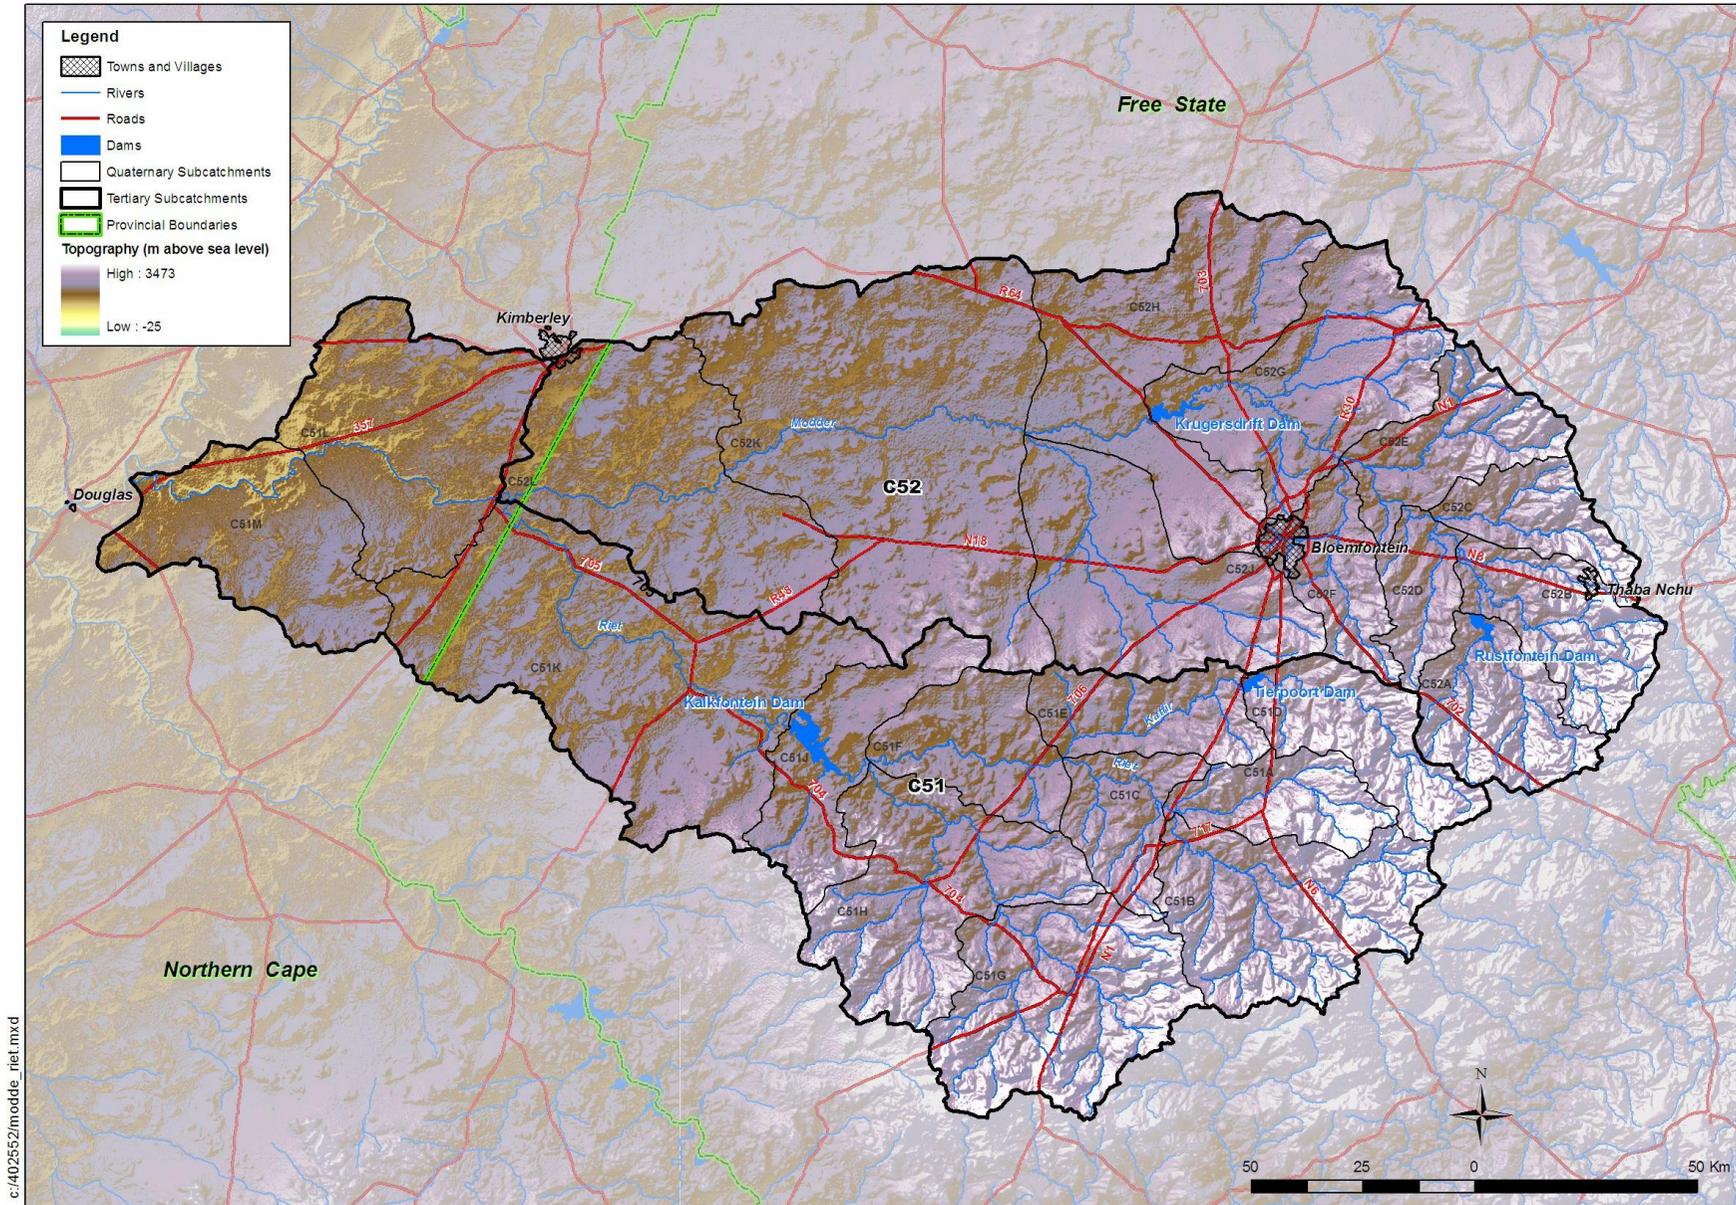
Figure 7.1 Map of the Modder-Riet catchment showing the major sub-catchments and rivers associated with it

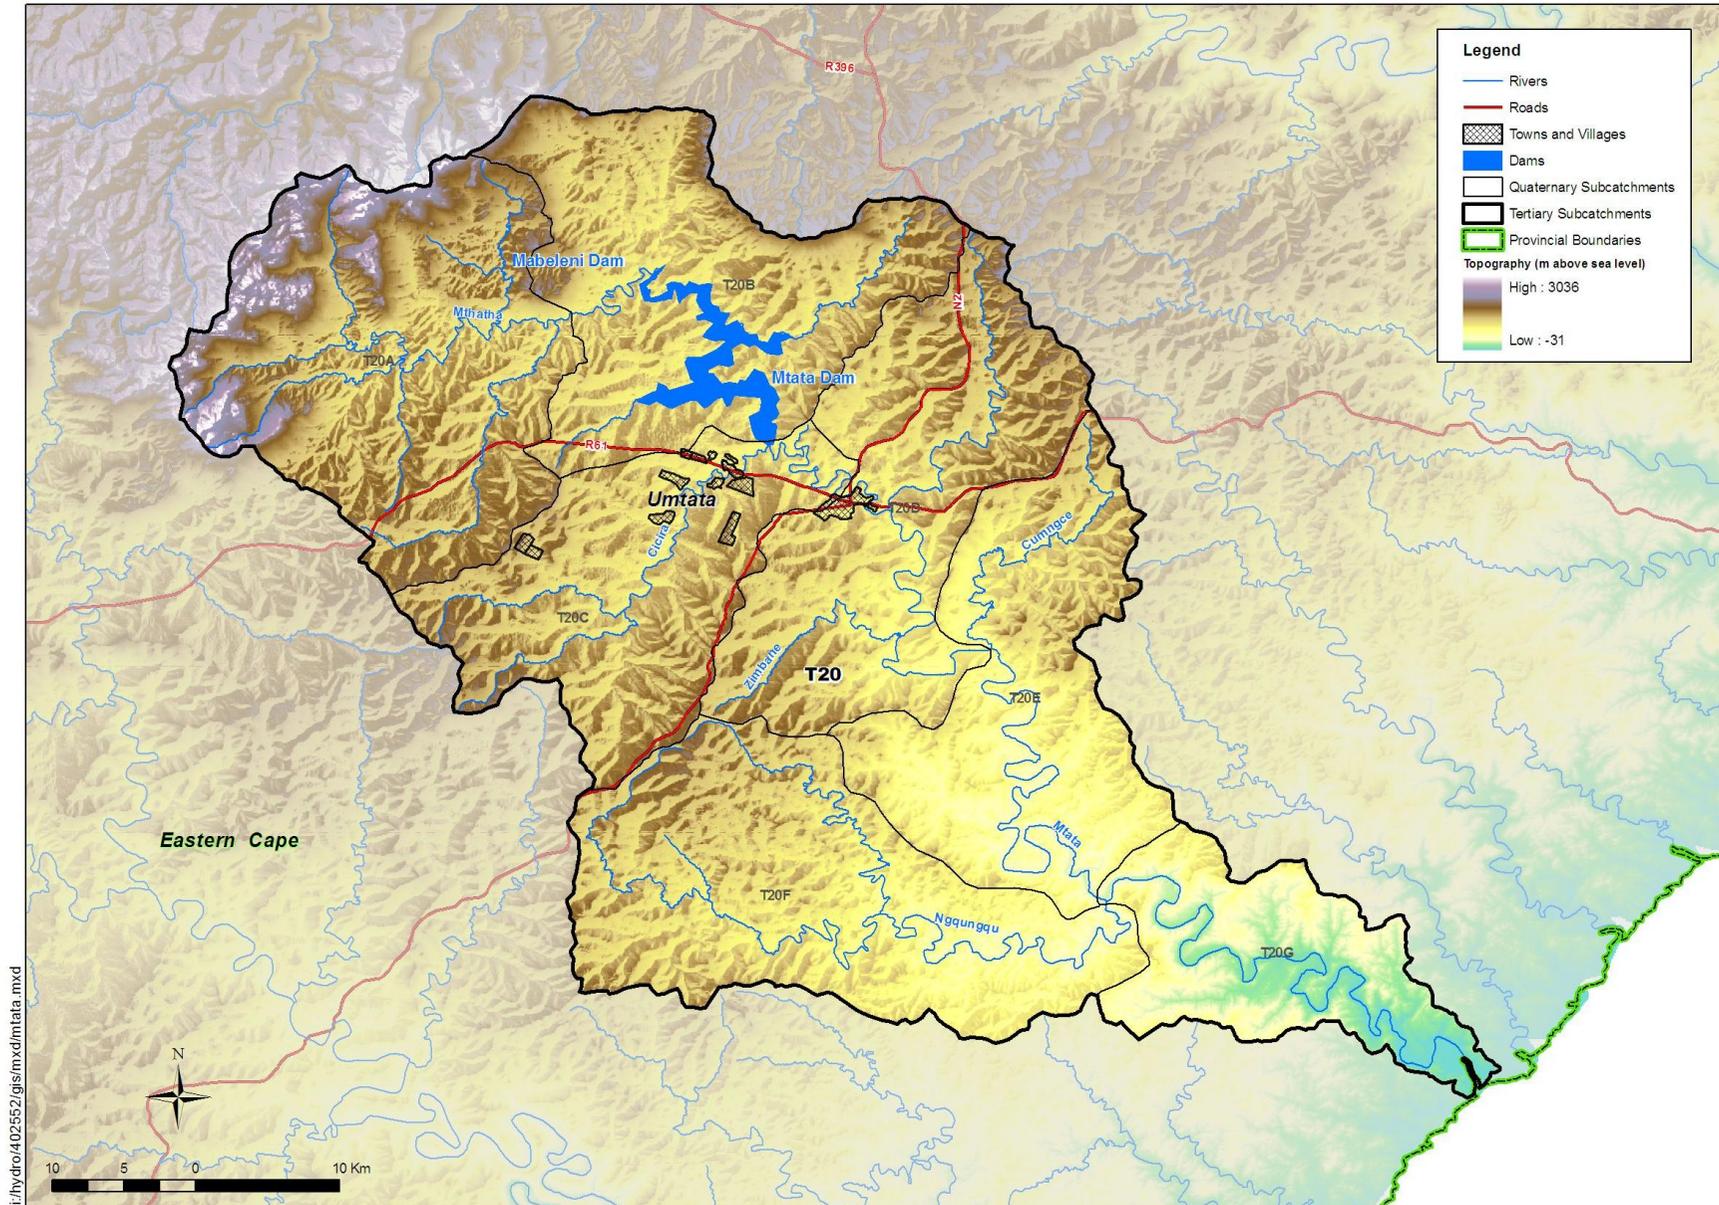
Figure 8.1 Map of the Mtata River catchment

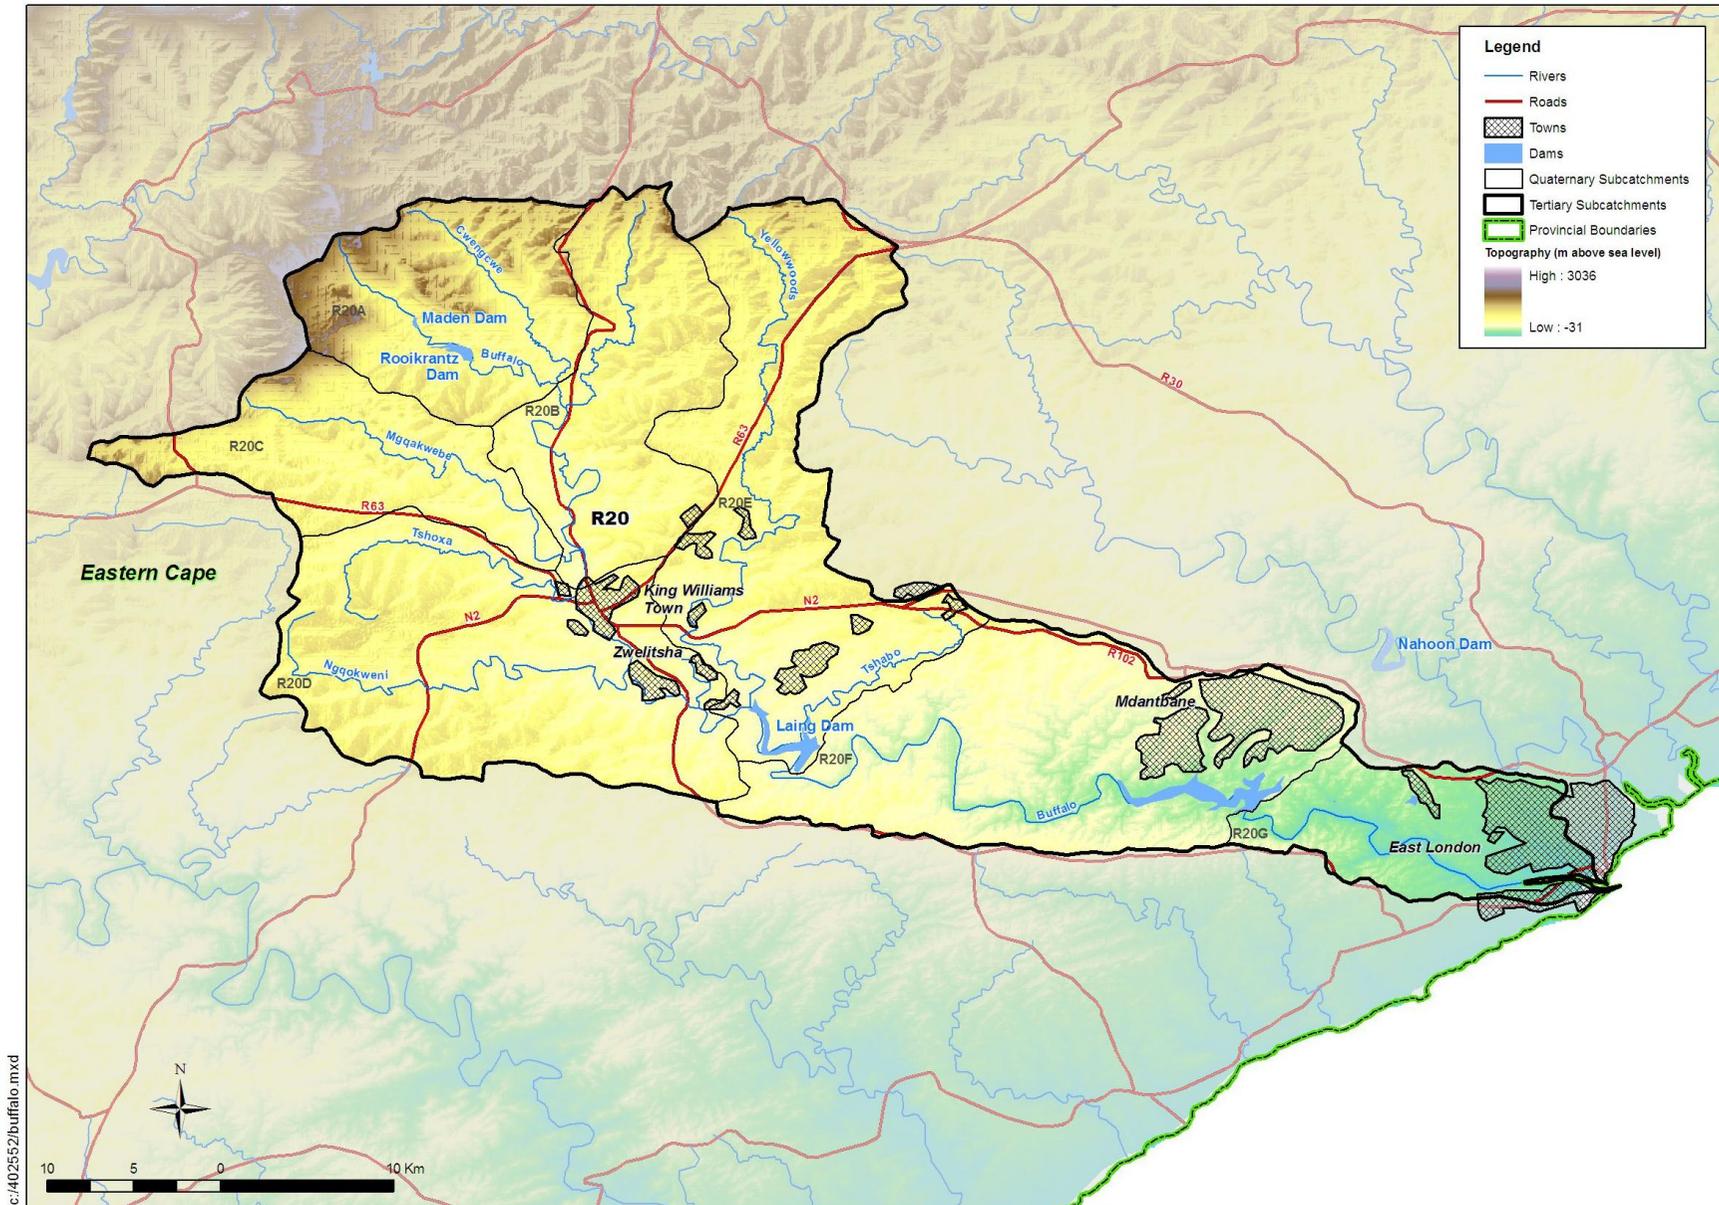
Figure 8.2 Map of the Buffalo River catchment showing the rivers and sub-catchments.

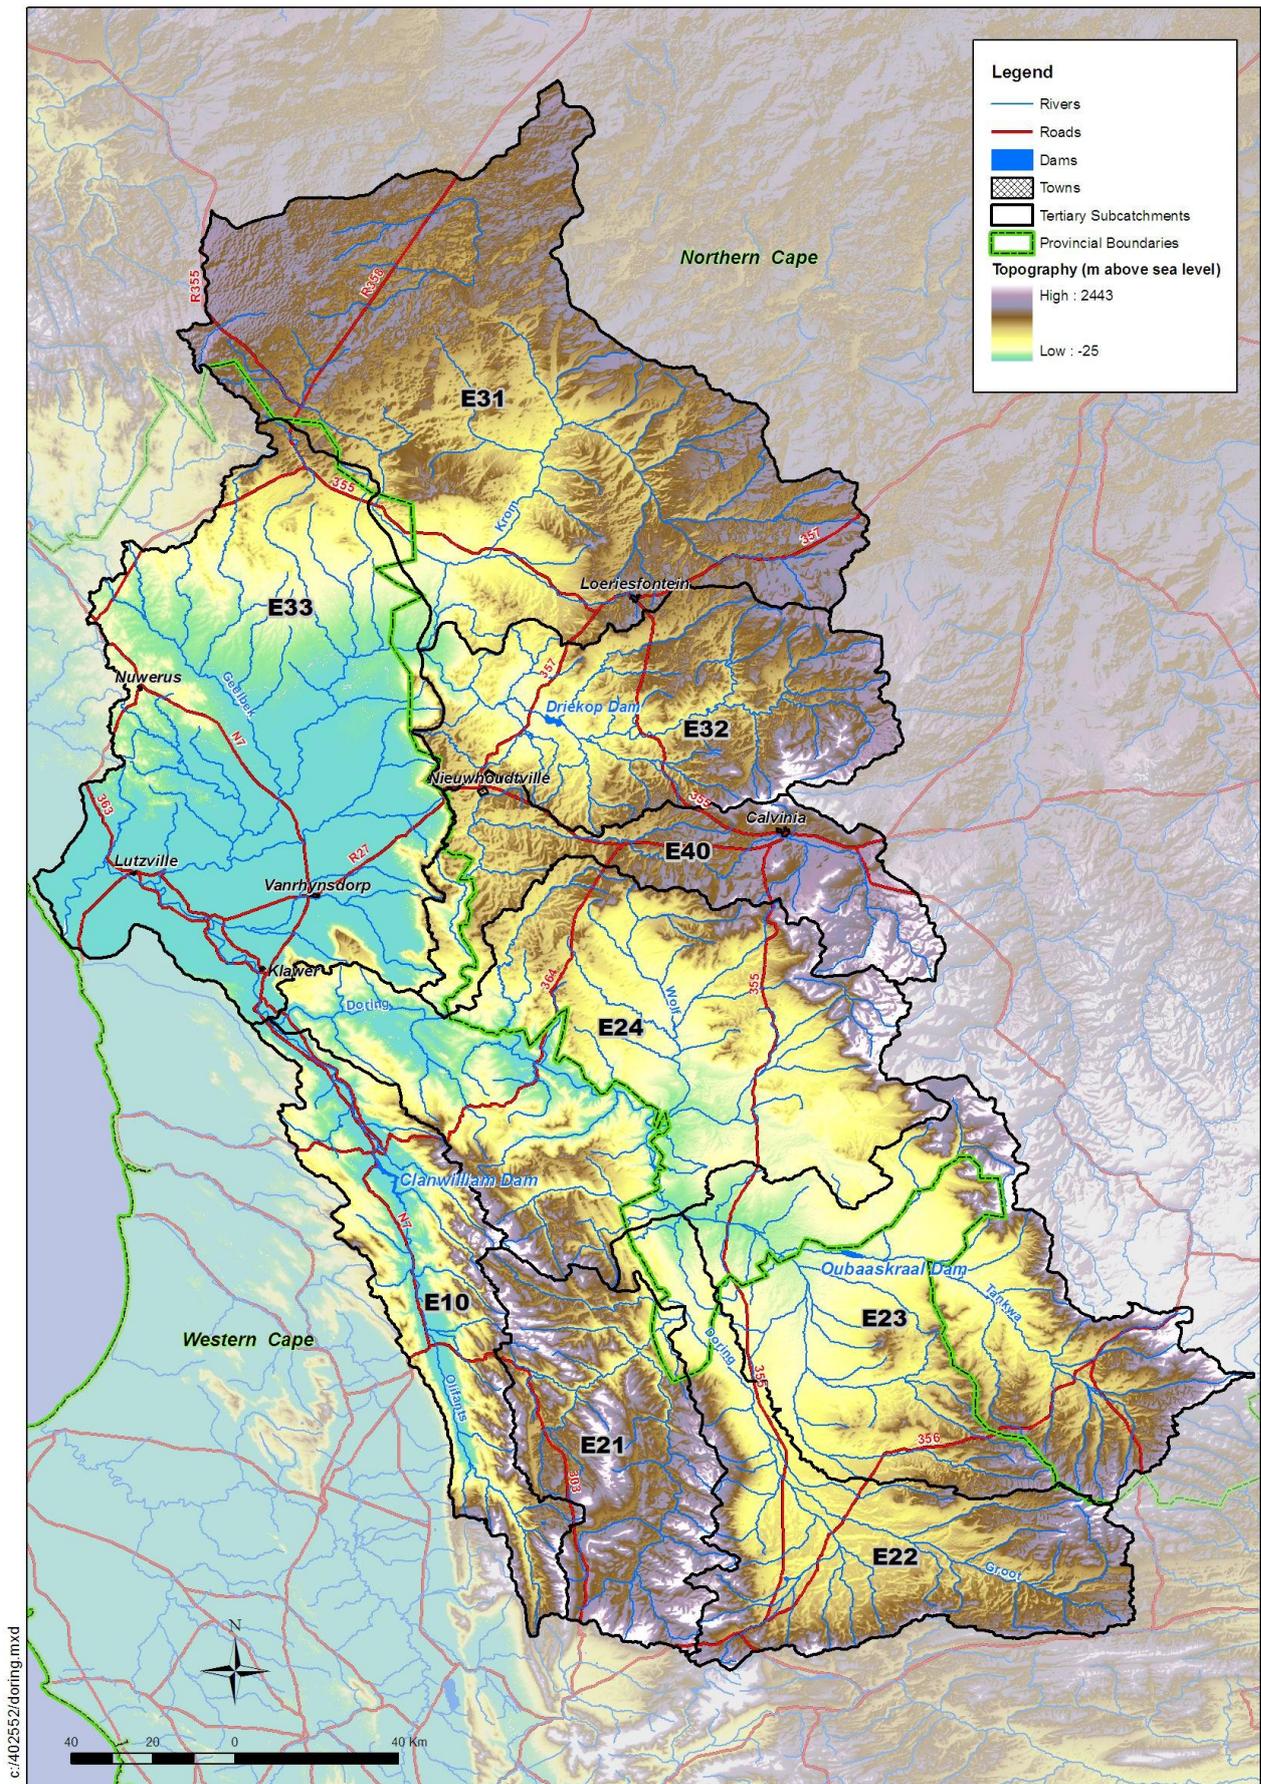
Figure 9.1 Map of the Olifants-Doring catchment showing the major sub-catchments and associated rivers

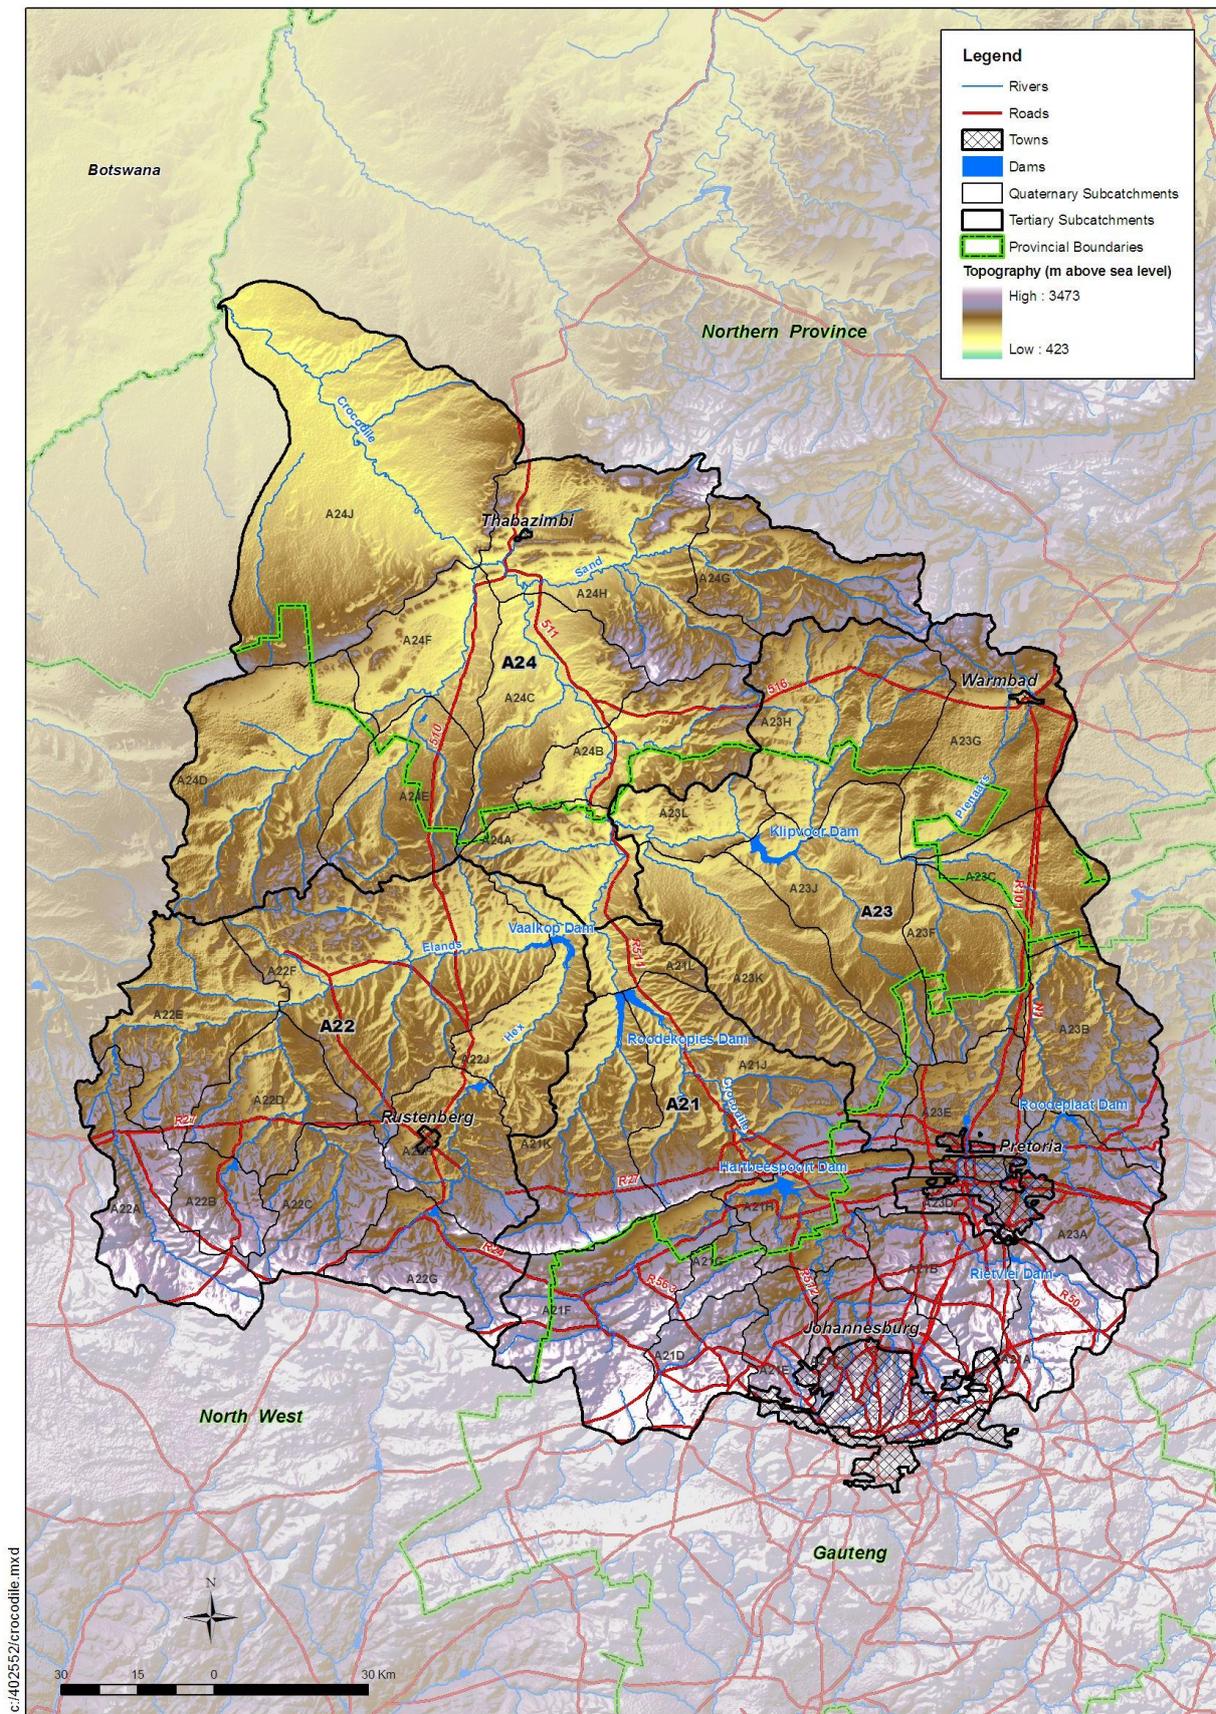
Figure 11.1 Map of the Crocodile (west) catchment showing the major sub-catchments and river

The Crocodile River (West) Catchment was divided into four sub-catchment areas to facilitate more detailed description of water resource quality issues and concerns (Figure 11.1). These sub-areas are the Upper Crocodile sub-catchment (A21), the Elands River sub-catchment (A22), the Apies/Pienaars sub-catchment (A23), and the Lower Crocodile sub-catchment (A24).
