INKOMATI-USUTHU
CATCHMENT MANAGEMENT AGENCY

ANNUAL WATER QUALITY STATUS REPORT FOR THE INKOMATI WATER MANAGEMENT AREA

2013 / 14 Financial Year

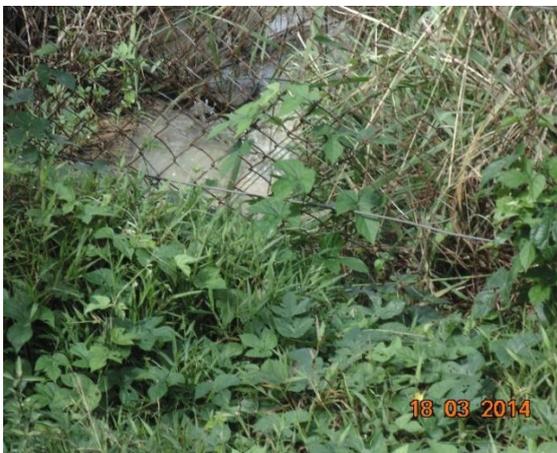
- Owing to the hole in pond 4, partially treated sewage seeps into the Inyaka Dam. See attached Figure 30 (a).
- The sewer manhole pipe has been broken since January 2014 and to date nothing has been done to fix it. See attached Figure 30.

a. Final sewage effluent into the Injaka Dam

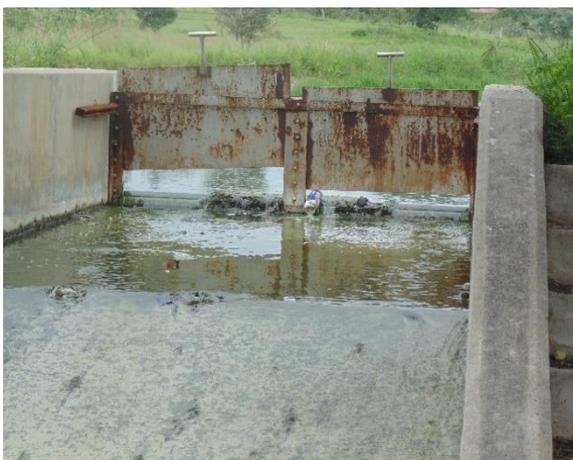
- HTH is used to disinfect the final effluent; however, HTH does not serve any purpose as the WWTW discharges raw sewage (effluent quality shown in Table 8) which is green in colour with surface scum and floats into the Mutlumuvi River. See Figure 32.

a. Scum and sludge from the final pond

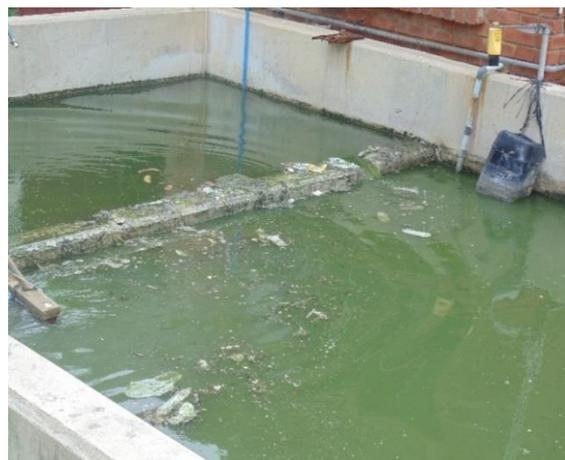
b. Chlorination channel full of floating scum and sludge

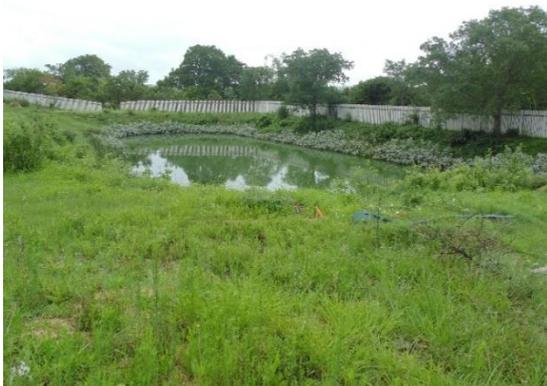
- Pumps from the collection sump were not working and the sewage is channelled/diverted into the emergency dam. See Figure 34.
- The emergency dam is full, allowing the discharge of the raw sewage (effluent quality shown in Table 9) into the unnamed stream which is a tributary of the Sabie River. See Figure 34.

a. Emergency dam full of raw sewage

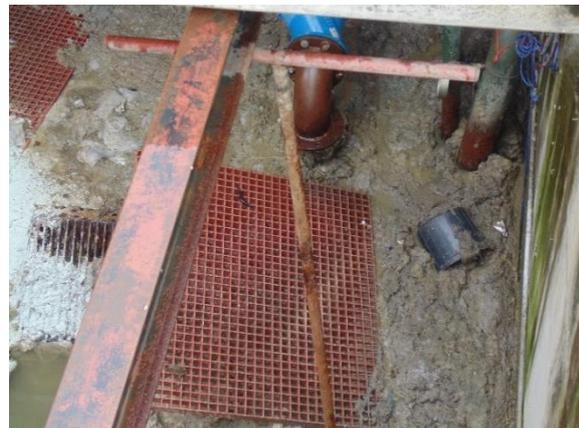
b. Pump not working and sump full of sludge

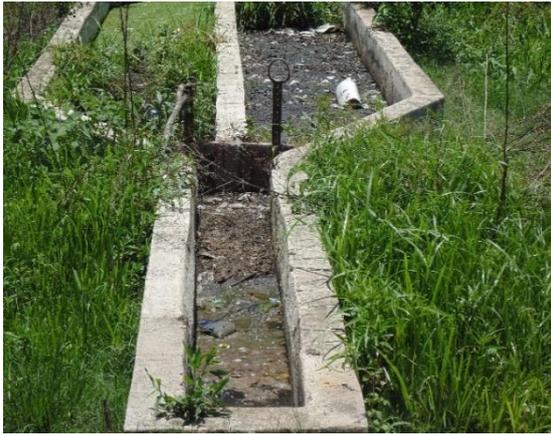
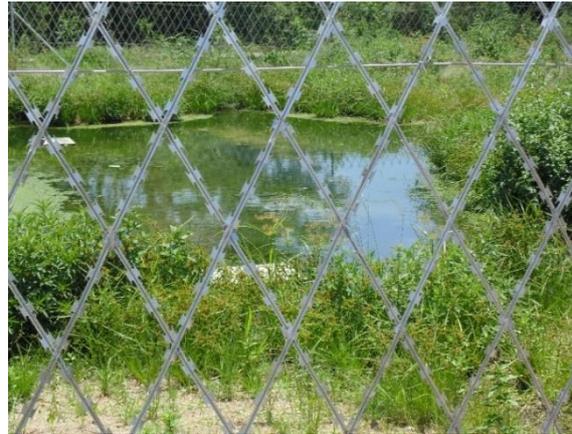
- Figure 35 shows a Google image (Google Earth, 2009) of the Hoxani WWTW.
- The type of process technology applied by the WWTW is oxidation ponds and currently a septic tank system is in use.
- The WWTW has a design capacity of 0.69 ML/day.
- The average daily flow (operational) capacity is unknown because the plant does not have flow measuring devices.
- The WWTW has not been registered in terms of the requirements of regulation 2834 and therefore the class of the plant is not known.
- There was no process controller at the plant.
- The WWTW does not have a water use authorisation for the discharge of effluent into the Sabie River.
- The Municipality is in the process of decommissioning the oxidation ponds.
- The septic tank was overflowing into the environment. See Figure 36.
- The inlet is full of scum and sludge.

a. Inlet with scum and sludge to the septic tank
b. Sewage overflow

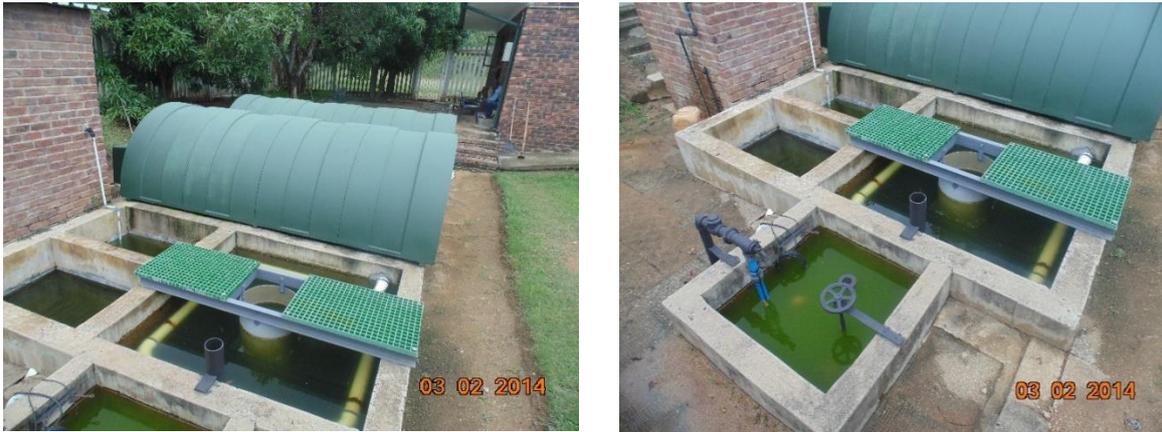
- The plant is not in operation and not receiving sewage. See Figure 38.

- a. Plant not in operation as it does not receive or discharge sewage
- b. Closer view of the plant

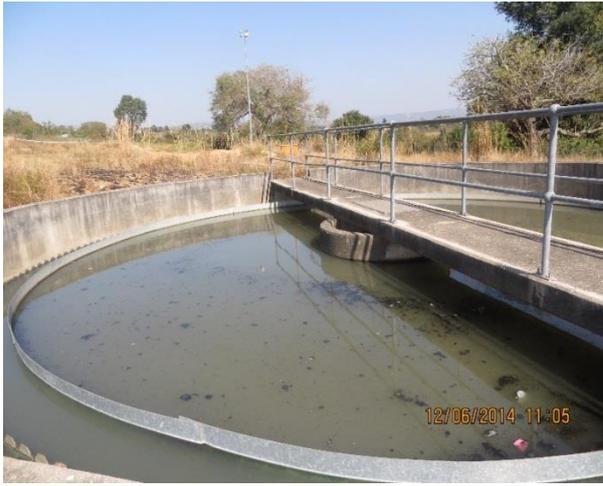
a. Humus tank with scum suspended on top

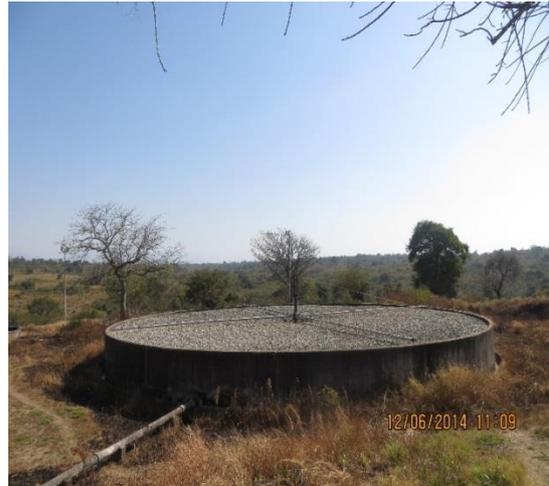
- The humus tanks and bio-filters are not functional. See Figure 40.
- There is chlorination taking place; however, it is not effective.
- The treatment plant discharges poor effluent quality (see Table 10) due to the bypass.

b. Non-functional bio-filter

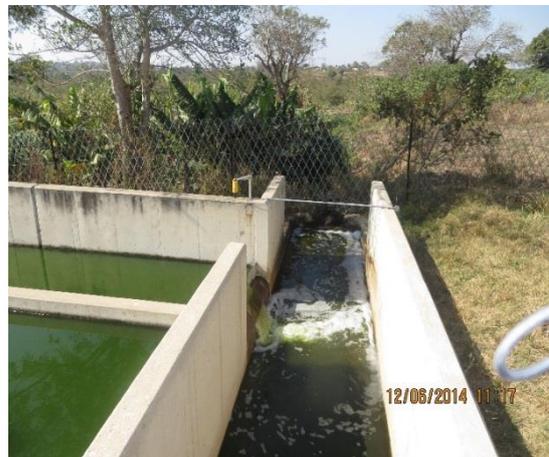
d. Discharge point

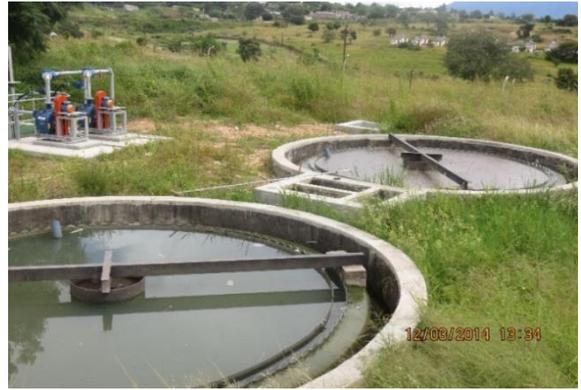
- The WWTW has been refurbished and functioned well for a few months but currently the plant is not in a good state of repair.
- The humus tanks are not functional due to the failure of the recycling pumps. See Figure 42.

b. Humus tanks with pumps that are not working

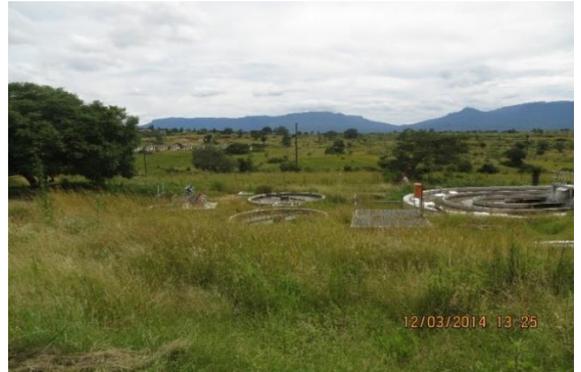
d. Overgrown grass in the yard well

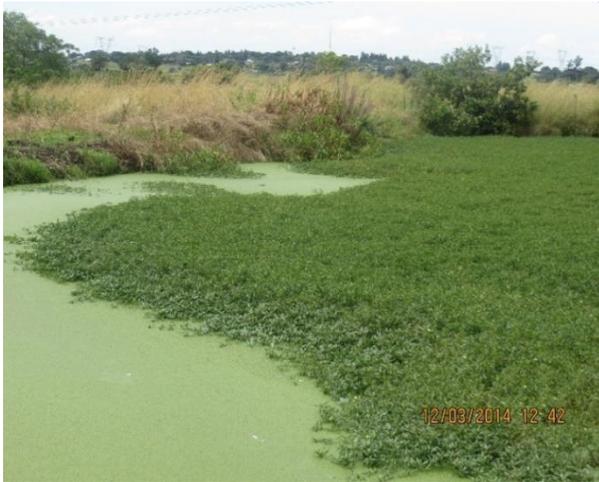
- The ponds have become overgrown with reeds. See Figure 44.

a. Primary pond overgrown with reeds

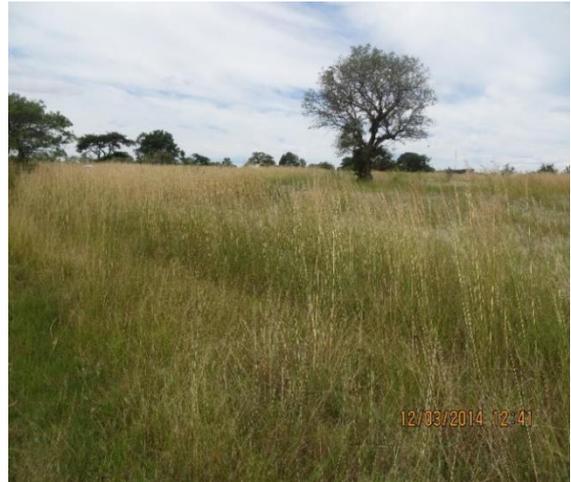
b. Overgrown grass within the yard of the WWTW

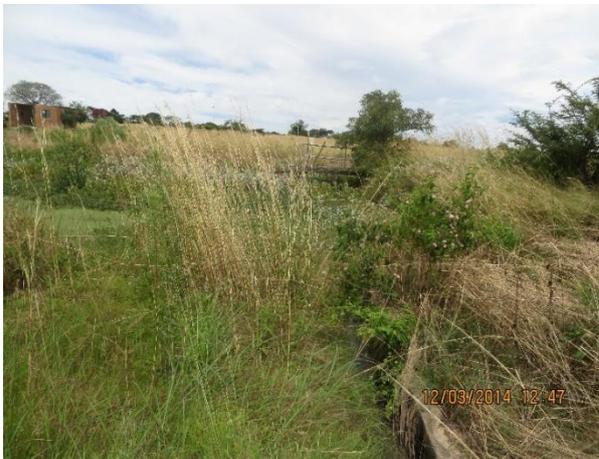
c. Overgrown grass and reeds inside the ponds

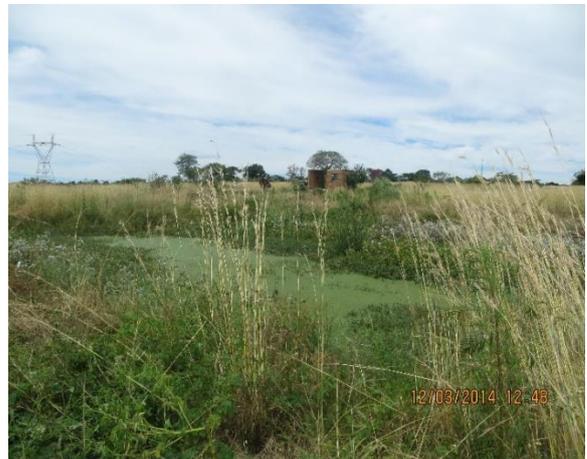
d. Overgrown grass and reeds inside the ponds

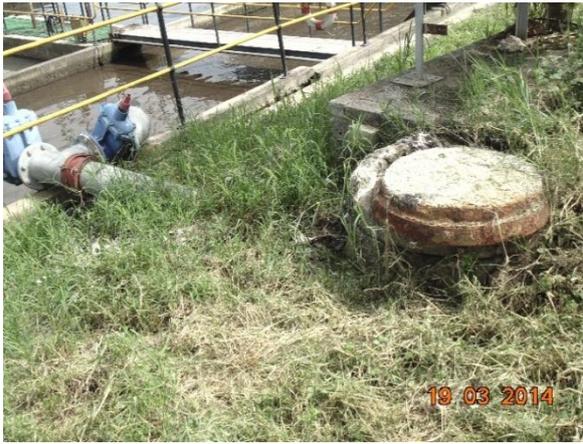
- All process controllers are classified as Class 0.
- Inflow and outflow meters are working.
- There were traces of previous sewage spillage on the ground from the manhole next to the aeration basin. See Figure 44.

a. Traces of manhole overflow

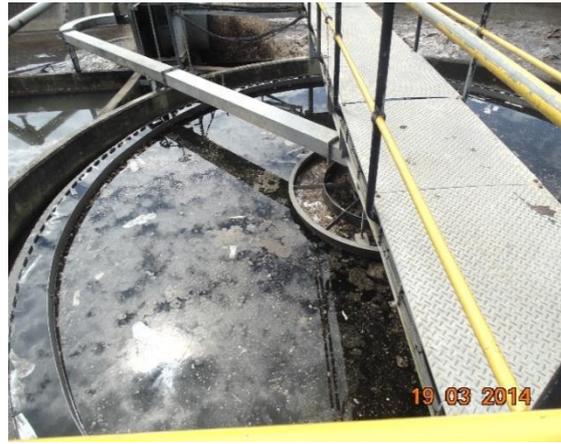
- There is built-up scum at the clarifier as there is no general worker to clean it. See Figure 46 (b).
- There are two drying beds, but only one was used at the time of reporting and both drying beds were full of weeds. See Figure 44.

b. Clarifier full of scum and floating sludge

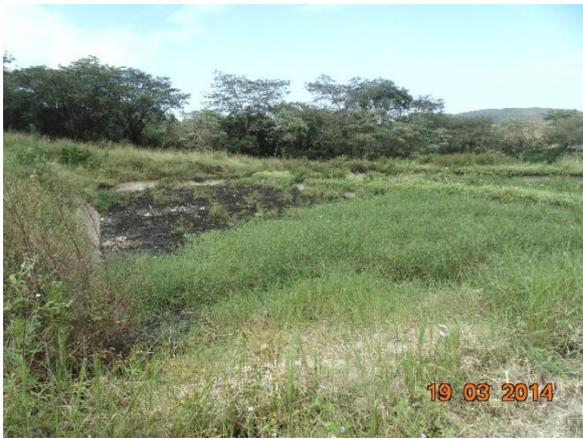
c. Drying bed full of weeds

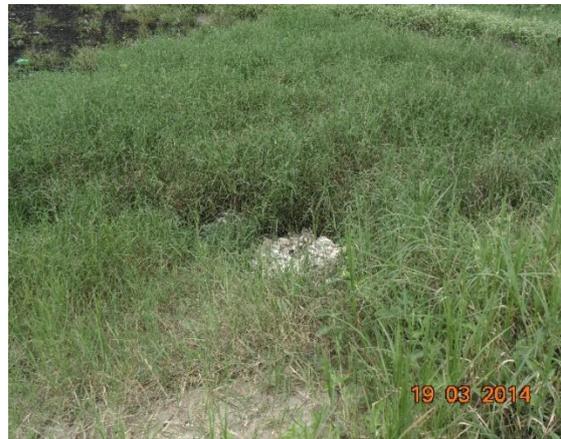
- Screenings are disposed of in the drying beds and the sludge pump was not working at the time of reporting. See Figure 46 (d).

d. Screenings disposed of in the drying beds

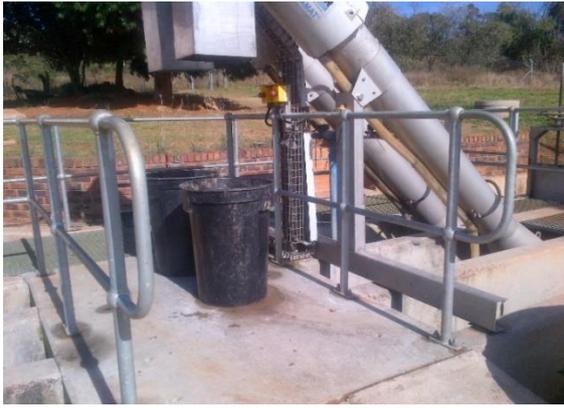
a. Mechanical screens

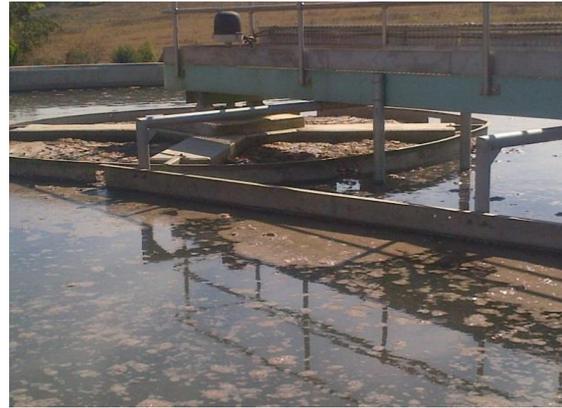
- Figure 47 shows a Google image (Google Earth, 2013) of the White River WWTW.
- The type of process technology applied by the WWTW is activated sludge.
- The WWTW has a design capacity of 6 ML/day.
- The average daily flow (operational) capacity is unknown because the plant does not have flow measuring devices.
- The plant has been classified as a Class B (02/07/2012) in terms of regulation 2834.
- The WWTW is authorised (Licence No. 24089442) to discharge treated effluent into the White River.
- Discharge effluent quality is shown in Table 12.
- Process controllers are all classified.
- The inflow meter is not working.
- The old plant is not working as the aerator and mixer have been working for more than two years and the sludge is stored on the banks of the drying beds. See Figure 48.

b. Clarifier full of sludge

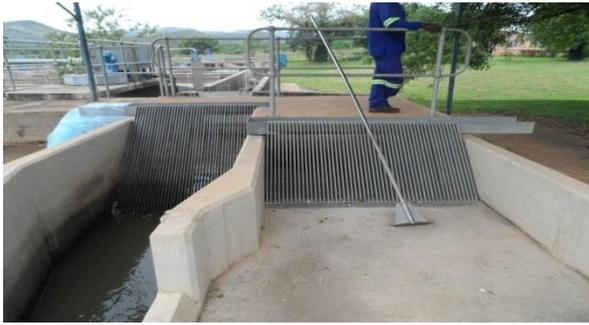
a. Inlet free of debris and screenings properly disposed of

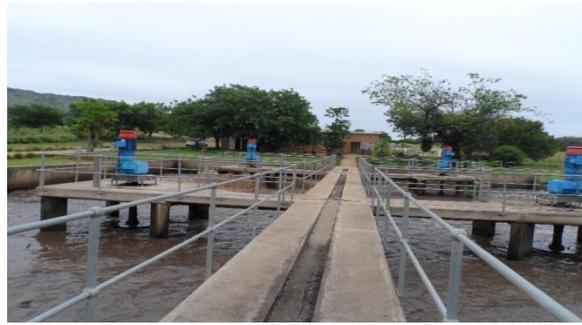
b. Activated sludge

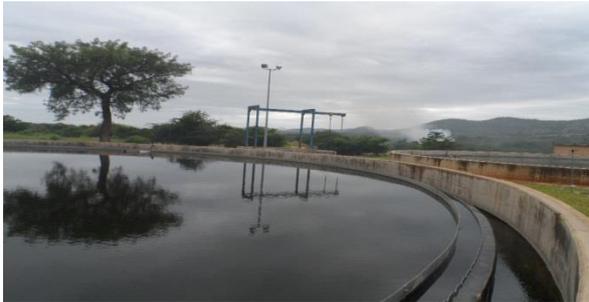
c. Clarifiers clear of algal growth

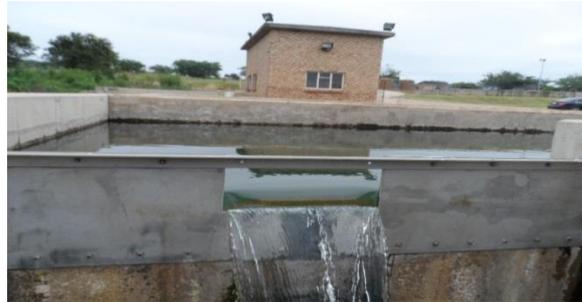
d. Final effluent disinfected and clear of scum

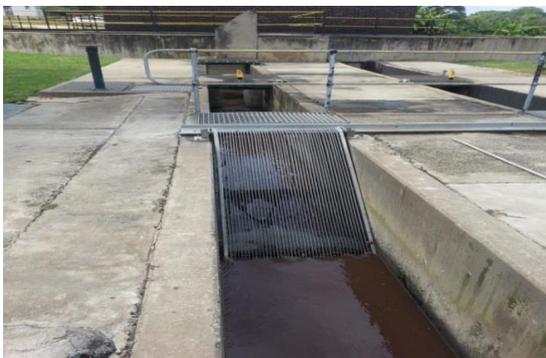
a. Inlet free of debris and equipped with automated screening remover

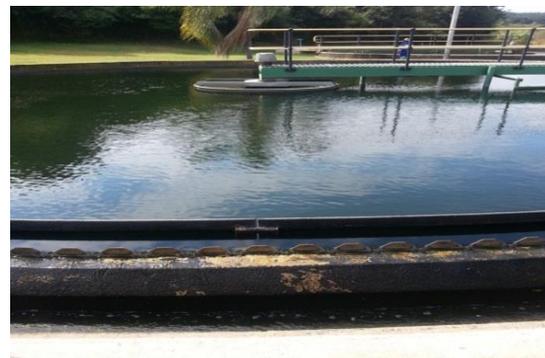
b. Clarifiers free of algal growth

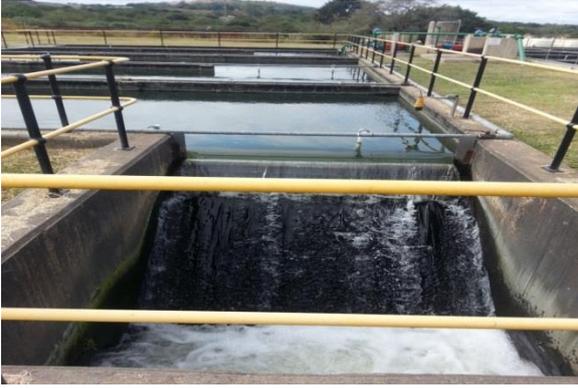
c. Final effluent disinfected and clear of scum

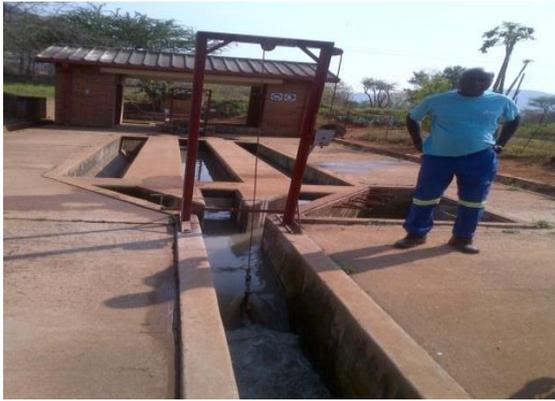
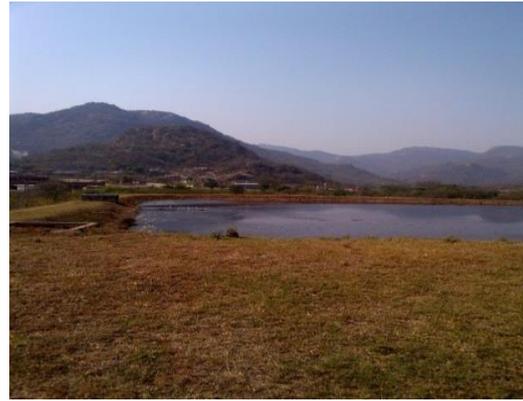
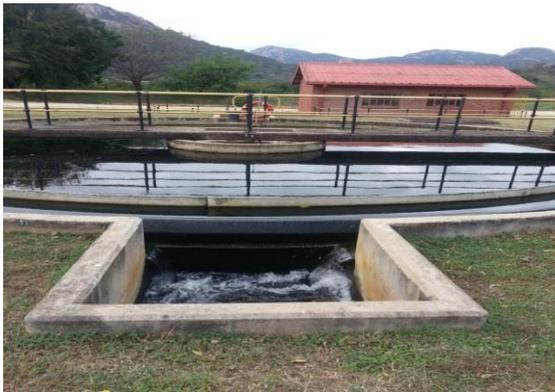
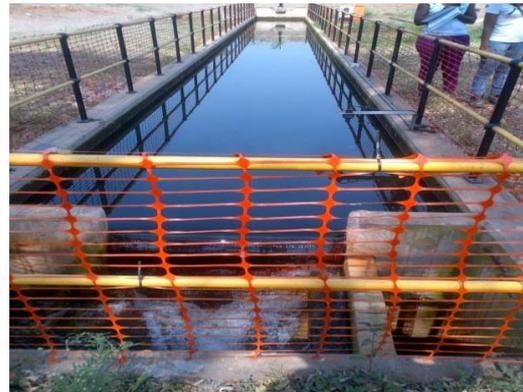
Figure 55: Pictures showing various components of the Kanyamazane WWTW

The above table indicates that the WWTW did not comply with the effluent discharge standards for NH₃, NO₃ and *E. coli* for almost the whole duration of the reporting period. High PO₄ and NO₃ contribute to nutrients which may result in eutrophication and the water not being fit for use. High *E. coli* is a threat for crop production, especially those crops eaten raw, and may also lead to waterborne diseases for those people who use water directly from the resource. The WWTW had introduced the usage of ferric chloride in the process to treat phosphate. This resulted in high levels of sludge being formed and was subsequently stopped. Weekly de-sludging and the usage of chlorine gas have been introduced.

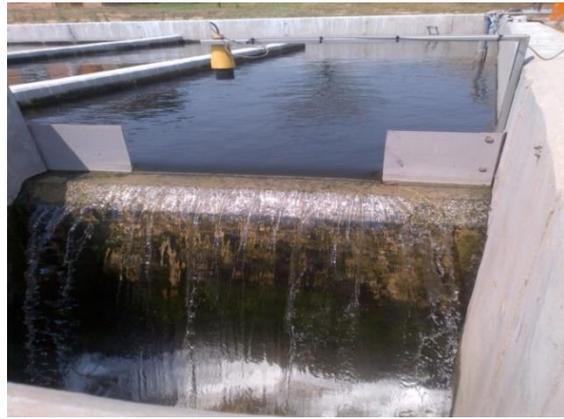
b. Effluent chlorine contact channel clear of scum

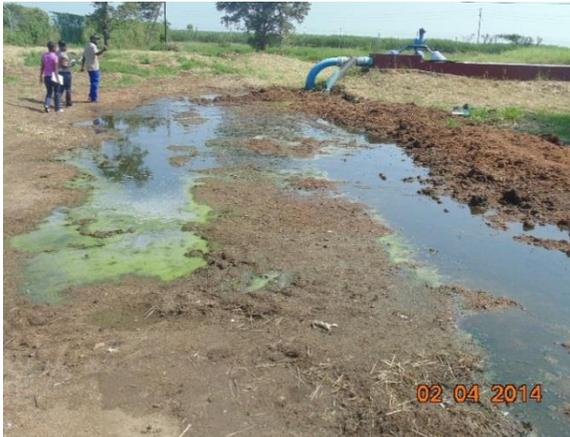
a. Sewage overflow next to the inlet pipe

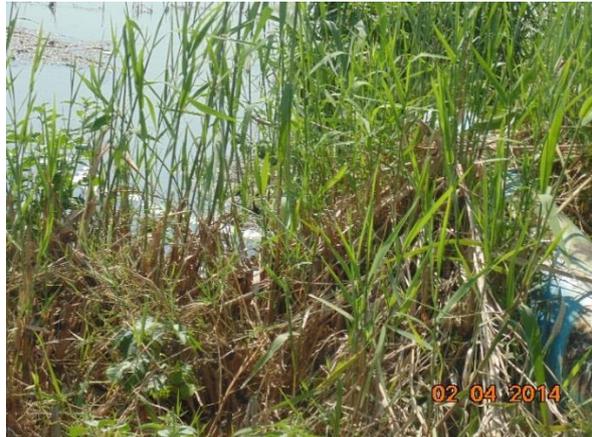
b. Sewage inflow in pond 2 with sludge and overgrown weeds

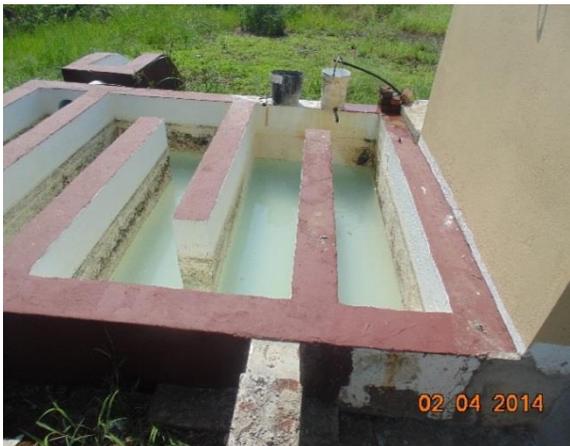
- The average daily flow (operational) capacity is unknown because the plant does not have flow measuring devices.
- The WWTW has not been registered in terms of the requirements of regulation 2834 and therefore the class of the plant is not known.
- There were no process controllers on site. Currently the Municipality employs two process controllers.
- The WWTW does not have a water use authorisation for the discharge of effluent into the Crocodile River.
- The office and the security house are currently undergoing refurbishment. No screening is taking place.
- Sewage from the inlet is diverted to the second pond, and all ponds are full of algae and there is no disinfection of the final effluent.
- The effluent discharge quality is shown in Table 18.
- There is no outflow from the outlet (see Figure 59) while there is an inflow into the second pond.

c. Chlorine channel with no outflow; only clean water

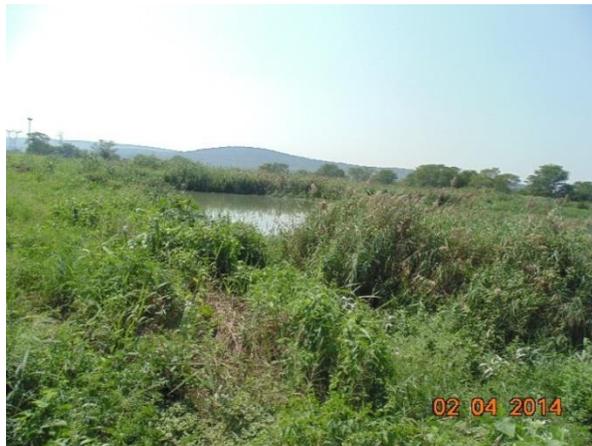
d. Ponds full of weeds

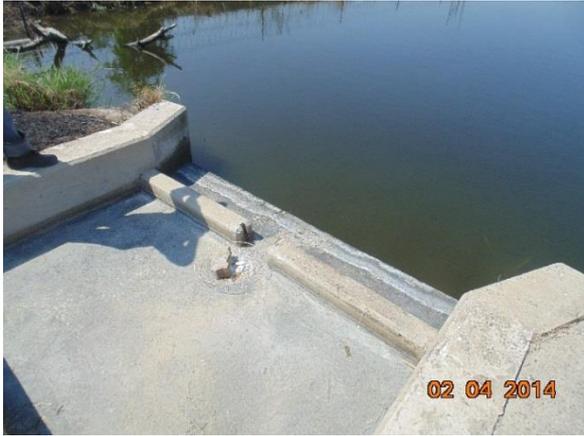
a. Final pond into chlorination channel with no outflow (HTH tablets)

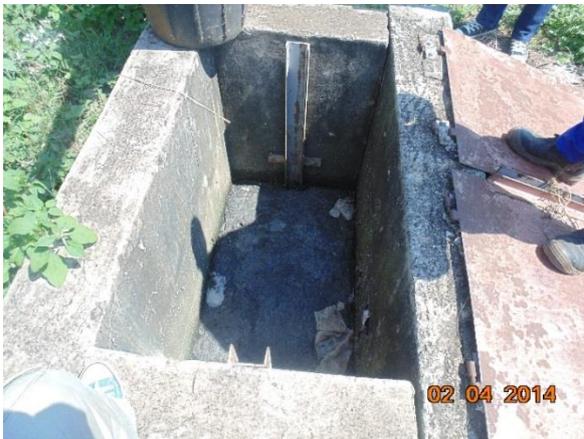
c. Inlet with no screens

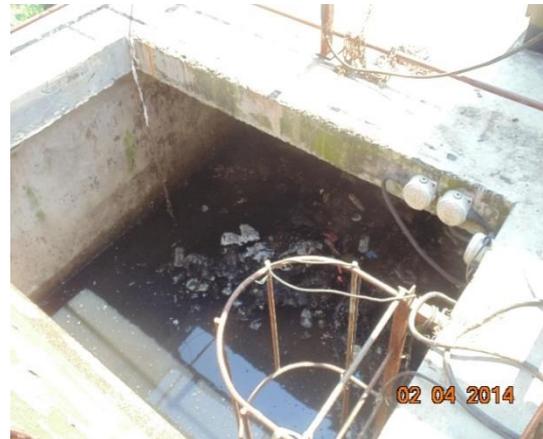
- The plant has built-up scum at ponds 1 and 2.
- The pumps at the pump station had been removed for repairs. See Figure 61.
- The removed pumps are normally used to pump raw sewage from the pump station to the oxidation ponds.

d. Sump full of sewage with no pump

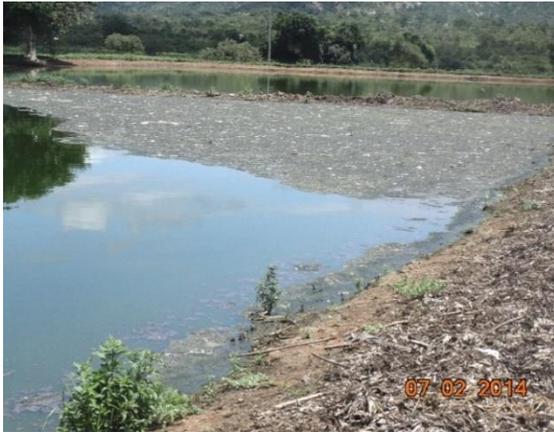
- There is a build-up of scum in the 2 primary ponds. See Figure 63.
- The final pond is full of algae. See Figure 63.
- The plant discharges partially treated sewage into the Crocodile River. See Figure 63.

a. Ponds full of scum and sludge

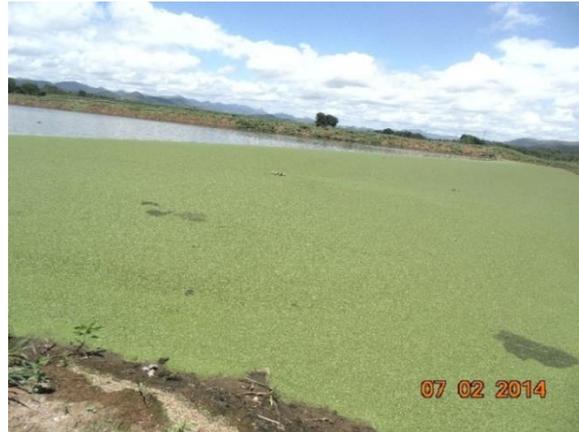
b. Final pond full of algae

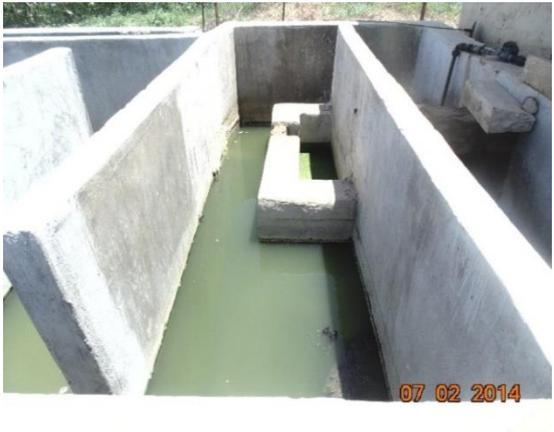
c. Chlorination channel with floating sludge

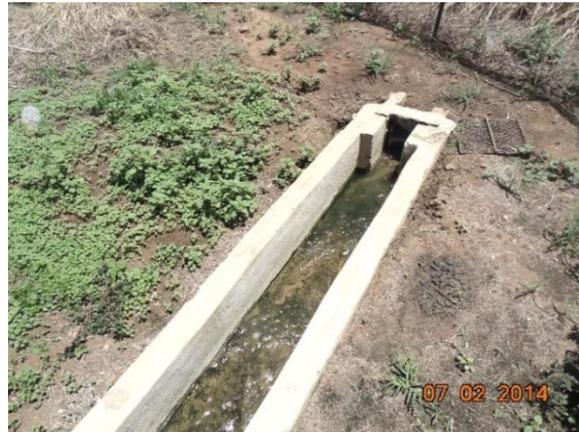
d. Partially treated effluent discharged at this point into the Crocodile River

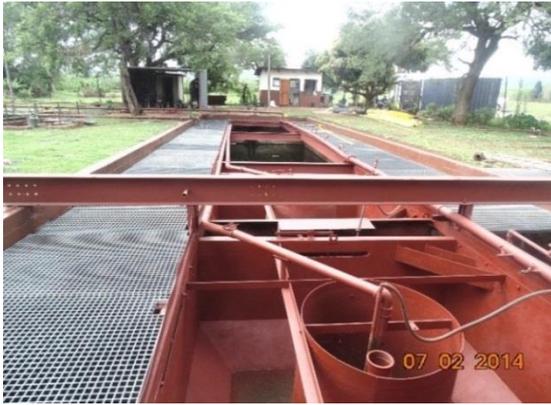
- One aerator and one clarifier were not functional due to the refurbishment that was taking place. See Figure 65.

a. Refurbished treatment works

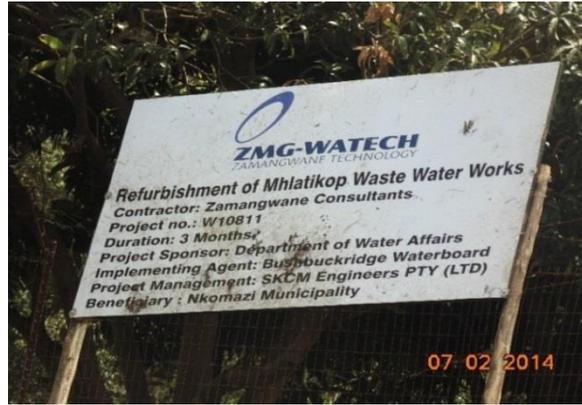
b. Sign board displaying refurbishment being conducted

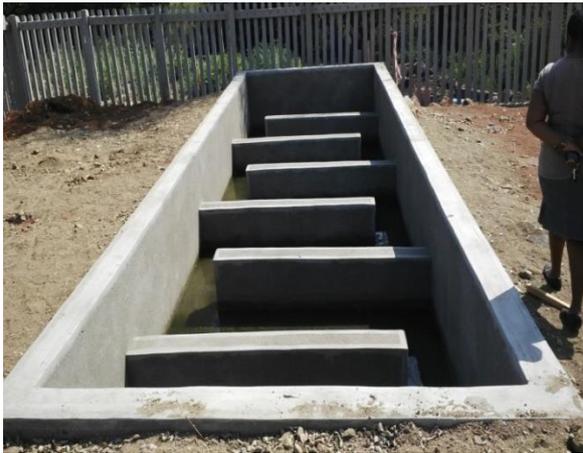
a. Disinfection chamber enlarged

- The plant is still undergoing refurbishment (see Figure 67) and expected to be handed over to the Municipality by the end of July 2014.

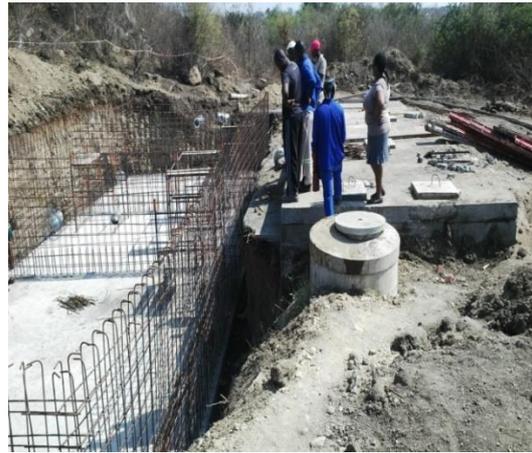
b. Screening chamber rebuilt

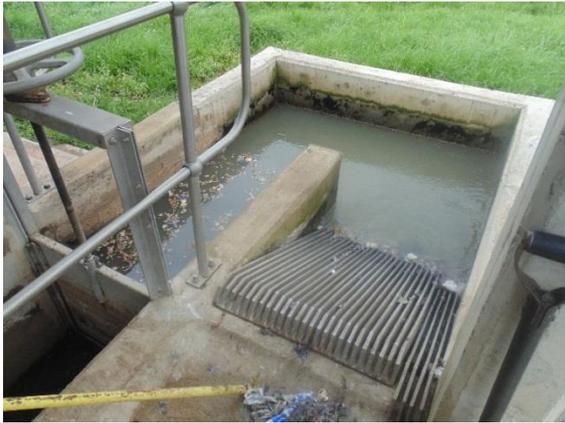
- The plant was using the manual screen only because the mechanical screen has been down since 2012. See Figure 12 (a).
- Previously the plant received raw sewage from the broken pump station into the drying bed.

a. Screens with screenings

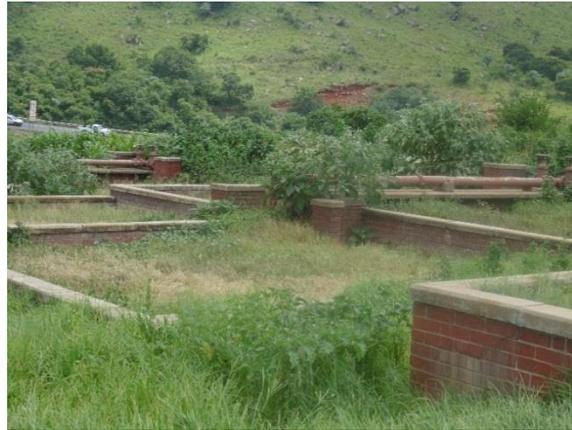
- There was evidence of raw sewage overflow near the inlet or screen.
- The digester was full of sludge. See Figure 69.
- The drying beds are not used and they were covered with grass/weeds. See Figure 69.

b. Drying beds full of weeds

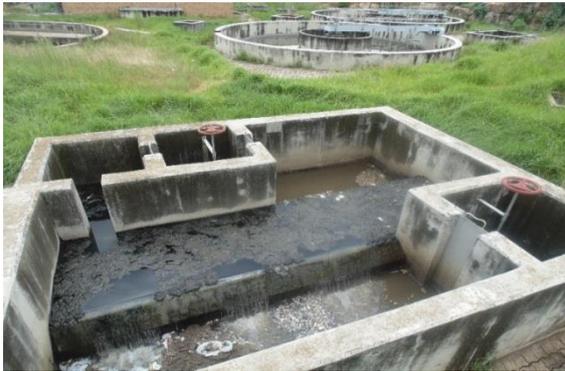
c. Sludge from the aeration basin

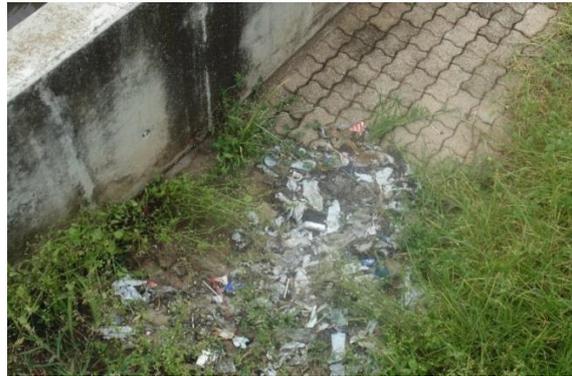
d. Screening deposited next to the aeration basin

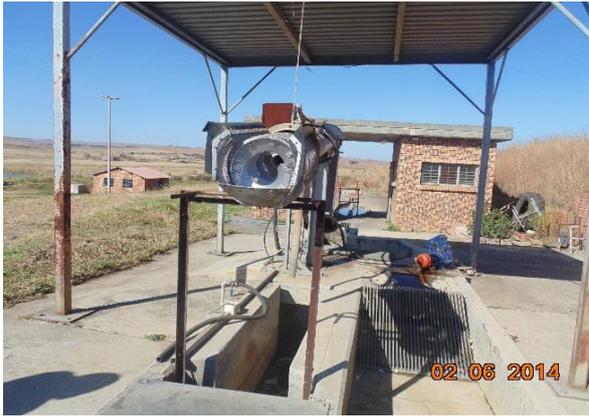
a. Mechanical screens not working

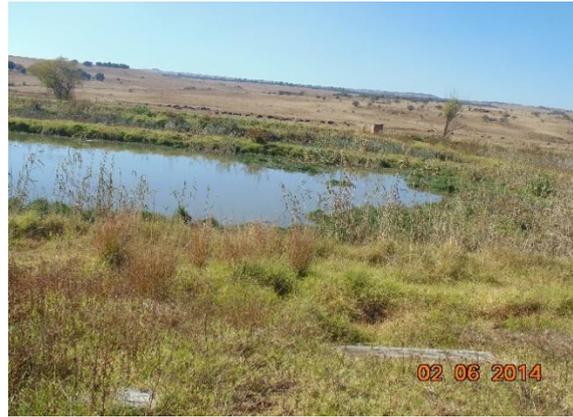
b. Ponds full of weeds

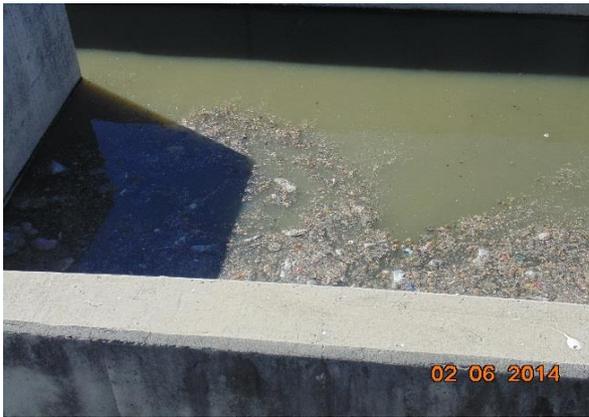
c. Aeration basin full of floating scum

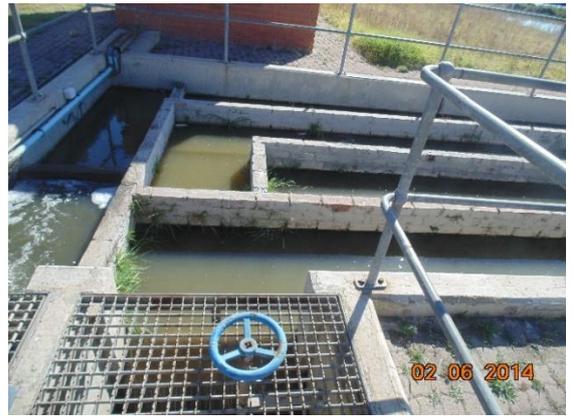
d. Chlorination channel full of floating sludge

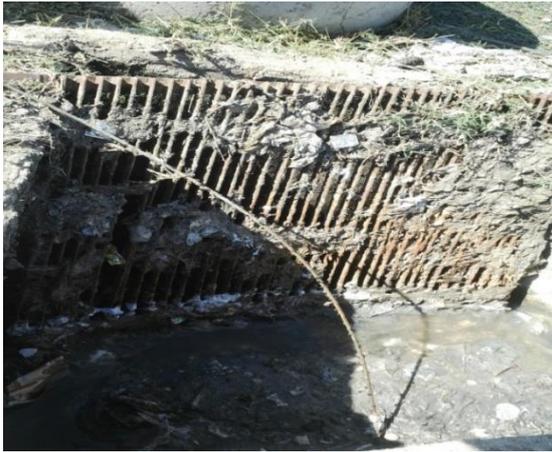
a. Screen located in residential area

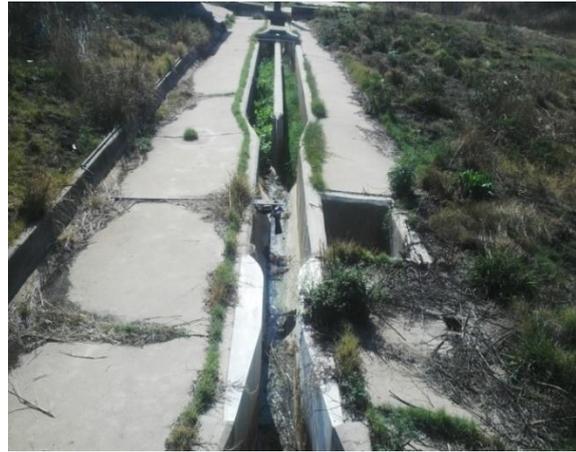
b. Plant poorly maintained

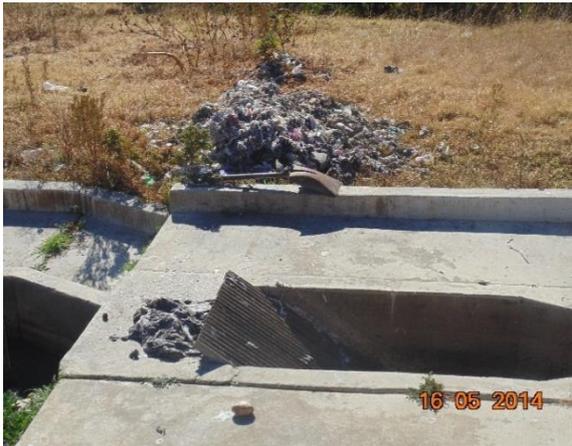
- The average daily flow (operational) capacity is unknown.
- The plant has been classified as a Class E (9/10/2012) in terms of regulation 2834.
- Screenings are not properly disposed of. See Figure 75 (a).

a. Screenings are properly disposed of

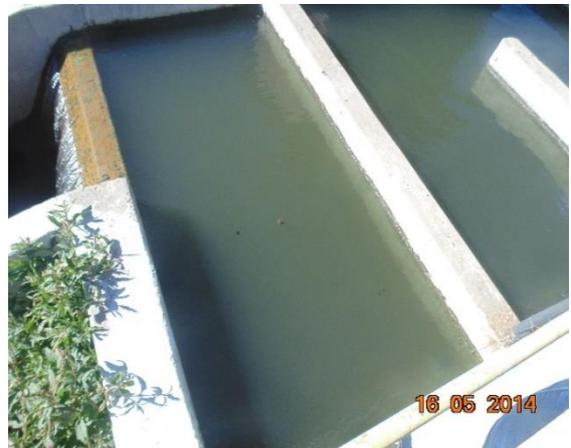
e. WWTW discharges partially treated sewage with floating sludge

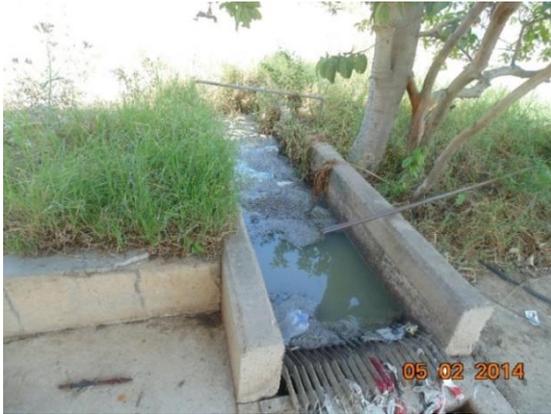
- Inlet screens were full of screenings. See Figure 77 (a).
- The copies of the process controllers' and supervisor's classification certificates were not available at the WWTW and therefore could not be verified.

a. Screens with screenings

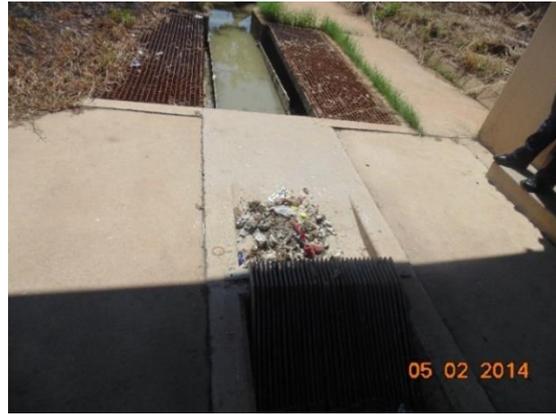
b. Screenings stored to dry up before disposal into the trenches

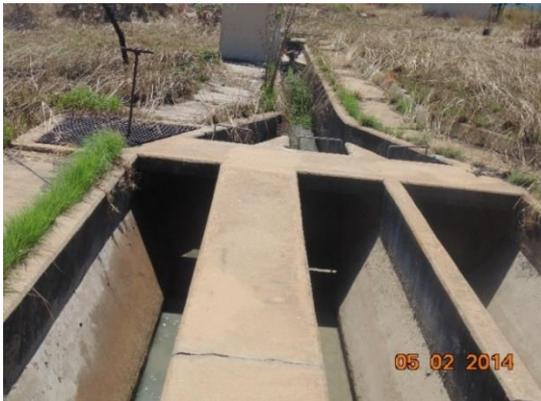
c. Grit channel overgrown with grass

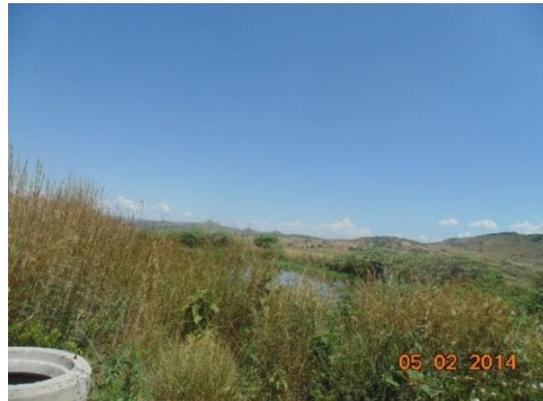
d. Ponds full of weeds

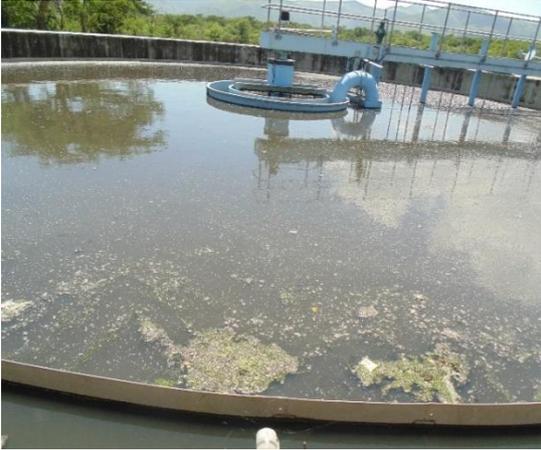
a. Clarifier full of sludge

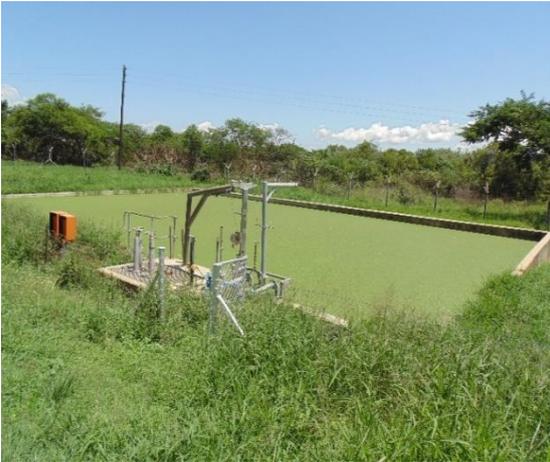
c. Drying bed full of water with algae

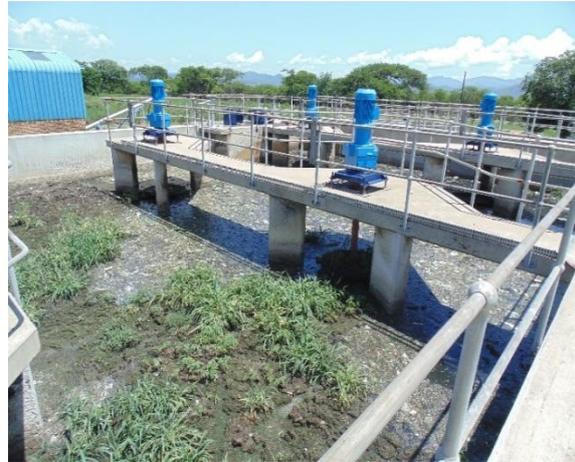
- The WWTW has a water use authorisation for the discharge of effluent into an unknown stream.
- The average effluent discharge quality is shown in Table 26.
- The WWTW does not have an emergency dam.
- All process controllers are classified.
- The plant uses one manual screen and the mechanical screen has been broken since January 2013.
- The plant also uses 2 aerators instead of 12, and 1 clarifier instead of 4.
- The WWTW discharges partially treated sewage with floating sludge into the environment.
- The WWTW is in the processes of refurbishment and during the inspection the contractor was not available on site. However, there was evidence of digging next to the bio-filters.
- The aeration basin located on the western side was full of sludge. See Figure 80 (d).

d. Aeration basin with built-up sludge

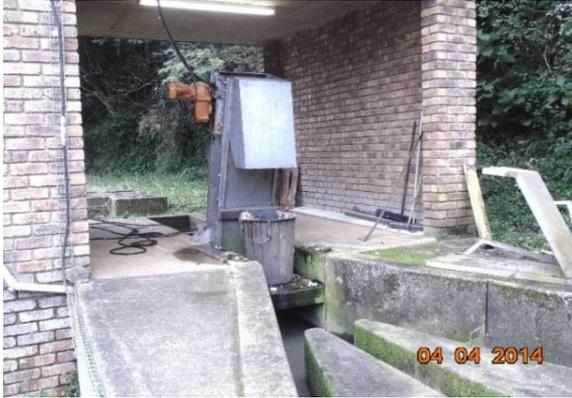
- An emergency dam is not available.
- The WWTW uses mechanical screens (see Figure 82 (a)). All aerators are working.
- The clarifier was covered with some floating sludge (see Figure 82 (c)) and the sludge pump had been removed for repairs.

a. Mechanical screen is working

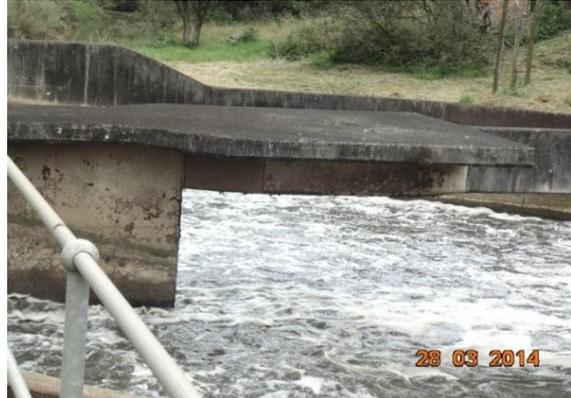
b. Aeration basin is working

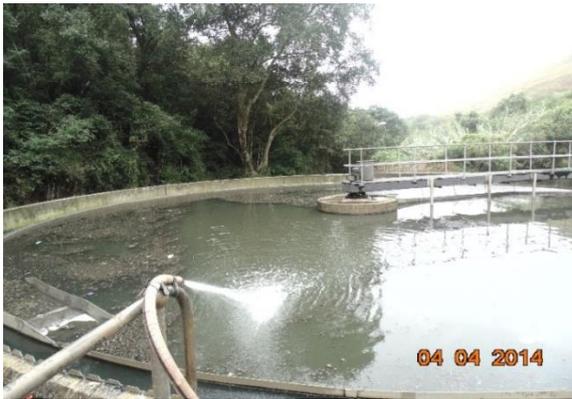
c. Pipe is installed to clean floating sludge in the clarifier

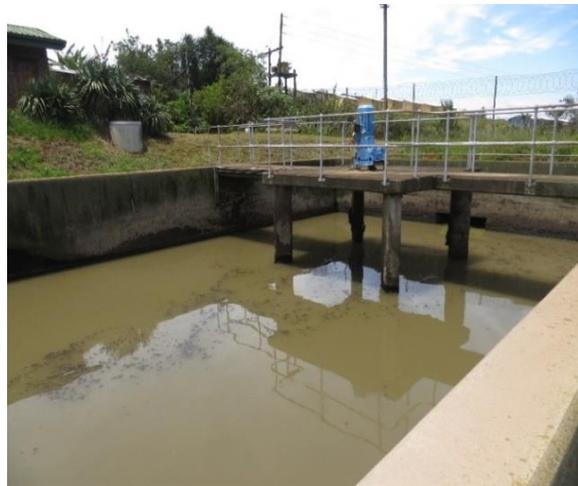
- Figure 83 shows a Google image (Google Earth, 2014) of the Graskop WWTW.
- The type of process technology applied by the WWTW is activated sludge.
- The WWTW has a design capacity of 1 ML/day.
- The average daily flow (operational) capacity is 1.2 ML/day.
- The WWTW has not been registered in terms of the requirements of regulation 2834 and therefore the class of the plant is not known.
- The copies of the process controllers' and supervisor's classification certificates were not available at the WWTW and therefore could not be verified.
- The average effluent discharge quality is shown in Table 28.
- The WWTW does not have a water use authorisation.
- The treatment plant has a crack on the walls of the aeration tank which results in partially treated sewage leaking out of the aeration tank. See Figure 84.
- The overflow is contained in an emergency pond.

d. Aeration tank

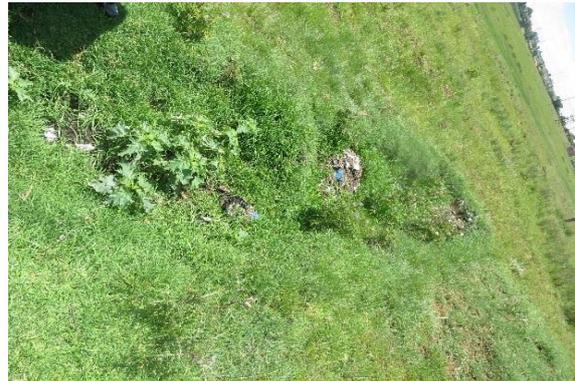
b. Screenings disposed of in a trench

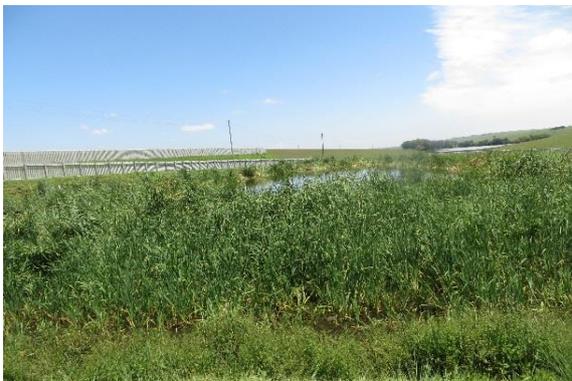
c. Ponds with weeds

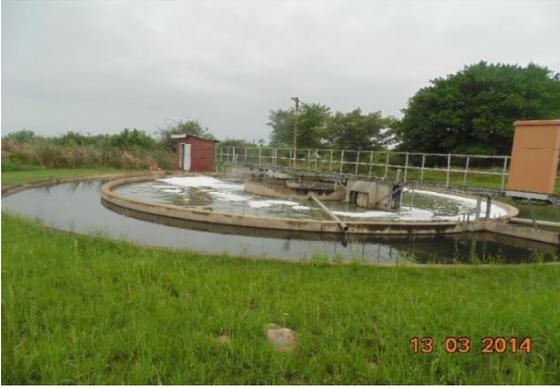
- The WWTW uses one rotation disk instead of two. Screenings are disposed of next to the inlet. See Figure 88 (b).
- There are suspended solids in the chlorination channel and the WWTW discharges partially treated sewage (see Table 29) with floating sludge into the environment.

a. Aeration basin with one rotation disk working

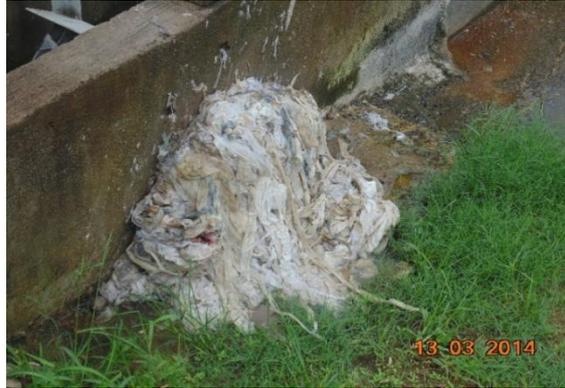
b. Screenings not properly disposed of

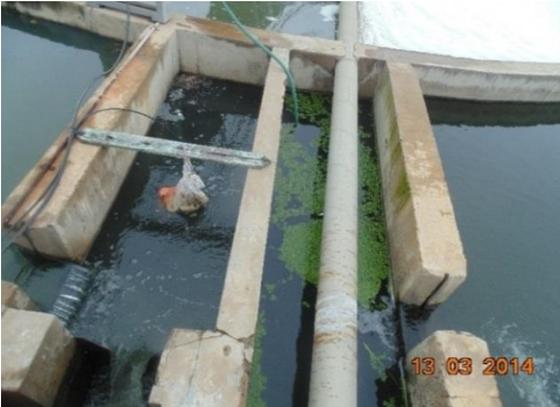
c. Some algae growing in the chlorination channel

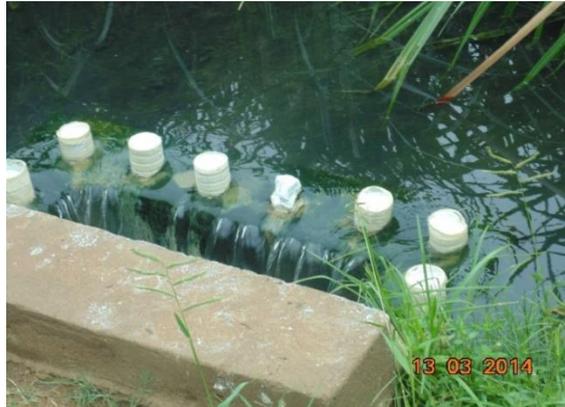
d. HTH tablets from the reed bed

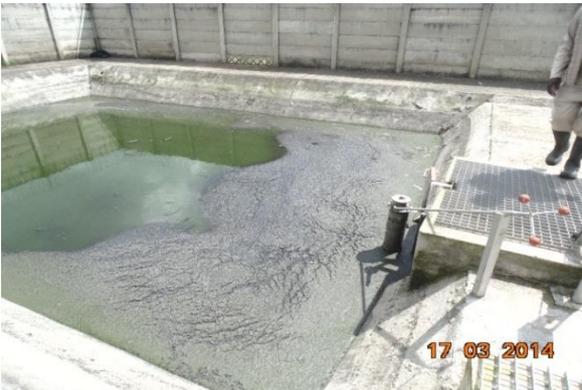
- The sludge pump was not working.
- The WWTW discharges partially treated sewage with algae floating. See Figure 90 (d).

c. Drying bed and the non-functional sludge pump
