INKOMATI-USUTHU
CATCHMENT MANAGEMENT AGENCY

ANNUAL WATER QUALITY STATUS REPORT FOR THE INKOMATI WATER MANAGEMENT AREA

2013 / 14 Financial Year

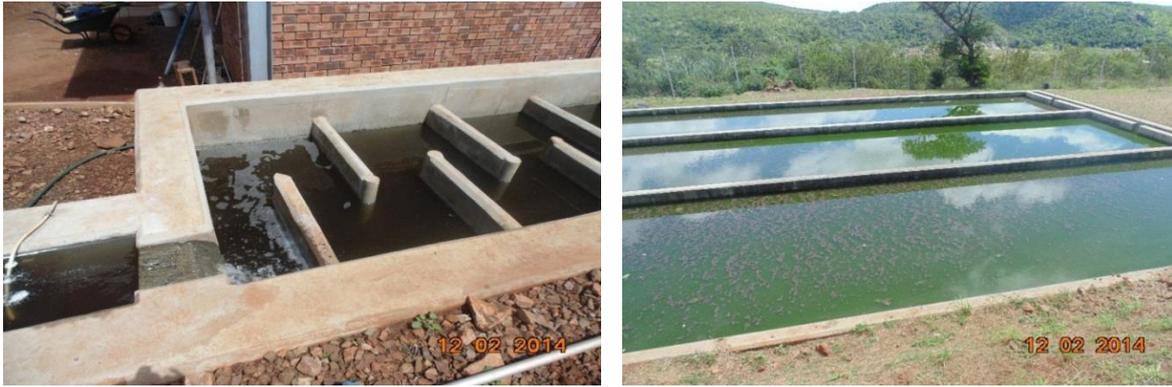
- Screenings are disposed of at Hectorspruit landfill site.
- Clarifiers were full of algae (see Figure 92) and the dried sludge is collected by the site manager.

a. Chlorination channel with foam formation and suspended solids b. Drying bed full of water and sludge

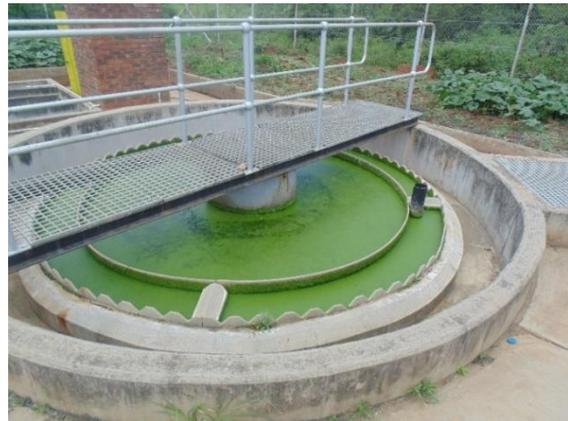
b. Humus tank full of algae

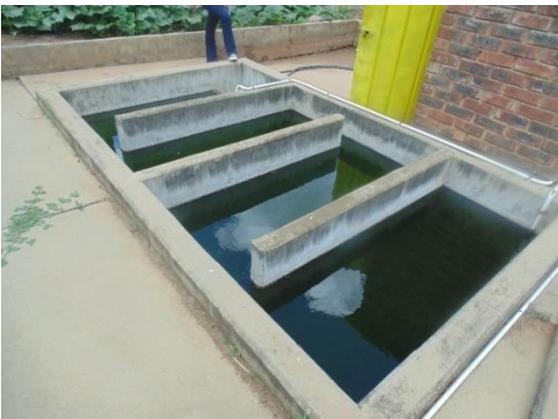
c. Chlorination channel with no disinfection taking place

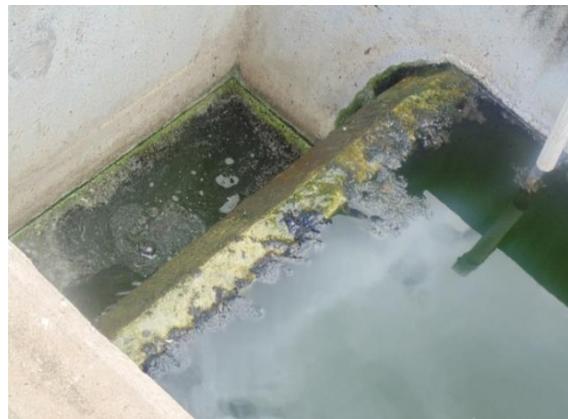
d. Discharge of partially treated sewage

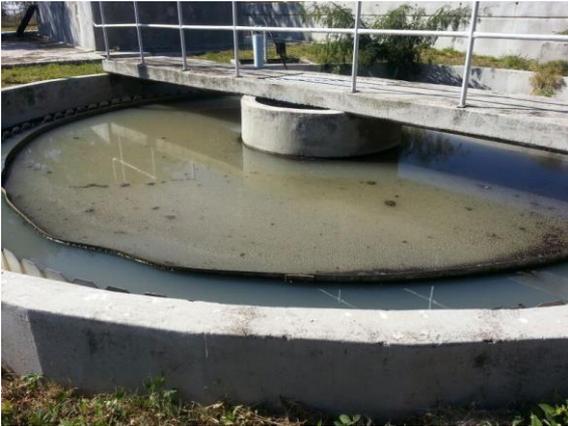
- The plant is operated by New Business Networks.
- The PC does not have protective clothing.
- The clarifier was full of scum and water hyacinth, and no disinfection of the final effluent is taking place at the WWTW. See Figure 96 (c).

c. Humus tank full of floating sludge

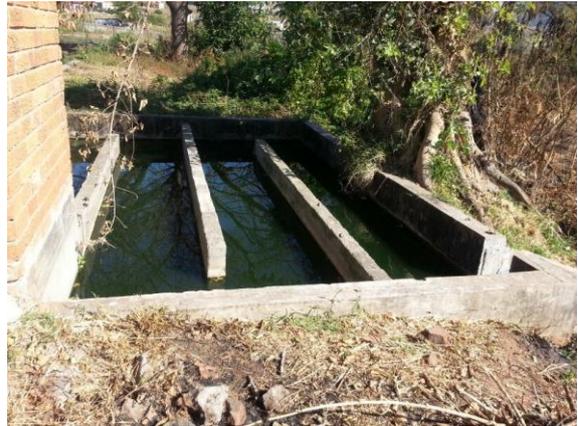
- The WWTW discharges partially treated sewage. See Figure 96 (d) and Table 30.

d. Chlorination channel with no disinfection

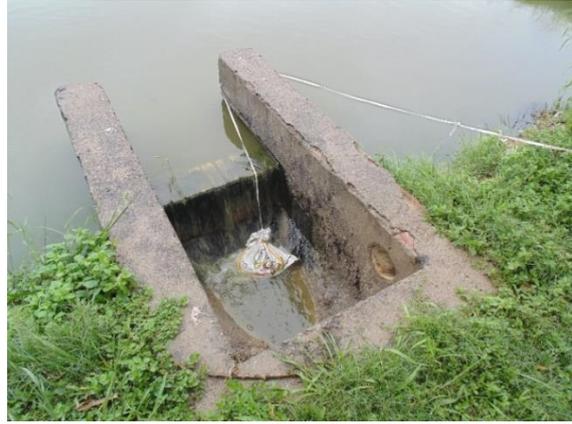
- HTH was used to disinfect the final effluent in the collection ponds and it does not serve the required purpose. See Figure 100 (b).
- There was a build-up of scum in the two ponds.

b. HTH disinfection point

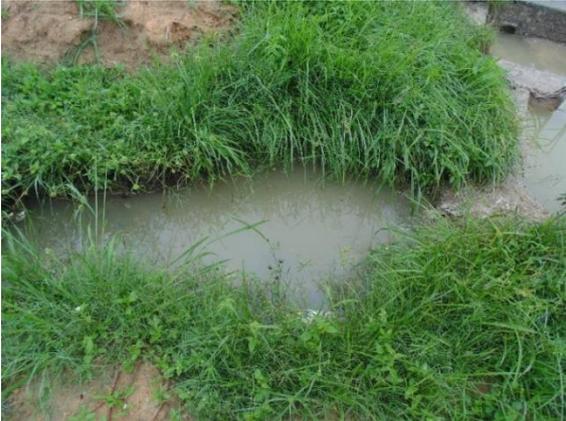
- The ponds discharge partially treated sewage into the unnamed stream.

c. Overflow into the unnamed stream

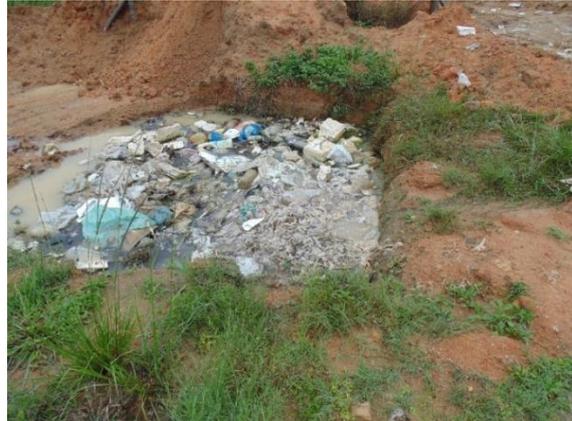
- Screenings are disposed of into a trench. See Figure 100 (d).
- The WWTW does not have a water use authorisation for the discharge of effluent into an unknown stream.

d. Screenings disposed of in a trench

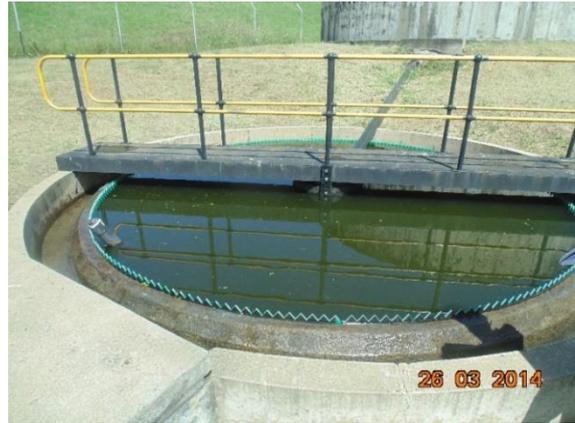
- The humus tank was full of algae and scum. See Figure 102 (b).
- Under the drain of the biological filter were debris and plant material and there was no disinfection taking place.

b. Humus tank with some algae

- Recently, the humus tank was replaced with a new one and the plant was using chlorine gas for disinfection.

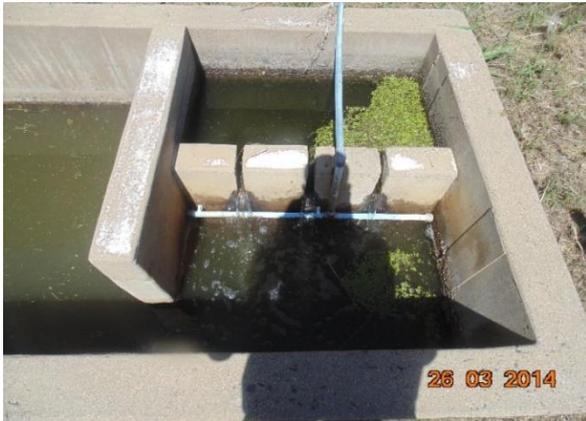
c. Chlorination channel with algae

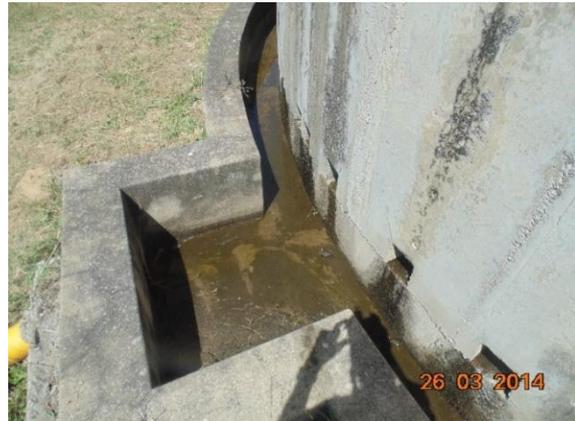
d. Overflow from the trickling filter

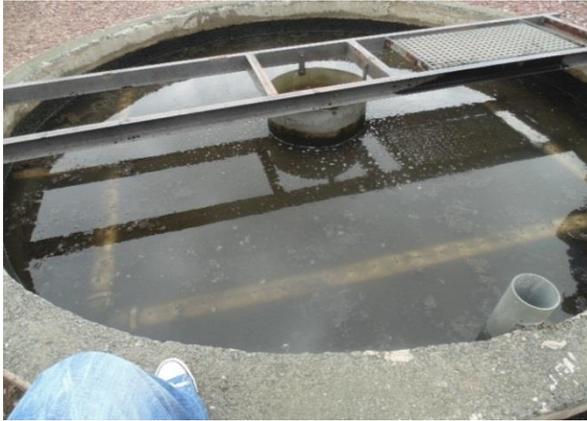
- The WWTW does not have a water use authorisation for the discharge of effluent into the Elands River.
- The humus tank was full of suspended solids and the reed bed filled with sewage effluent. See Figure 104.

a. Humus tank with suspended solids

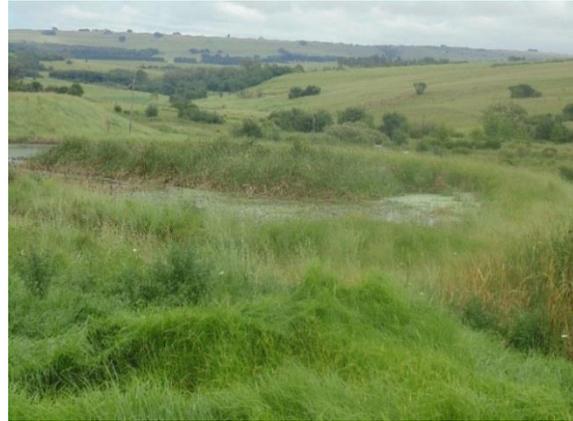
b. Reed bed full of sewage effluent

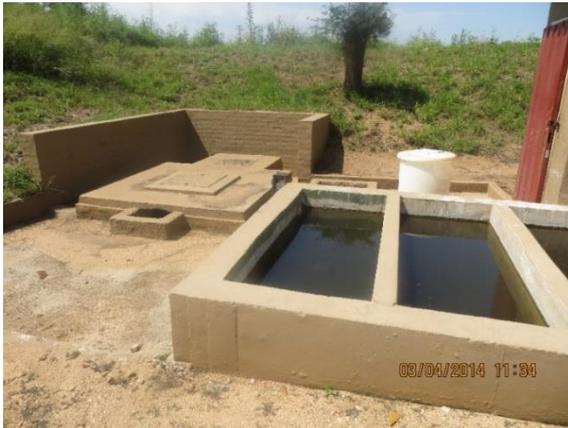
a. Chlorine dosing housing

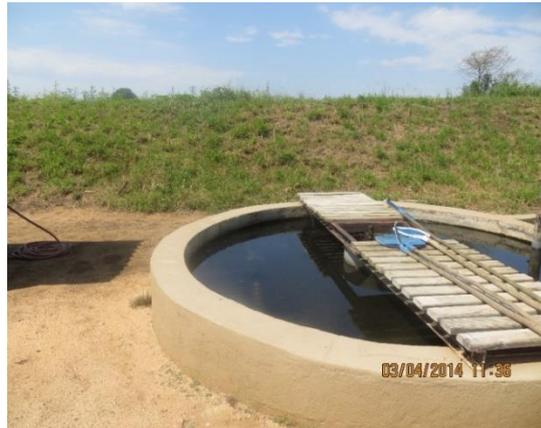
b. Humus tank

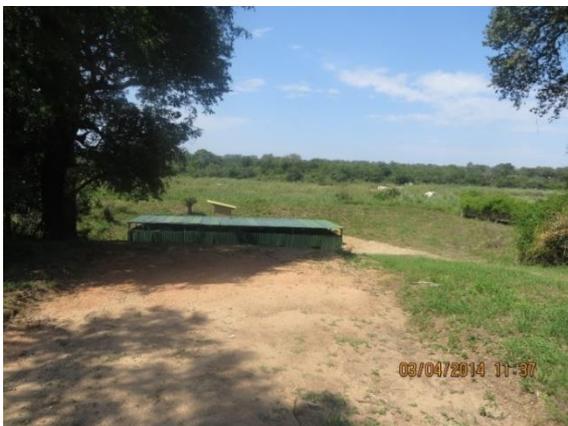
c. The yard and the bio-disc house

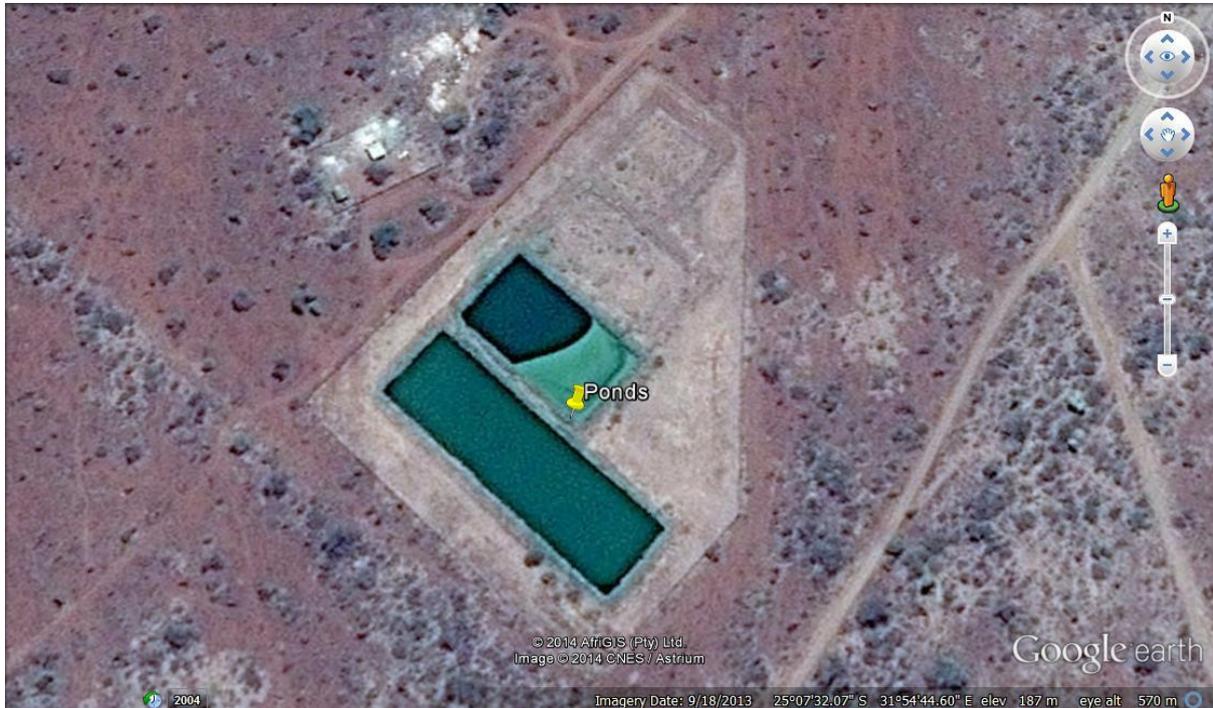
Figure 109: A Google image showing the location and layout of the Lower Sabie Rest Camp WWTW

- Figure 109 shows a Google image (Google Earth, 2013) of the Lower Sabie Rest Camp WWTW.
- The type of process technology applied by the WWTW is oxidation ponds.
- The WWTW design capacity is unknown.
- The WWTW has been registered in terms of the requirements of regulation 2834 and therefore the class of the plant is Class E.
- There are no bathrooms on site. Workers make use of the camp's bathrooms and lunch facilities.
- Ponds receive effluent from the septic tank. Pond 2 was full of algae. Only two ponds are operational at present.

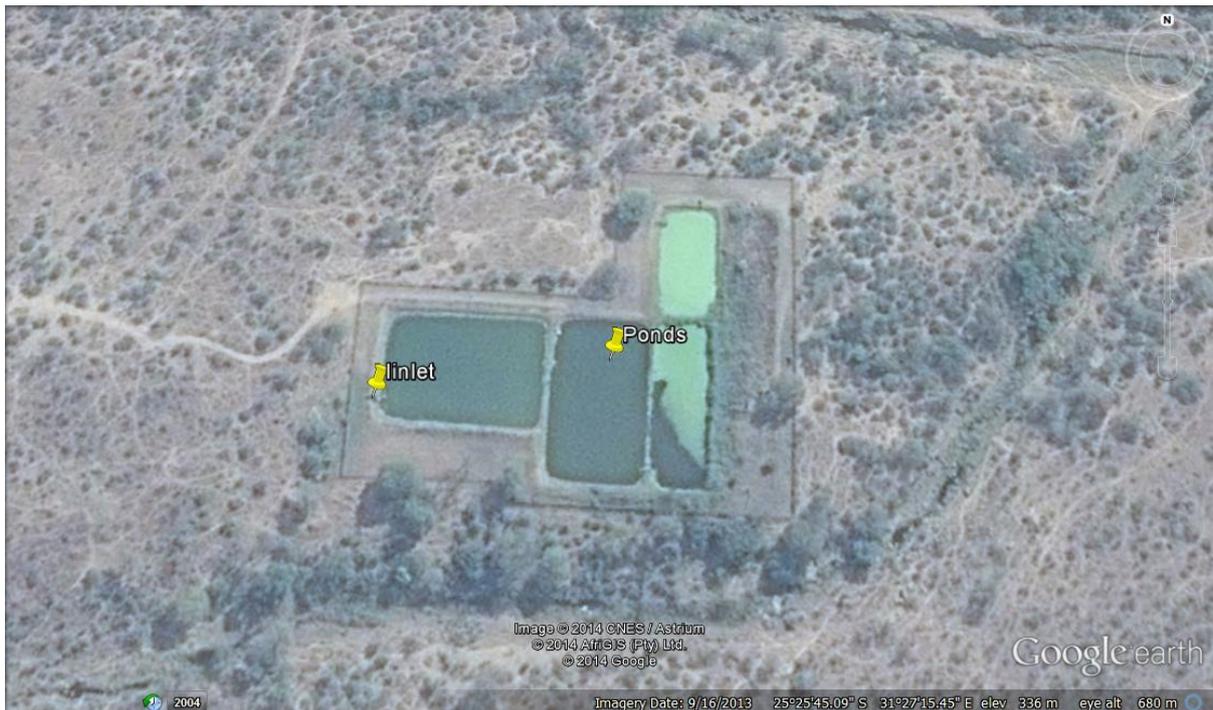
Figure 111: A Google image showing the location and layout of the Berg-en-dal Rest Camp WWTW

- Figure 111 shows a Google image (Google Earth, 2013) of the Berg-en-dal Rest Camp WWTW.
- The type of process technology applied by the WWTW is oxidation ponds.
- The WWTW design capacity is unknown.
- The WWTW has been registered in terms of the requirements of regulation 2834 and therefore the class of the plant is Class E.
- There are no bathrooms on site. Workers make use of the camp's bathrooms and lunch facilities.
- Pond 1 is full of scum, and the banks of ponds 3 and 4 are overgrown with weeds and full of algae.

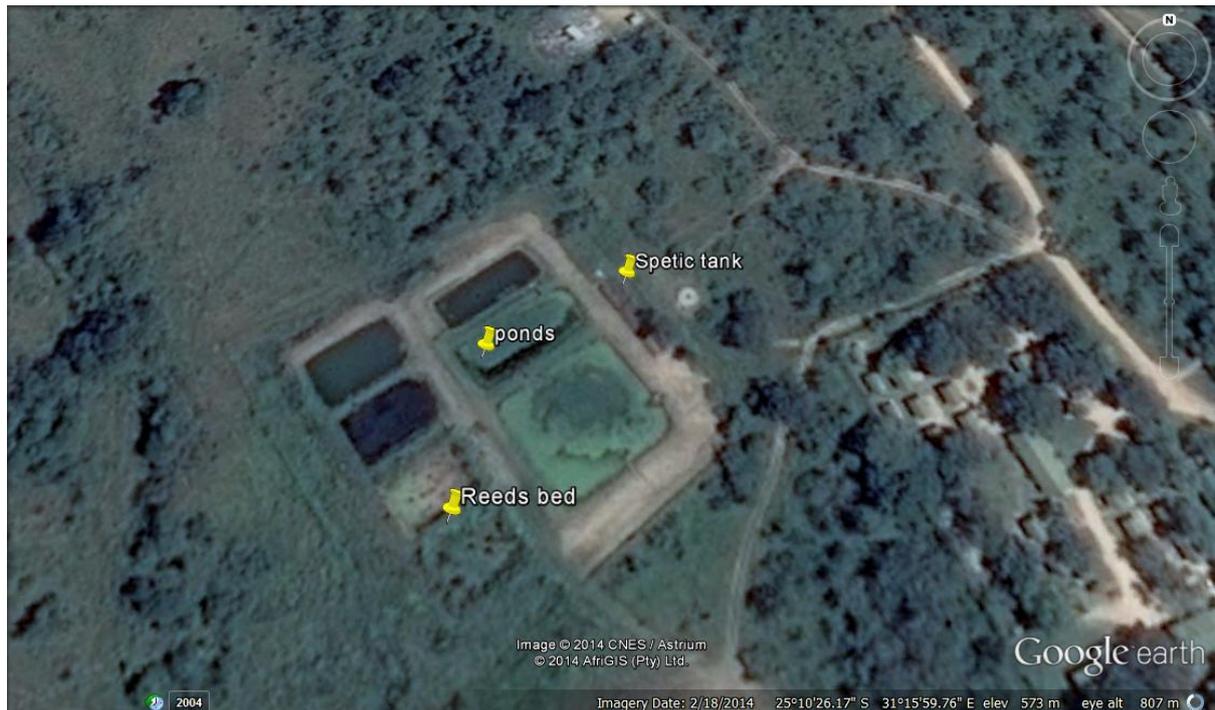
Figure 115: A Google image showing the location and layout of the Pretorius Kop Rest Camp WWTW

- Figure 115 shows a Google image (Google Earth, 2014) of the Pretorius Kop Rest Camp WWTW.
- The type of process technology applied by the WWTW is oxidation ponds and reed beds.

- The reeds were not controlled and have become overgrown.
- The gate was broken and housekeeping was poor.
- The WWTW was in an unacceptable condition.
- Reeds were not controlled and they were more than 2 metres high.
